## 7 FORESHORE EROSION AND STRUCTURES ASSESSMENT

### 7.1 Introduction

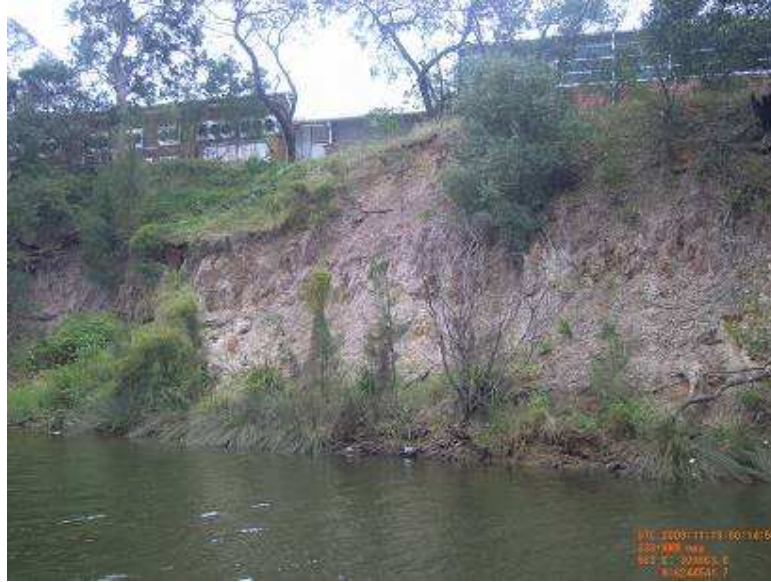
The main channel of the Georges River between Liverpool Weir and Moore Lake is not protected by seawall – except the area surrounding the Liverpool Weir – and is subject to erosion (Figure 7.1). The foreshore along the railway is highly-to-severely eroded as well as the north-western part of McMillan Park foreshore. Some light undercutting occurs on the foreshore opposite the park and moderate erosion occurs opposite the railway (location reference E1 to E6).

Figure 7.1 – Severe erosion between Liverpool Weir and Moore Lake

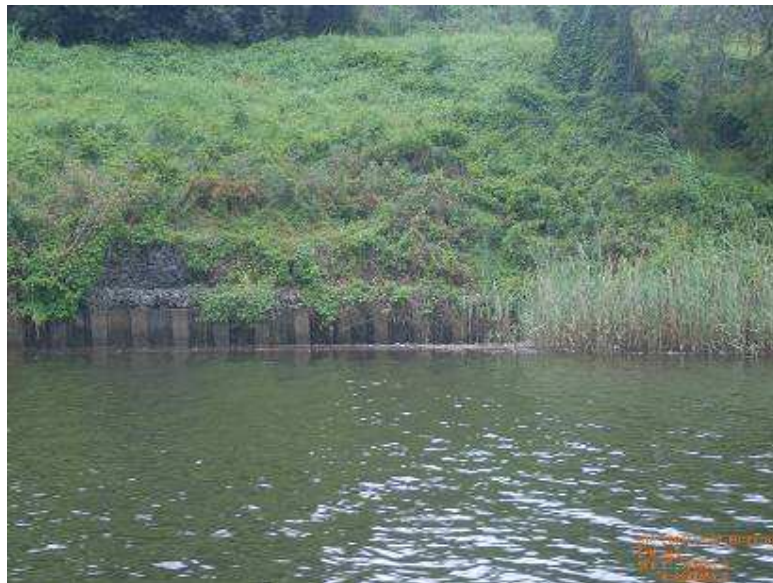
A part of Liverpool Weir is settling on its eastern half. There are only a few seawalls along the foreshore upstream of Chipping Norton. A small gabion seawall supported by sheet piles is located along the northern bank between McMillan Park and Gandangara Island (Figure 7.2). This seawall looks to be in relatively good condition but has been covered with invasive plants (location reference S1-2).

Figure 7.2 – Gabions seawall between McMillan Park and Gandangara Island

Location	LGA	Priority Rating	Management Options (Options provided refer to Seawall Options of Section 7.3.2 of the report)
S1.Liverpool Weir	Liverpool	Medium	Fix the settling part of the weir on its eastern half Creation of more habitat in front of weir (Option S2)
S2.Along northern bank between McMillan Park and Gandangara Island	Liverpool	Medium/High	Sheet piles can be replaced by environmentally friendly rock seawall to allow vegetation growing in the gap of rocks (Option S5) Creation of more habitat in front of sheet piles seawall (Option S2)

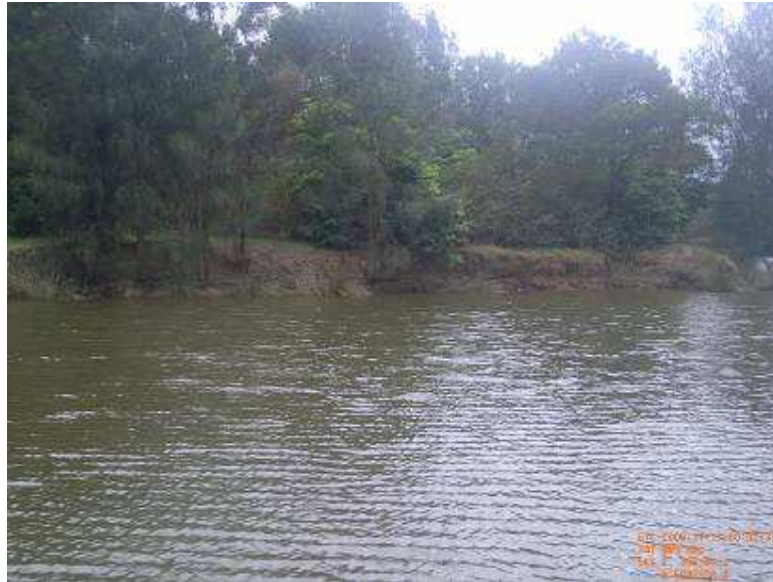
Moore Lake foreshore is in good condition and mostly well vegetated. Some light tidal undercutting occurs along the northern side of the lake and some moderate erosion occurs along the south-eastern side of Bulba Dibeen Island (Figure 7.3). The bank located directly east of Moore Lake entrance along Georges River main channel is moderately eroding (location reference E7 to E10).

Figure 7.3 – Moderate undercutting at Bulba Dibeen Island

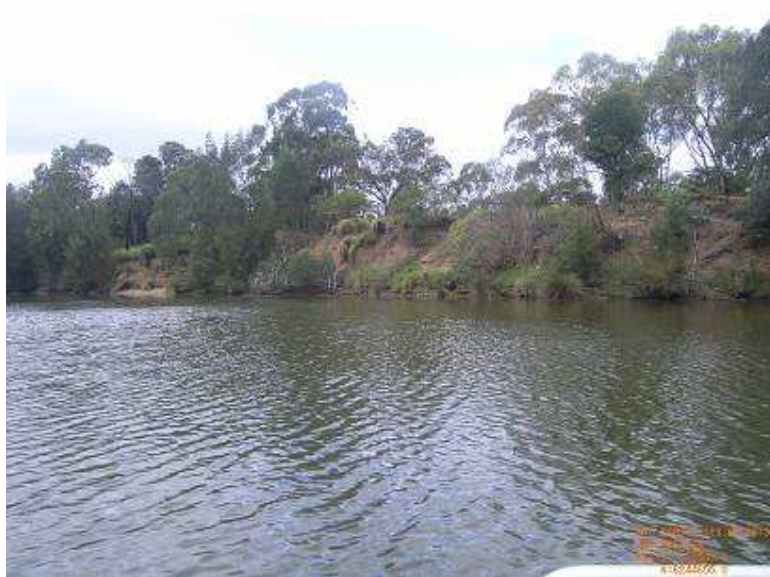
Ngamba Island located in the Georges River east of Lake Moore entrance and upstream of the River bend is subject to light tidal undercutting. The Georges River embankments surrounding this island suffer from light to moderate erosion. The area downstream of this island but upstream of the private dwellings located along the river on the eastern bank within the bend is subject to high erosion (Figure 7.4). Many of the private dwellings have their own seawall and some undercutting is noticeable between the private seawalls (location reference E11 to E16). Between the bend of the river and the Cabramatta Creek entrance, some erosion is visible on both side of the river (location reference E17 to E20).

Figure 7.4 – Erosion east of Chauvel Park

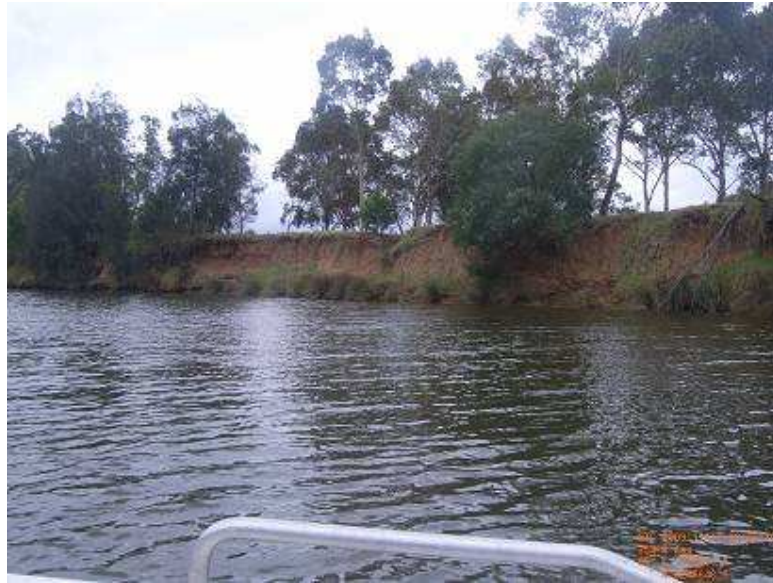
Between the bend of the river and the Cabramatta Creek entrance, some severe erosion is visible on both side of the river (Figure 7.5). Some stormwater drains have been destroyed by the strong erosion in this area. Some areas show old severe erosion which has been stabilised and covered with vegetation (location reference E19-23 and E25-26).

Figure 7.5 – Erosion along Warwick Farm

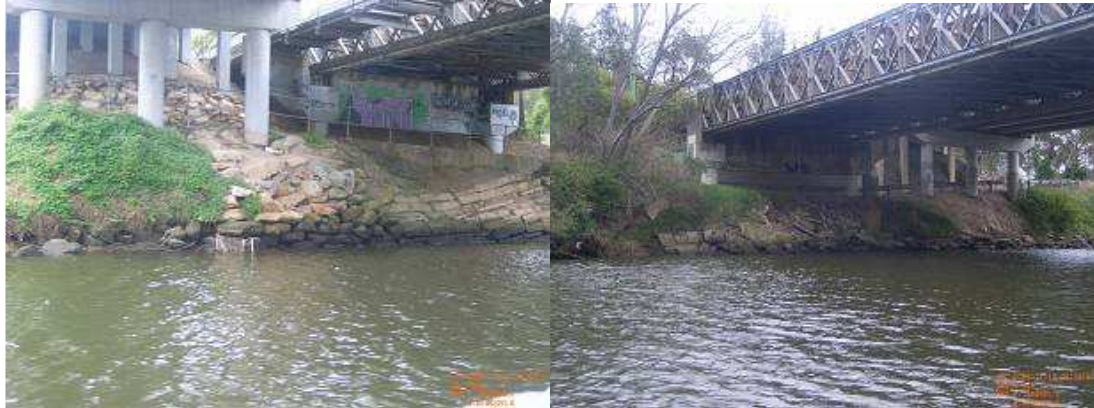
Some dumped rocks have been used on the western embankment under the bridge itself. The eastern embankment under the bridge has been stabilised using seawalls but these seawalls are subject to settling (Figure 7.6). Gabion protection has been placed on a stormwater drain along South Park (location reference S5-6).

Figure 7.6 – Protections under the eastern (left) and western (right) side of Governor Macquarie Bridge

Location	LGA	Priority Rating	Management Options (Options provided refer to Seawall Options of Section 7.3.2 of the report)
S5.Governor Macquarie Bridge Western Bank	Liverpool	Medium	Replace dumped materials by seawall built to engineered standard and allowing vegetation to grow in the gaps of rocks (Option S1)
S6.Governor Macquarie Bridge Eastern Bank	Liverpool	Low	Replace settling part of seawall by a rocks seawall (Option S1)

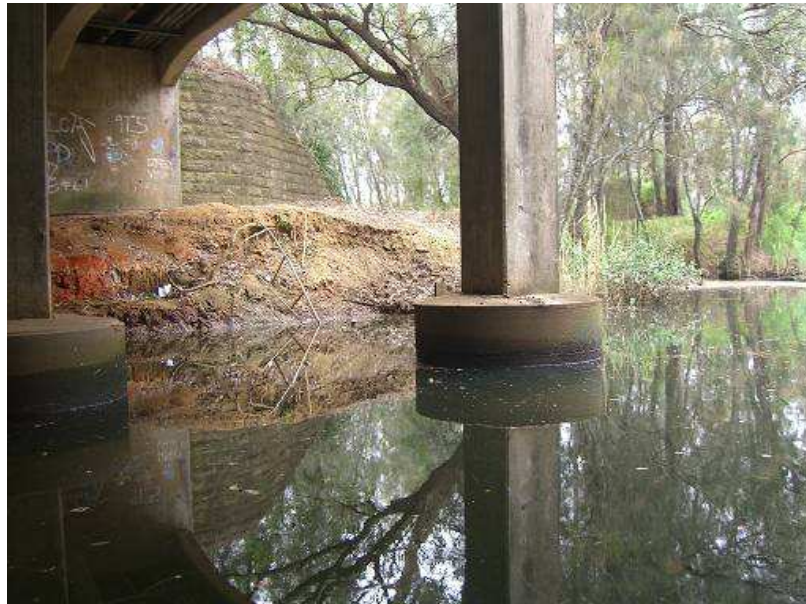
Westlake Point is eroding moderately (Location reference E24). Generally, Cabramatta Creek is well vegetated and some minor tidal undercutting appears where there are gaps in the vegetation. Some high erosion is visible on the western bank in the most downstream bend of the River and under Hume Highway Bridge (Figure 7.7). The bank located between the two small seawalls along Hoy and Cherrybrook Parks west of Cabramatta River mouth suffer from severe erosion (location reference E27-30 and E38).

*Figure 7.7 – Erosion under Hume Highway Bridge*

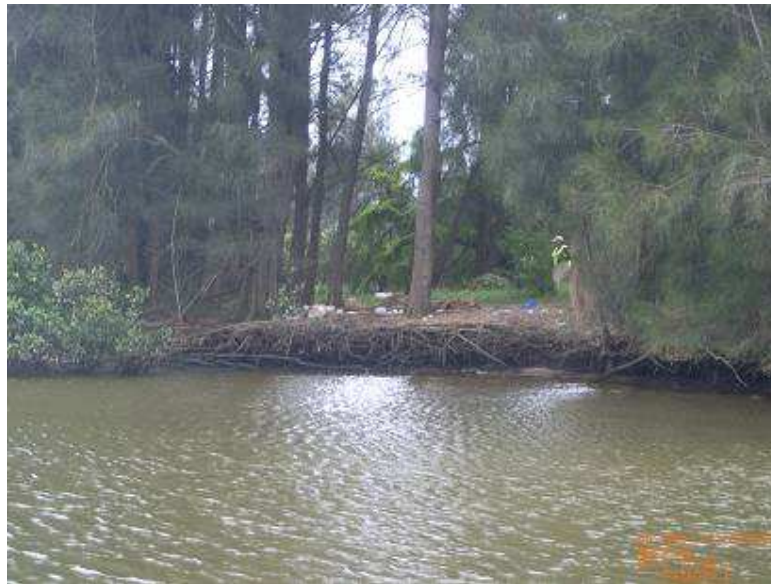
Most of Chipping Norton Lake foreshore is protected by seawalls. Some light undercutting is also noticeable along Silver Crescent. Crescent and Bass Island located along the northern embankment of the Lake are well vegetated but some undercutting is visible where there are some gaps in the vegetation. The same phenomenon is observable on the northern end of Wildlife (or Bulba-Gong) Island (Figure 7.8) and on the bank opposite the southern end of the island. Some light undercutting is visible along Angle Park despite some dumped rocks and on both side of Grand Flaneur Beach where some trees are falling into the water on the western side (location reference E31 to E42).

Figure 7.8 – Undercutting at Wildlife Island

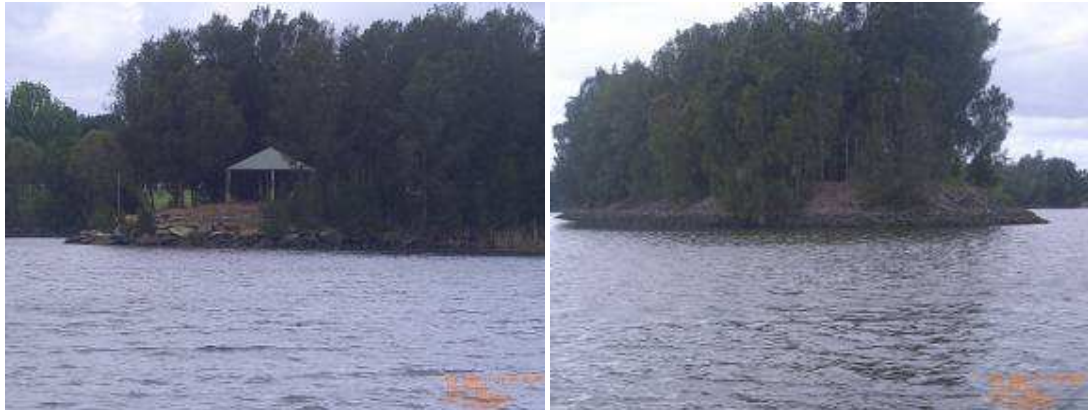
Chipping Norton Lake has mostly been surrounded by seawalls. Fair condition seawalls surround Ascot Point (Figure 7.9). Some small rocks – same size as gabion filling rocks – have been placed all along Long Point and Daruk Island. A poor condition seawall was observed along the southern end of Wildlife Island while a fair condition seawall protects the eastern embankment along the channel separating Wildlife Island from the Chipping Norton Foreshore (location reference S9 to S15).

Figure 7.9 – Rock seawall around Ascot Point (left) and rock protection at Daruk Island (right)

Location	LGA	Priority Rating	Management Options (Options provided refer to Seawall Options of Section 7.3.2 of the report)
S9.Ascot Point	Liverpool	N/A	No specific action required
S10.Grand Flaneur Beach	Liverpool	N/A	No specific action required
S11.Howard Boat Ramp	Fairfield	N/A	No specific action required
S12.Daruk Island	Liverpool	N/A	No specific action required
S13.Long Point	Liverpool	N/A	No specific action required
S14.Between Eora Beach and Strong Park Wharf	Fairfield	Medium/High	Upgrade of seawall to engineered standard and environmentally friendly condition using rocks (Option S1)
S15.Wildlife Island Southern Bank	Liverpool	Medium	Rock seawall can be extended to avoid edge effect along Wildlife Island (Option S3)

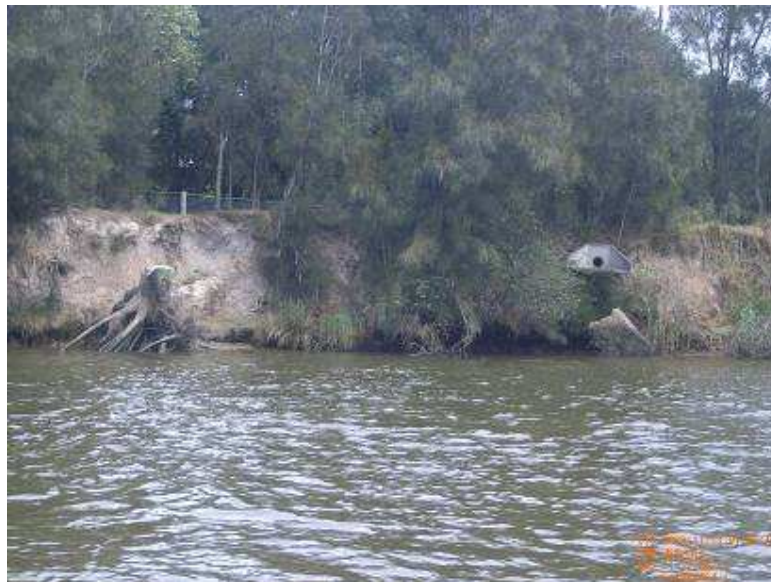
The channel separating Chipping Norton Lake from Floyd Bay is subject to high erosion where there is no seawall. A stormwater drain has been eroded (Figure 7.10). Erosion weakens along the western bank in direction of Floyd Bay. Some undercutting is visible along the southern bank of Floyd Bay. Some light undercutting is noticeable on the eastern side of Floyd Bay northern bank (location reference E43 to E46).

Figure 7.10 – Erosion directly south of Long Point

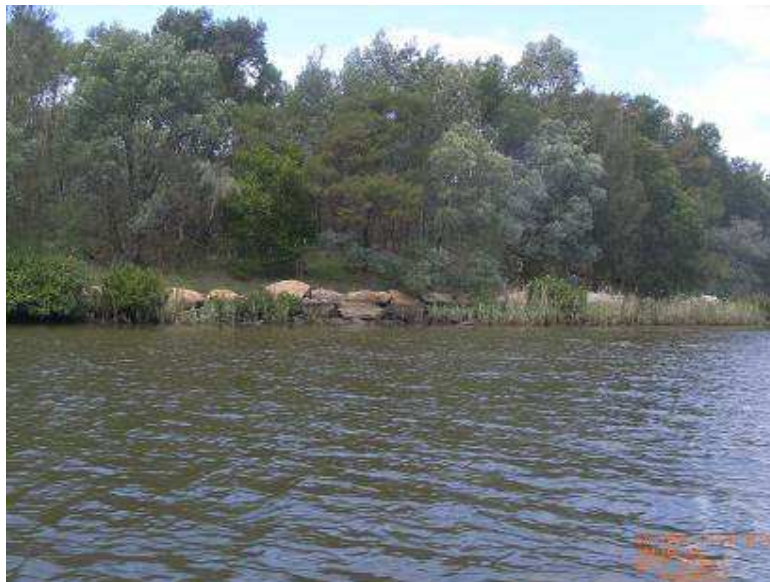
Howard Park has been surrounded by good quality and environmentally friendly seawalls all along its foreshore up to the Dowling Beach Boat Ramp (Figure 7.11) while a poor condition rock wall protects Shearer Park (location reference S16-17).

Figure 7.11 – Rock seawall at Howard Park

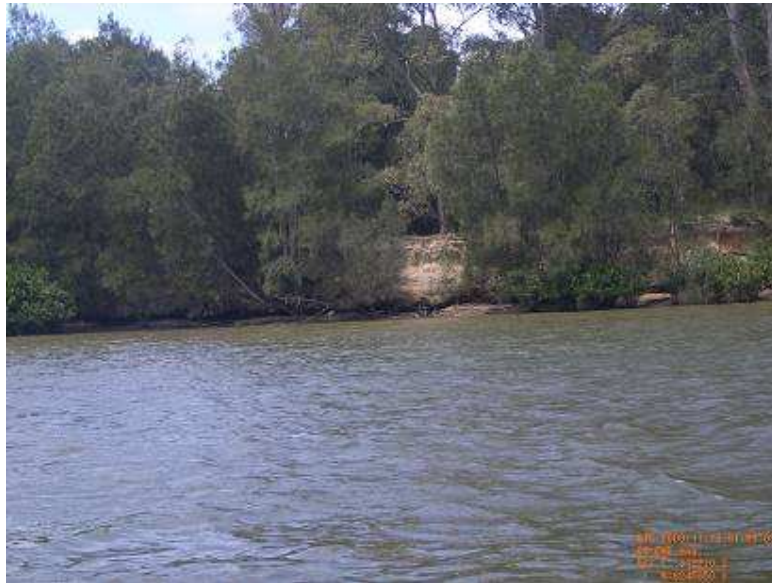
High erosion has been observed along Coot Island southern embankment where there is no seawall (Figure 7.12). High erosion is visible on the eastern side of Dhurawal Bay certainly due to the edge effect created by the private seawalls directly south of this eroded area. The eastern bank of the Prospect Creek mouth is subject to moderate-to-high erosion (location reference E47 and E57-58).

Figure 7.12 – Severe erosion behind vegetation, south of Beatty Reserve

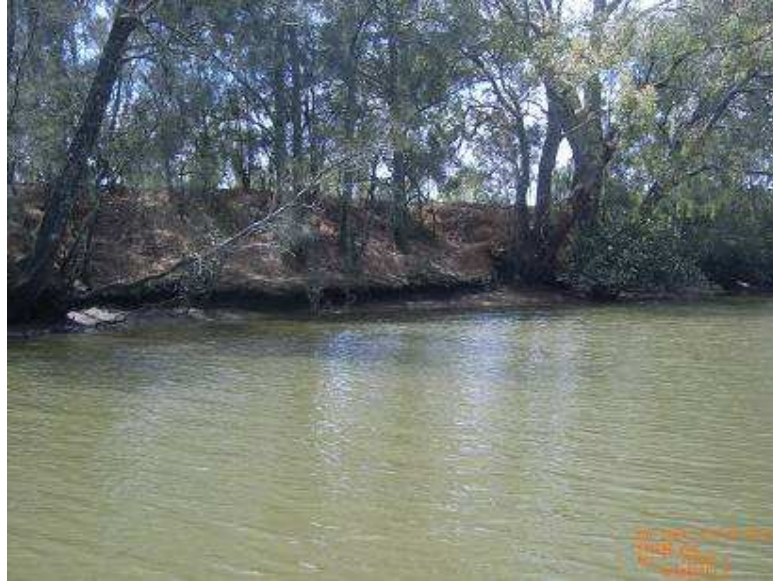
Along Prospect Creek, some moderate erosion is noticeable along Liverpool Golf Course southern embankment and on both side of the creek along the northern embankment of the Club while some light undercutting appears on the foreshore opposite the eastern side (Figure 7.13). Some undercutting has also been observed downstream of the private houses located along Knight Street. Some moderate erosion occurs in the gaps of vegetation between Day Street end and Liverpool Road Bridge (location reference E48 to E56).

Figure 7.13 – Undercutting along Prospect Creek

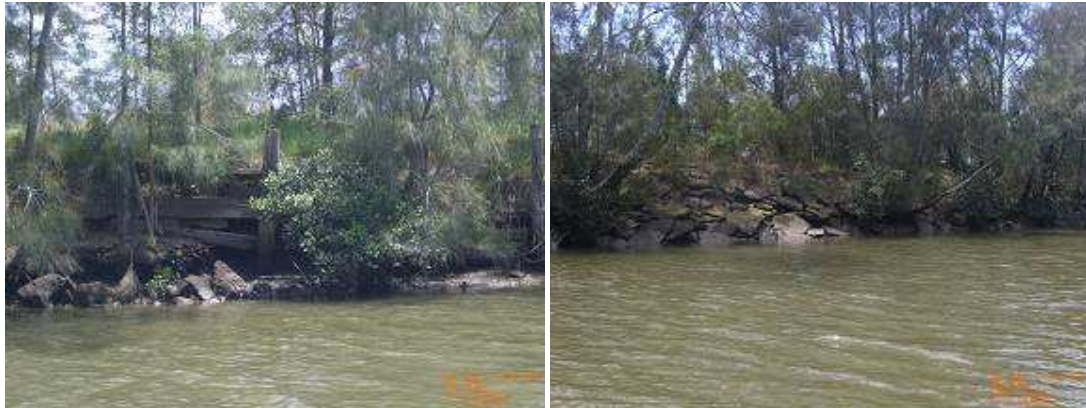
Along Prospect Creek, within the most downstream bend of the creek the remnant of a timber retaining wall was observed along the north-eastern side of Hollywood Park while some dumped concrete plate have been dumped directly upstream of the poor condition timber wall (Figure 7.14). A poor condition brick wall surrounding a small boat ramp is noticeable on the eastern side of Beatty Reserve. Some seawalls of various qualities were visible along the private properties along Knight Street (location reference S21 and S24).

Figure 7.14 – Remnant of a timber retaining wall (left) and dumped concrete plate (right) at Hollywood Park

Location	LGA	Priority Rating	Management Options (Options provided refer to Seawall Options of Section 7.3.2 of the report)
S21.Most downstream bend of Prospect Creek along Hollywood Park	Fairfield	High	Timber retaining wall can be removed and replaced by vegetation (Option S4)
S24.Eastern bank of Prospect Creek mouth	Bankstown	High	Old abandoned structures can be replaced by vegetation (Option S4)

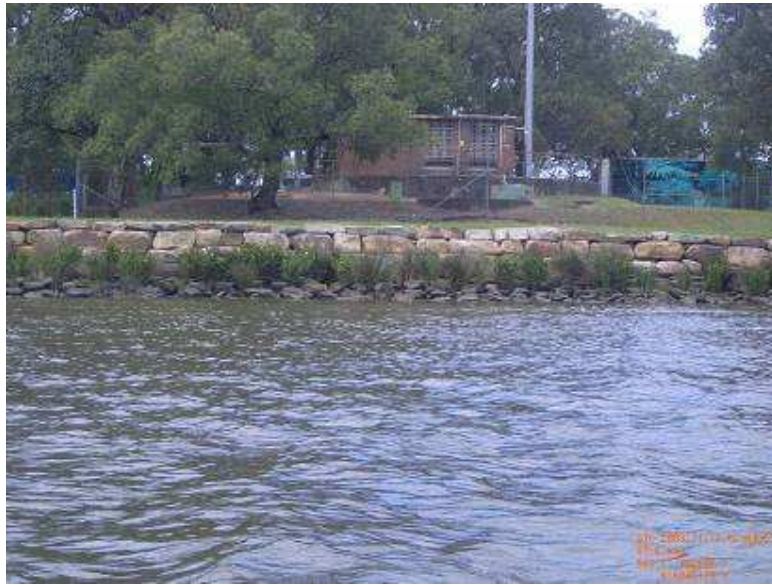
The same wide range of seawall condition was observed along the private houses located between Dhurawal Bay and Georges River Golf Course. The area located under the footbridge directly south of Heron Park is covered with rocks. The northern end of the Golf course is protected by a good quality and environmentally friendly seawall (Figure 7.15) and opposite this seawall a small gabion seawall was visible (location reference S23, S25 and S26).

Figure 7.15 – Rock seawall at the northern end of Georges River Golf Course

Location	LGA	Priority Rating	Management Options (Options provided refer to Seawall Options of Section 7.3.2 of the report)
S23.Natural entrance under footbridge directly south of Heron Park	Liverpool	N/A	No specific action required
S25.Northern End of Georges River Golf Course	Bankstown	N/A	No specific action required
S26.Bank opposite the northern end of the Georges River Golf Course	Liverpool	Medium	Seawall can be removed and replaced by vegetation (Option S4)

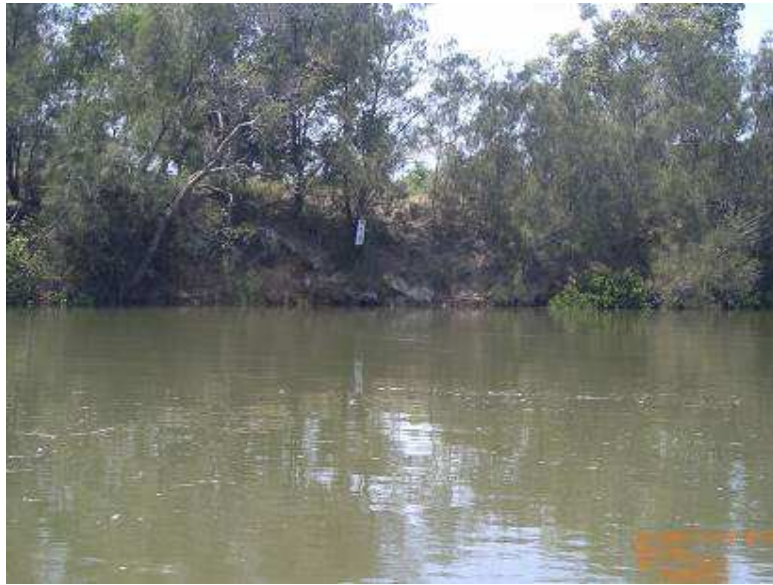
Some localised erosion is visible on both sides along the bend of the River directly upstream of Newbridge Road Bridge (Figure 7.16) as well as the western embankment under the bridge (location reference E62-63).

Figure 7.16 – Erosion north of Newbridge Road Bridge, eastern bank

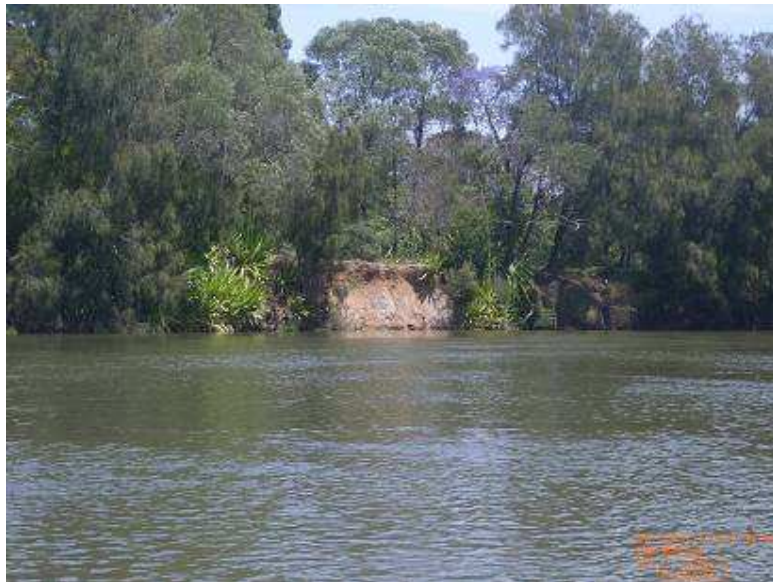
Localised high erosion is noticeable on the southern bank directly downstream of the private properties along Auld Avenue certainly as a result of the edge effect of the old brick stormwater device. The erosion destroyed a stormwater drain at this location. Some light to moderate erosion occurs between the different private seawalls around the Beveridge Park and the wharf at the end of Davy Robinson Drive (location reference E64 to E67).

Figure 7.17 – Localised severe erosion opposite Hind Park

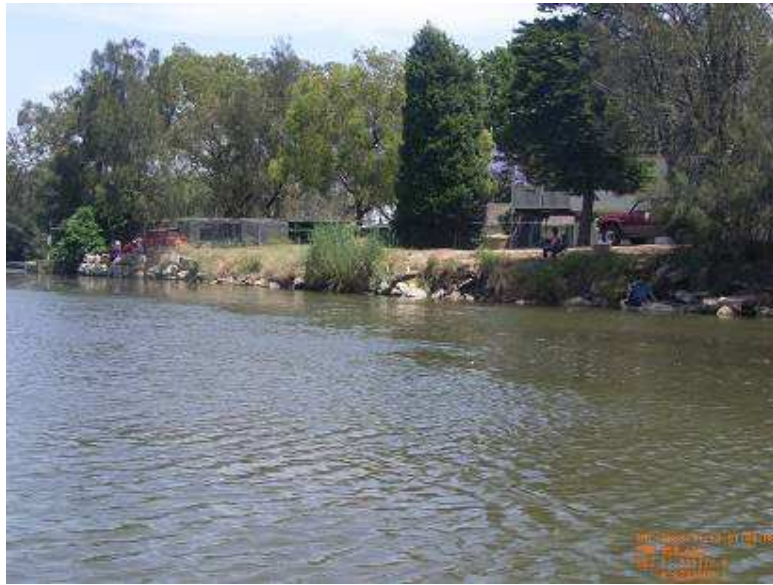
The bank along the northern end of Rickard Street is protected by an old poor condition concrete seawall covered with invasive plants. The tip located on the western side of the Newbridge Road Bridge is mostly surrounded by a poor condition seawall and dumped rocks (Figure 7.18) with only a good condition small seawall along Hind Park (Figure 7.19). The seawall under the bridge on the eastern side of the bridge is in good condition. Some damaged brick wall and brick stormwater drains were observed opposite Hind Park. Beveridge Park located behind a good condition gabion seawall (location reference S27 to S31).

Figure 7.18 – Dumped material south-west of Newbridge Road Bridge

Location	LGA	Priority Rating	Management Options (Options provided refer to Seawall Options of Section 7.3.2 of the report)
S27. Along northern end of Rickard Street	Liverpool	High	Seawall can be removed and replaced by vegetation (Option S4) Seawall can be replaced by environmentally friendly seawall (boulder seawall) (Option S5)
S28. Tip on the western side of Newbridge Road Bridge	Liverpool	High	Dumped material can be replaced by rock seawall allowing vegetation to grow between rocks (Option S1)

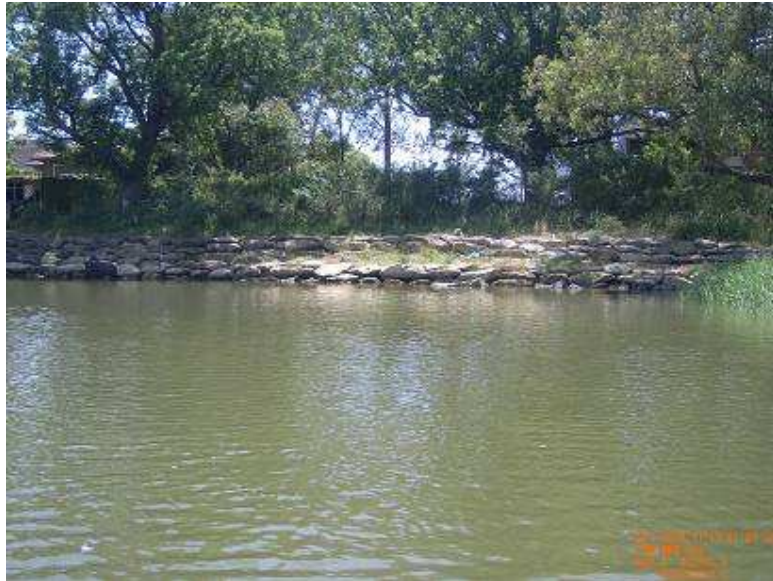
Figure 7.19 – Good condition seawall along Hind Park

Location	LGA	Priority Rating	Management Options (Options provided refer to Seawall Options of Section 7.3.2 of the report)
S29.Eastern side of Newbridge Road Bridge	Bankstown	N/A	No specific action required
S30.Hind Park	Liverpool	N/A	No specific action required
S31.Beveridge Park	Liverpool	Low/Medium	Gabion seawall can be replaced by a step seawall or boulder seawall (Option S5)

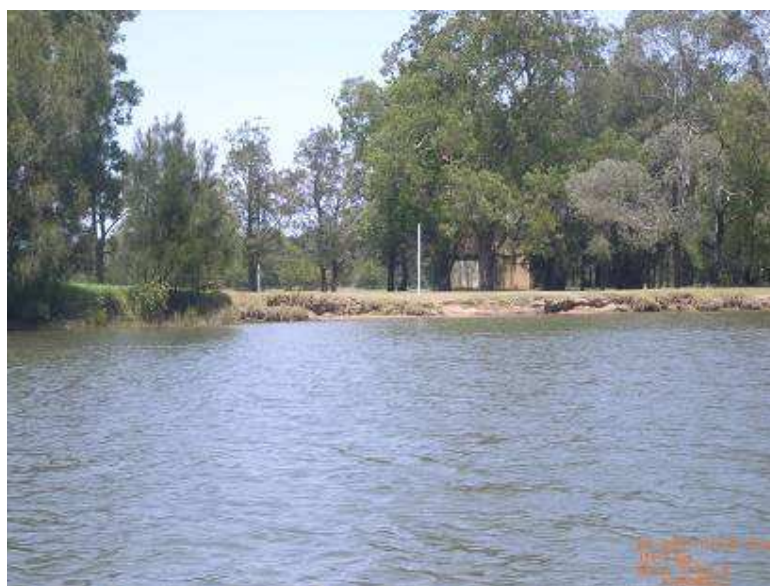
The northern embankment along Gordon Parker Reserve is subject to light undercutting in the areas unprotected by vegetation due to high motor boat waves (Figure 7.20). This zone of light erosion where there is neither seawall nor vegetation stretches until the recycling plant, Vale Of Ah Reserve embankment and the foreshore along New Brighton Golf Course (location reference E68 to E72).

Figure 7.20 – Undercutting along Gordon Parker Reserve

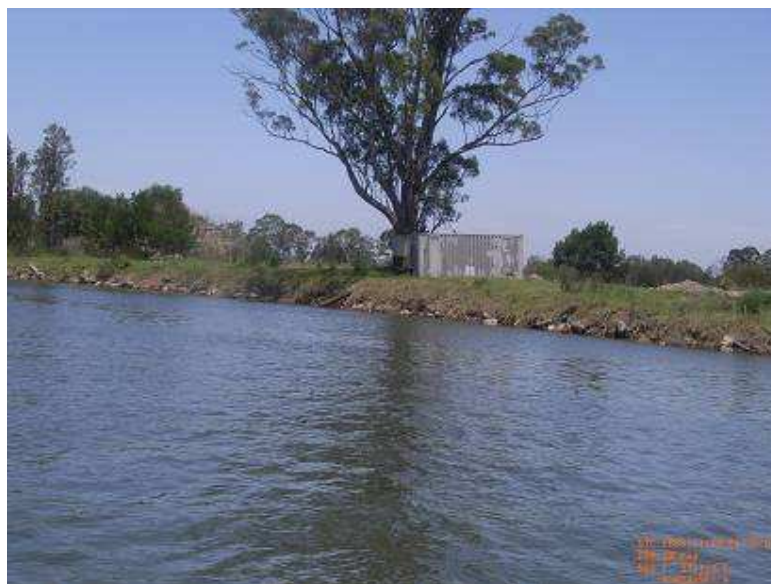
The wharf and boat ramp located at the end of Davy Robinson Drive is in poor to fair condition with the small seawall along the pier and boat ramp suffering from settling. From the boat ramp downstream to the southern end of the recycling plant (Figure 7.21), the western embankment of the river is covered with dumped rocks and diverse material such as bricks, concrete blocks, etc. (location reference S32).

Figure 7.21 – Dumped materials along the recycling plant

Location	LGA	Priority Rating	Management Options (Options provided refer to Seawall Options of Section 7.3.2 of the report)
S32. Between Davy Robinson Drive and the southern end of the recycling station	Liverpool	Medium/High	<p>Replace dumped materials by rock seawalls to allow seedlings to grow between the rocks (Option S1)</p> <p>Replace existing protection by boulder seawall without cement to create new habitats (Option S5)</p>

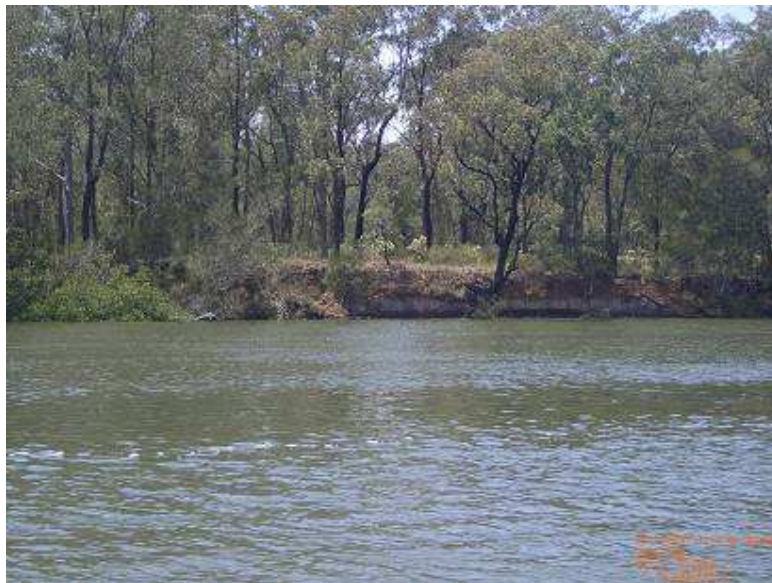
High erosion is visible downstream of the M5 bridge until Williams Creek mouth on the eastern embankment (Figure 7.22). From the building located opposite Williams Creek mouth downstream along Webster Street erosion reduces and there is only light undercutting remaining (location reference E73-74 and E76).

Figure 7.22 – Erosion opposite Williams Creek Entrance

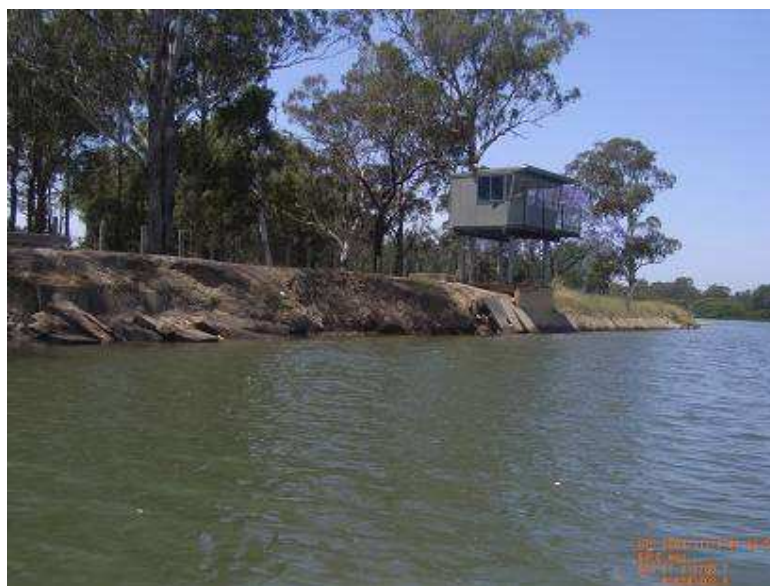
Several localised dumped materials were also noticed along New Brighton Golf Course foreshore (location reference S33). Along the area opposite Williams Creek entrance (Figure 7.23), the seawalls are in very poor condition with sometimes only some remnants of previous structures remaining (location reference S34).

Figure 7.23 – Eroded seawall opposite Williams Creek

Location	LGA	Priority Rating	Management Options (Options provided refer to Seawall Options of Section 7.3.2 of the report)
			the rocks (Option S1)
S34. Inside of Georges River bend along opposite Williams Creek mouth	Bankstown	Medium/High	Replace dumped materials by rocks seawall allowing seedling to grow in the gap between the rocks (Option S1) Replace dumped materials by native vegetation (Option S4)

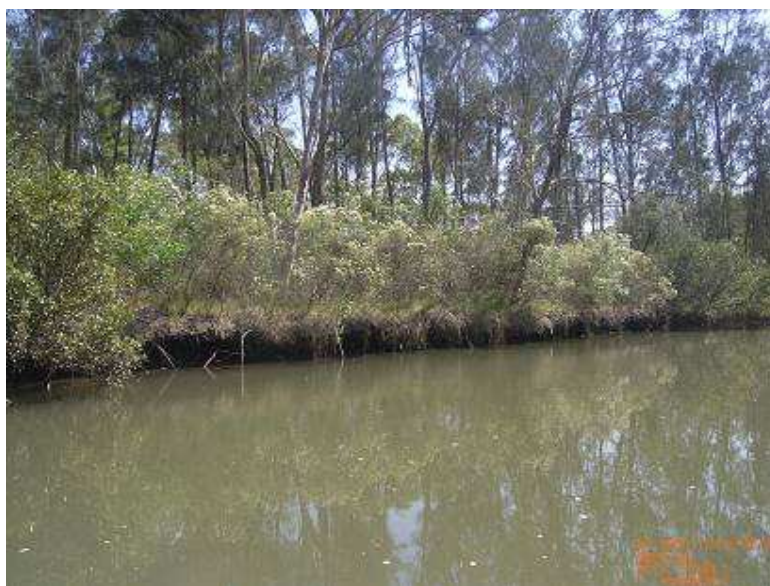
Williams, Deadmans and Mill Creeks are in similar condition. Mostly well vegetated and well protected, the foreshore along these creeks looks relatively pristine. Some tidal undercutting is visible where there are gaps in the vegetation (Figure 7.24). However, these creeks are generally in very good condition as they are located in sandstone areas which are less erodible. Some small occasional natural entrances bring sediments within these creeks (location reference E75, E80 and E84).

Figure 7.24 – Tidal undercutting where there is no vegetation at Mill Creek

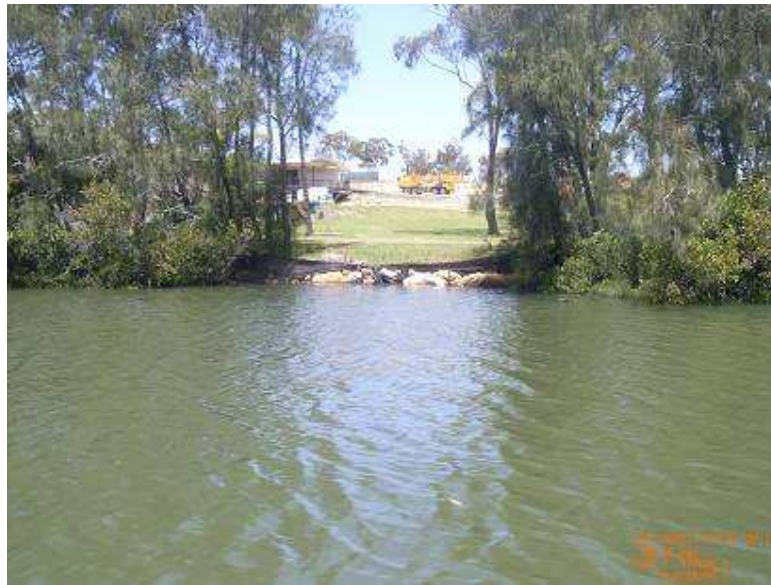
Opposite East Hills Park, some scattered dumped rocks are visible where there is no vegetation (Figure 7.25). Along the bend of the river adjacent to Pleasure Point, the south-western embankment is protected by poor condition seawalls while the seawalls on the

north-eastern side are in relatively good condition. The private seawalls on this side of the river extend until Deadmans Creek mouth (location reference S35 to S38).

Figure 7.25 – Dumped rocks in gap of vegetation opposite East Hills Park

Location	LGA	Priority Rating	Management Options (Options provided refer to Seawall Options of Section 7.3.2 of the report)
S35.South of the Kelso Park	Bankstown	N/A	No specific action required
S36.Opposite East Hills Park	Liverpool	High	Replace dumped materials by native vegetation (Option S4)
S37.Directly upstream of Monash Reserve natural entrance	Bankstown	Medium/High	Seawall can be replaced by boulder seawall to create more habitats (Option S5)
S38.Inside of the bend along Pleasure Point	Liverpool	Medium	Replace seawall by boulder seawall to create more habitats (Option S5) Creation of more habitats by adding rocks in front of the seawall (Option S2)

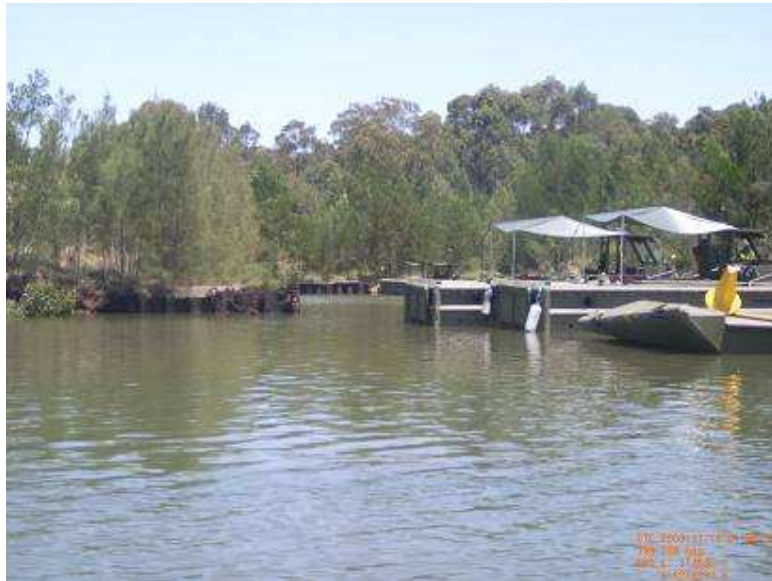
Figure 7.26 – Sheet pile protection at the military entrance upstream of Deadmans Creek mouth

Location	LGA	Priority Rating	Management Options (Options provided refer to Seawall Options of Section 7.3.2 of the report)
S39.Military boat ramp directly upstream Deadmans Creek mouth	Liverpool	High	Rusty sheet pile seawall can be replaced by vertical seawall including object to increase surface and habitats (Option S7)
S40.Lambeth Reserve	Bankstown	High	Groyne can be removed and replaced by vegetation (Option S4)
S41.Opposite Lambeth Reserve	Sutherland Shire	Medium	Some rocks can be placed in front of the existing seawall to increase habitats (Option S2) Objects can be placed along or in front of the seawall to increase colonisation by various species (Option S7)
S42.Sandy Point	Sutherland Shire	High	Fix eroded seawall Some rocks can be placed in front of the existing seawall to increase habitats (Option S2) Objects can be placed along or in front of the seawall to increase colonisation by various species (Option S7)

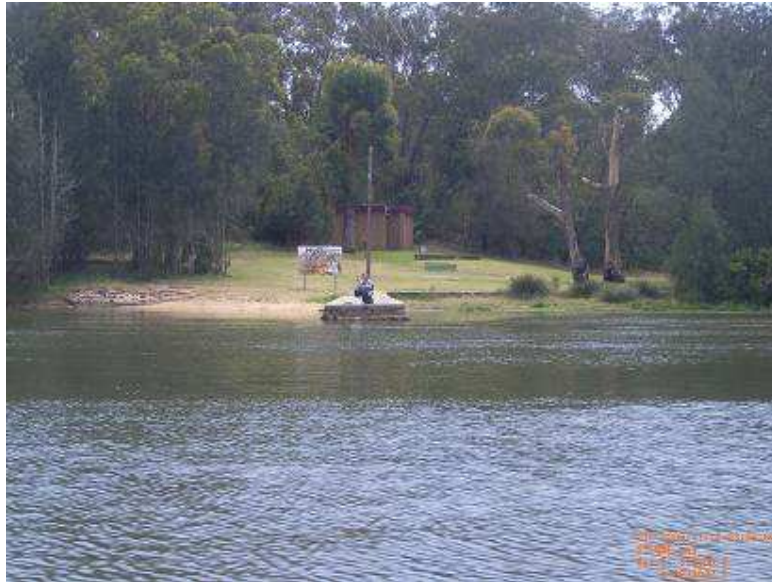
Seawalls at the tip of Sandy Point are in good condition while the ones opposite the Lambeth Reserve groyne (Figure 7.27) are in poor to fair condition. The groyne is in good condition and is accreting on the upstream side while eroding on the downstream side (location reference S40 to S42).

Figure 7.27– Lambeth Reserve groyne

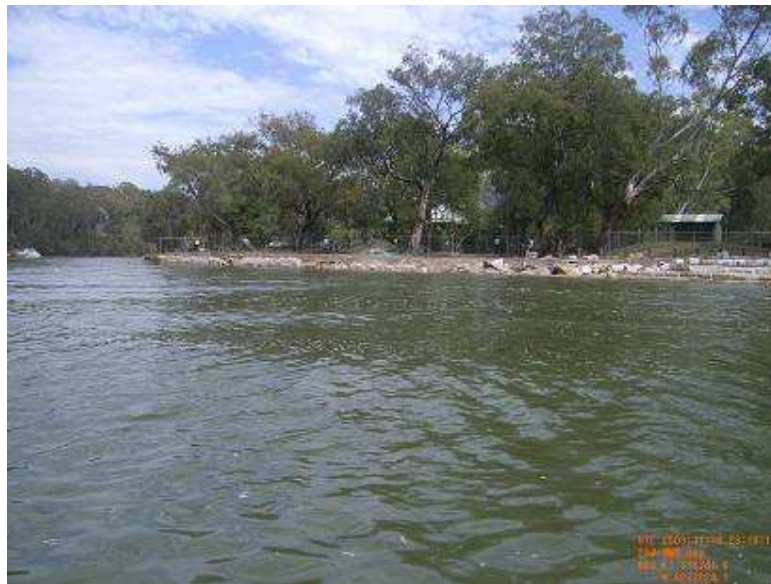
Between Sandy and Picnic Point, the western bank is protected by a fair condition seawall while some scattered good condition seawalls are protecting the walkway along the eastern bank in some area. Picnic Point is well protected by good condition seawalls. Some maintenance is needed in a localised area along the eastern side of Picnic Point (Figures 7.28 and 7.29) and the seawall is currently being upgraded in this area (location reference S43-S44).

Figure 7.28 – Seawall maintenance along Picnic Point

Location	LGA	Priority Rating	Management Options (Options provided refer to Seawall Options of Section 7.3.2 of the report)
S43. Between Sandy and Picnic Point	Sutherland Shire	Medium/High	Seawall can be removed and replaced by vegetation (Option S4)
S44. Western and Southern side of Picnic Point	Bankstown	Medium	Scattered seawall at the northern end can be removed and replaced by vegetation (Option S4) Some rocks can be placed in front of the existing vertical seawalls to increase habitats (Option S2) Objects can be placed along or in front of the vertical seawalls to increase colonisation by various species (Option S7)
S45. Eastern side of Picnic Point and Yeramba Lagoon entrance	Bankstown	Medium/High	Maintain eroded area of the seawall along the eastern foreshore of Picnic Point Some rocks can be placed in front of the existing vertical seawalls to increase habitats (Option S2) Objects can be placed along or in front of the vertical seawalls to increase colonisation by various species (Option S7) Low vertical seawall can be replaced by boulder seawall to allow the creation of new habitat (Option S5)

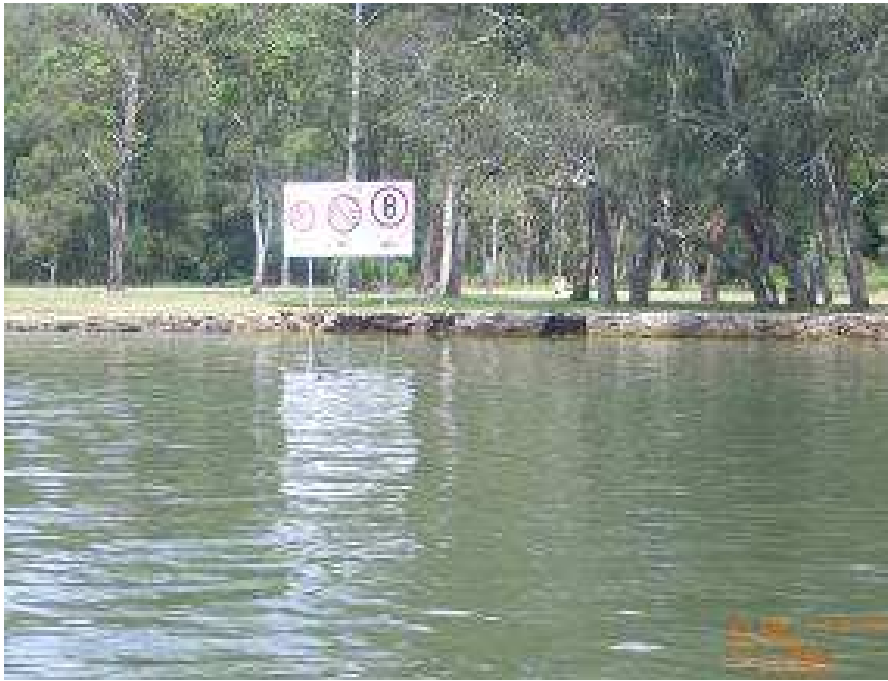
The foreshore located between Little Salt Pan Creek entrance and Yeramba Lagoon entrance is mostly protected by fair to good condition seawalls with a couple of pocket beaches which formed within the seawall bends (location reference S45).

*Figure 7.29 – Seawall needing light maintenance east of Picnic Point*

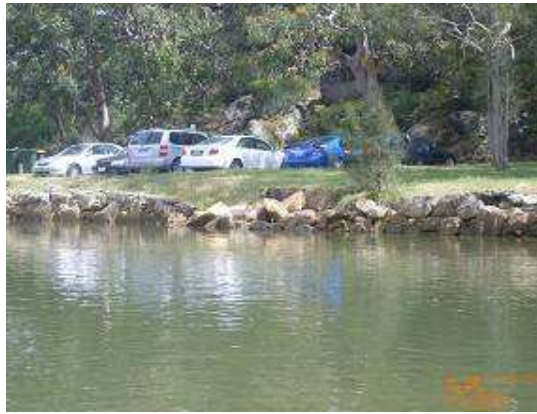
The foreshore from Yeramba Lagoon entrance downstream up to Anvil Rock is protected by low-height seawalls in poor to fair condition (Figures 7.30 and 7.31). Along this foreshore, parts of the seawall have failed and need significant maintenance. Seawalls from Anvil Rock to the Little Salt Pan Creek entrance are in relatively good condition with only some rare locations where the top of the seawall needs maintenance (location reference S46-47).

Figure 7.30 – Seawall needing light maintenance east of Anvil Rock

Location	LGA	Priority Rating	Management Options (Options provided refer to Seawall Options of Section 7.3.2 of the report)
S46.Cattle Duffers Flat up to Anvil Rock	Bankstown	Medium/High	<p>Highly eroded seawalls can be removed and replaced by vegetation (Option S4)</p> <p>Seawall can be replaced by boulder seawall to increase habitats (Option S5)</p> <p>Low vertical seawall can be faced by vegetation (Option S6)</p> <p>Some rocks can be placed in front of the existing vertical seawalls to increase habitats</p>

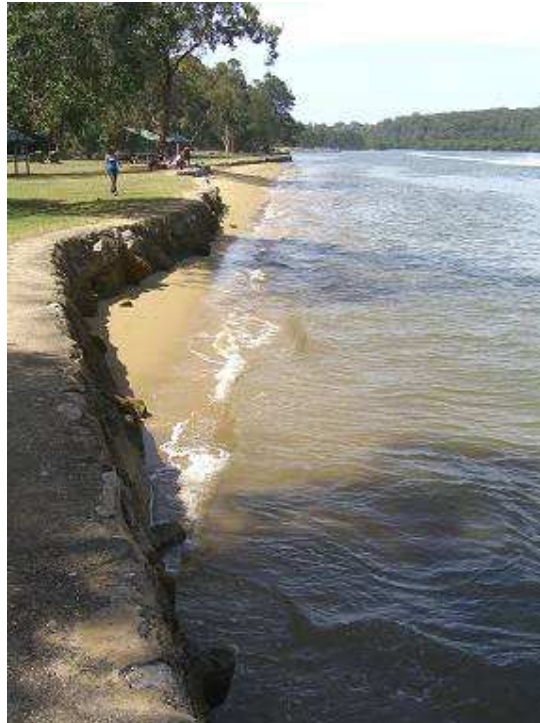
Figure 7.31 – Pocket beach along the seawall west of Georges River National Park carpark

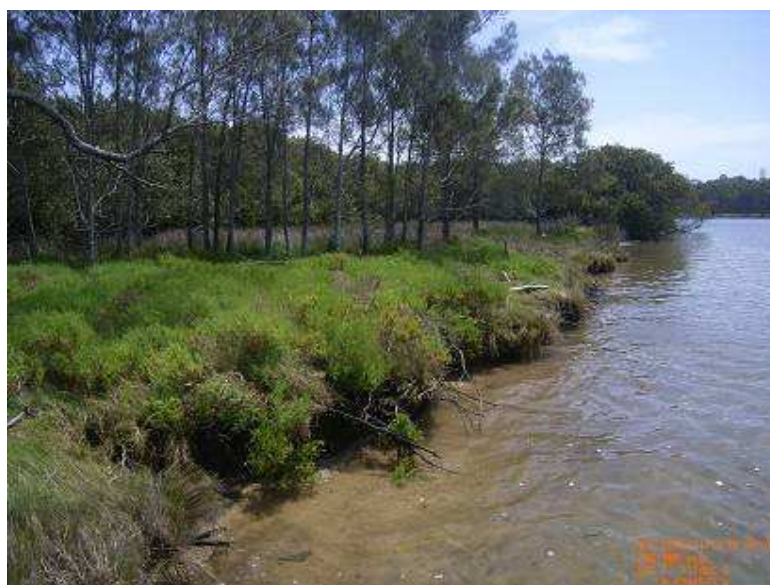
Figure 7.32 – Light undercutting opposite Little Salt Pan Creek

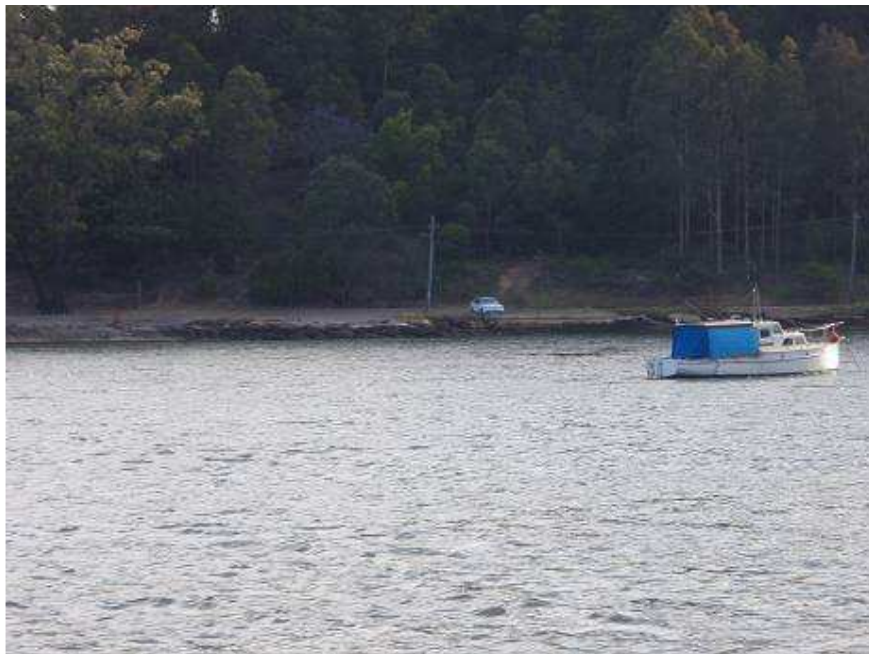
Figure 7.33 – Small rock seawall at Illawong opposite Lugarno

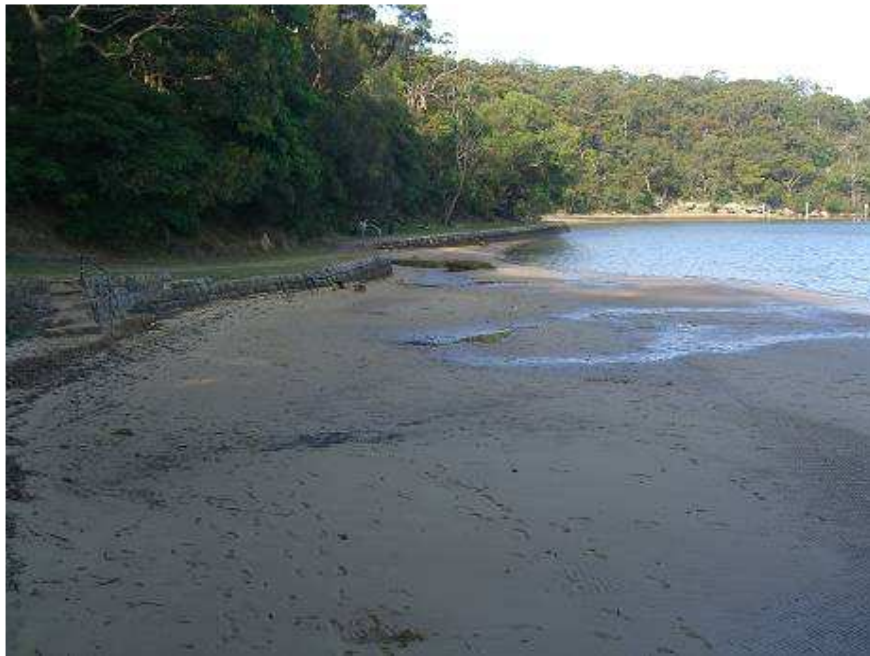
Jewfish Bay swimming area is protected by a vertical sandstone seawall (Figure 7.34) in fair condition (location reference S51).

*Figure 7.34 – Seawall at Jewfish Bay Swimming Area*

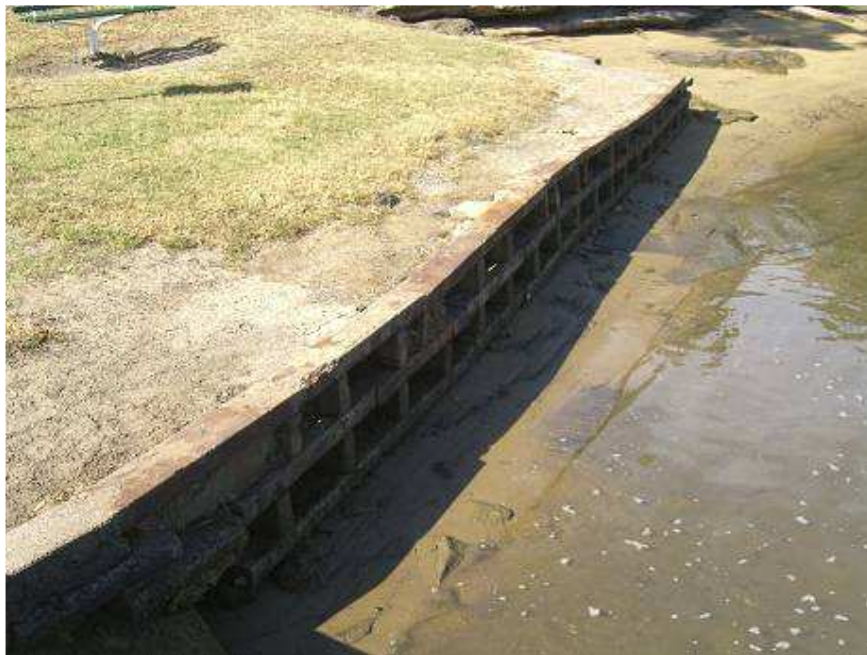
Figure 7.36 – Seawall at Moore Reserve Boat Ramp

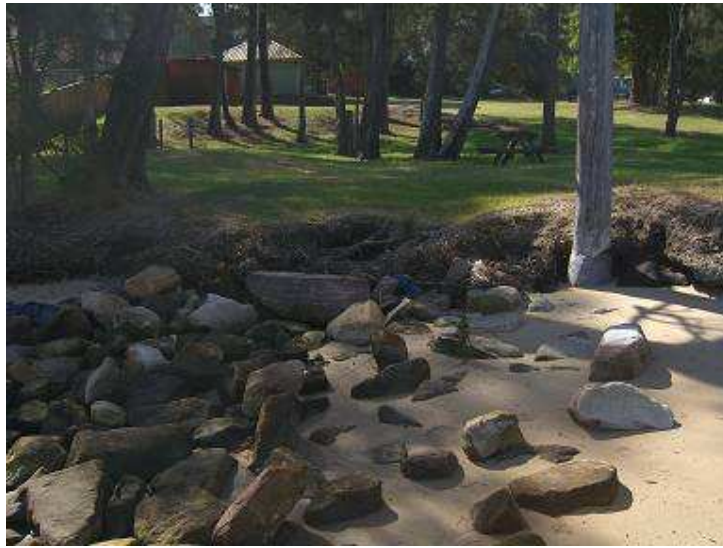
*Figure 7.37 – Erosion at Connells Point Reserve*
