## 7 FORESHORE EROSION AND STRUCTURES ASSESSMENT

### 7.1 Introduction

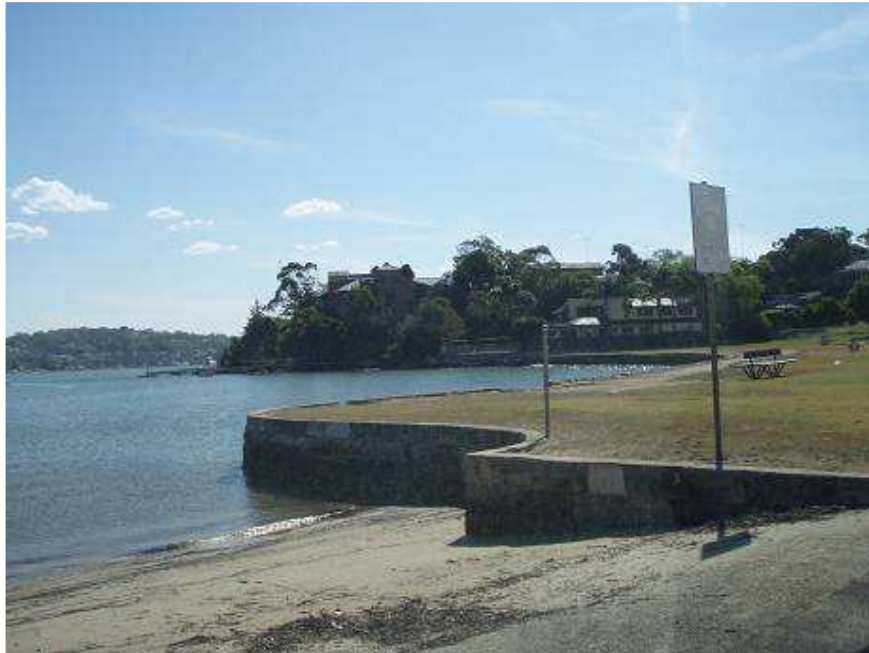
Figure 7.38 – Seawall at Donnelly Park

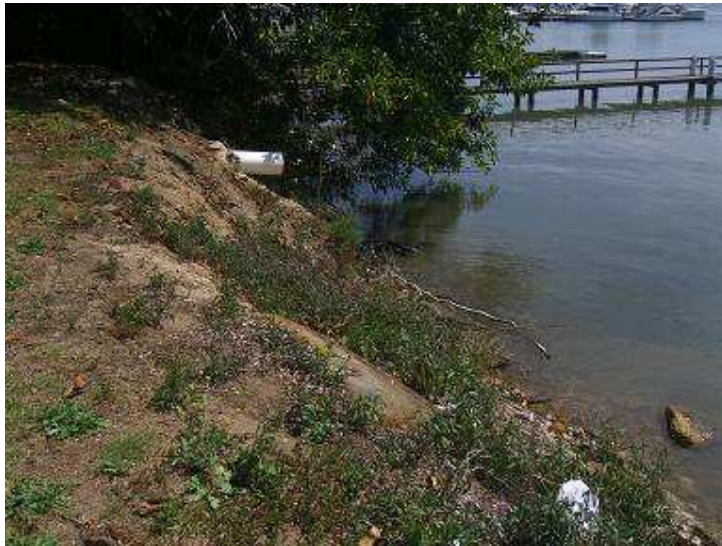
Figure 7.39 – Erosion at Dover Park West

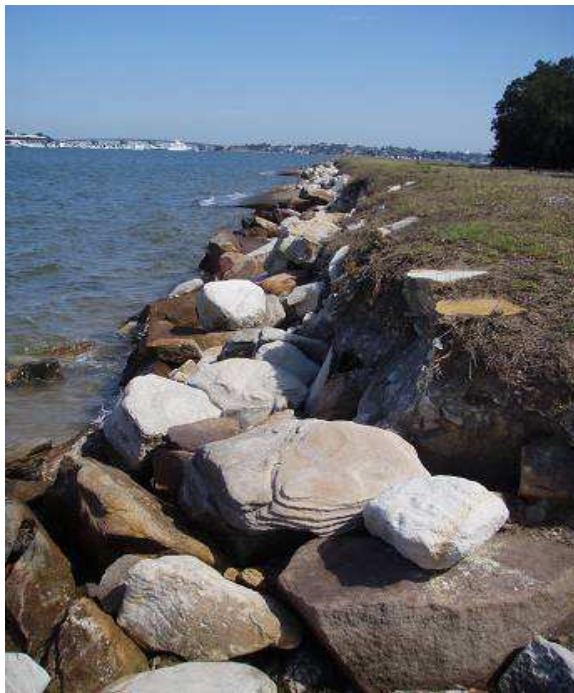
Figure 7.40 – Eroded seawall at Dover Park

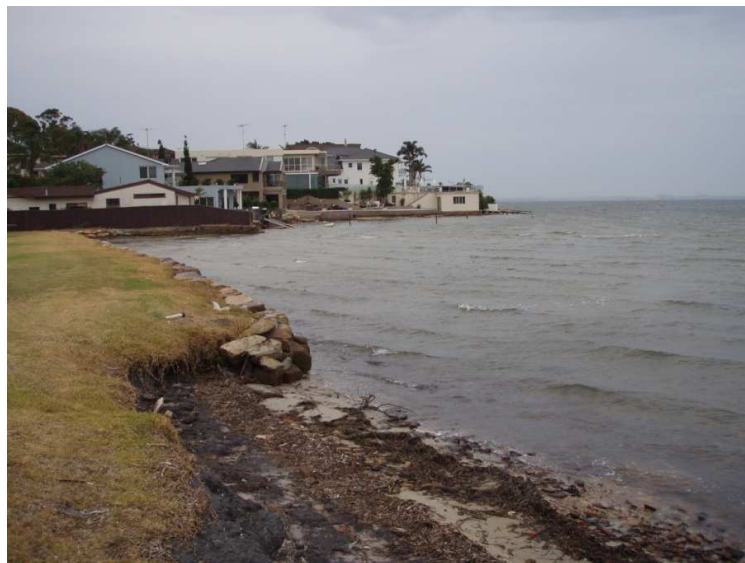
Figure 7.41 – Erosion due to edge effect of a small seawall along the north-western side of Woolooware Bay

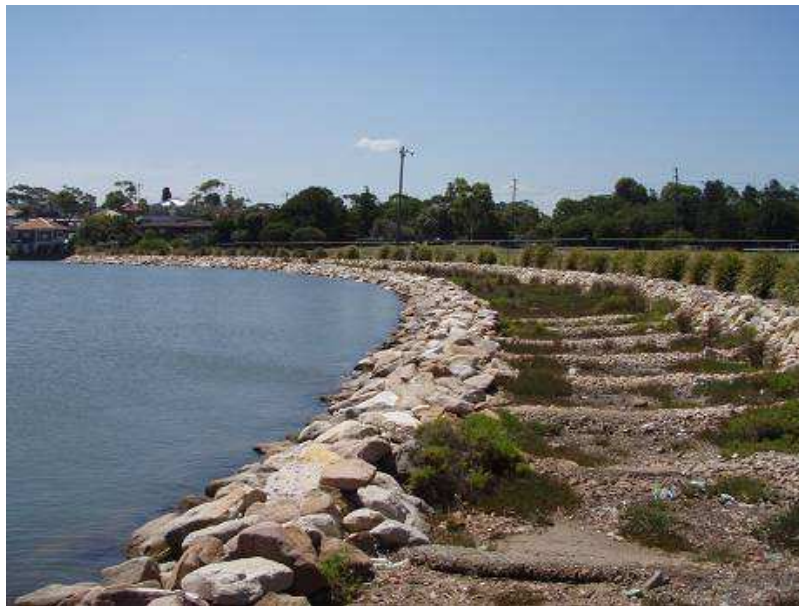
Figure 7.42 – Good condition seawall at Claydon Reserve, Kogarah Bay

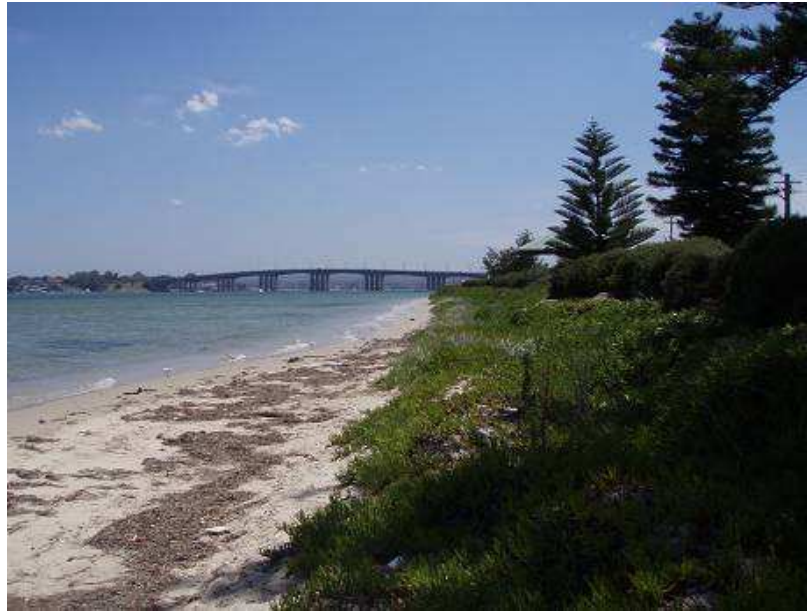
Figure 7.43 – Seawall covered by sand and vegetation east of Captain Cook Bridge

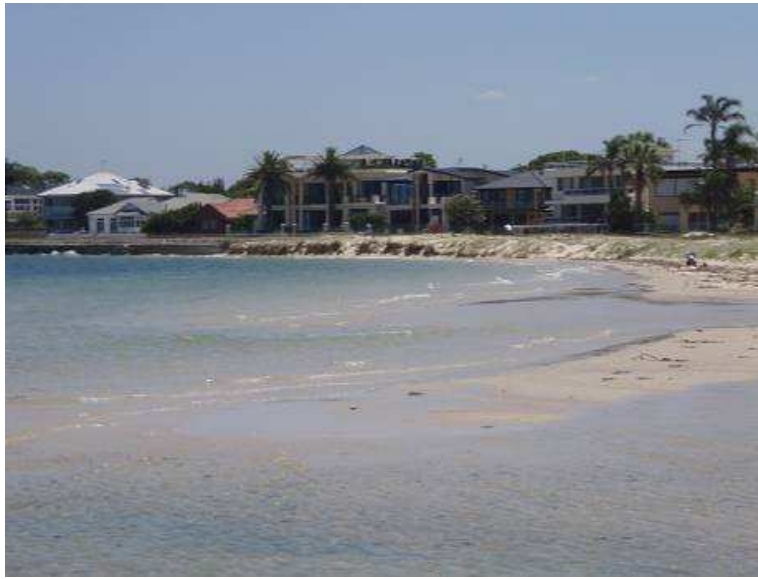
Figure 7.44 – Erosion at the northern end of Sandringham Bay

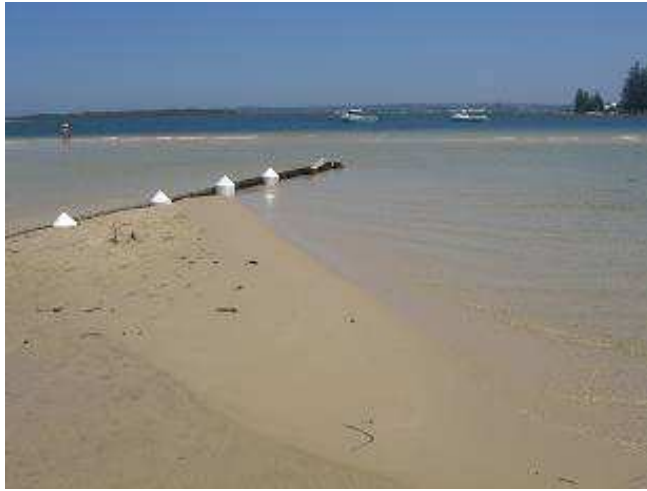
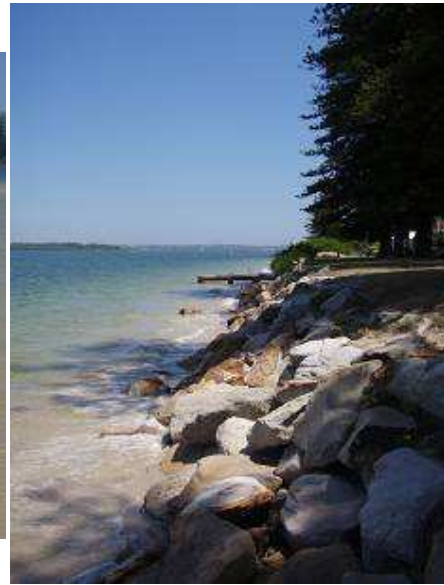
Figure 7.45 – Timber groyne (left) and rock seawall (right) at Sandringham Bay

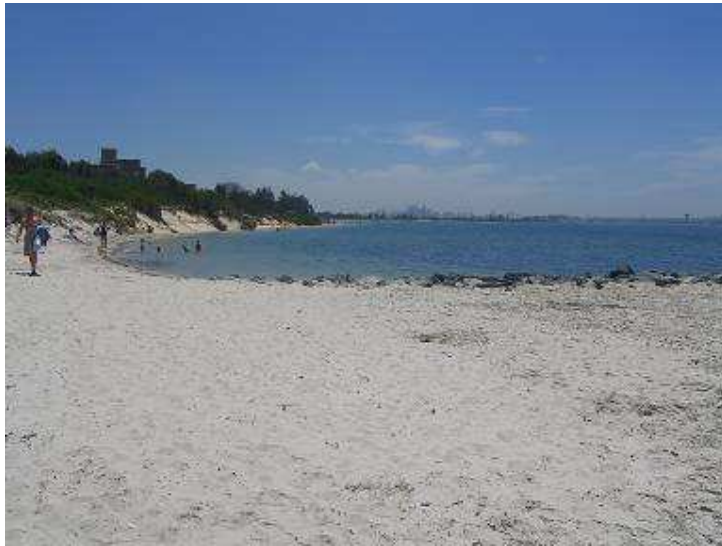
*Figure 7.46 – Erosion generated by the northernmost groyne along Lady Robinsons Beach*

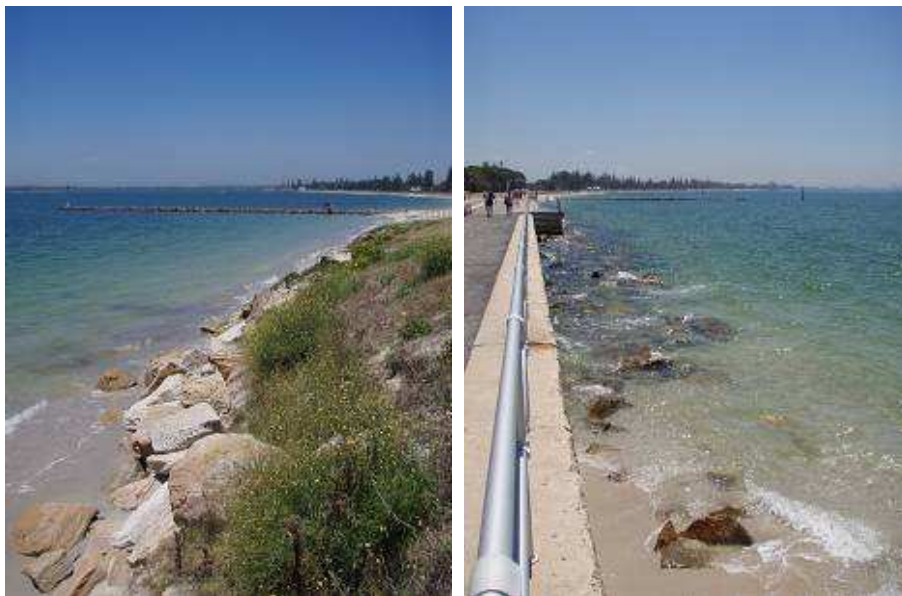
Figure 7.47– Rock seawall in the middle of Lady Robinsons Beach (left) and seawall covered by water at the southern end of the beach (right)

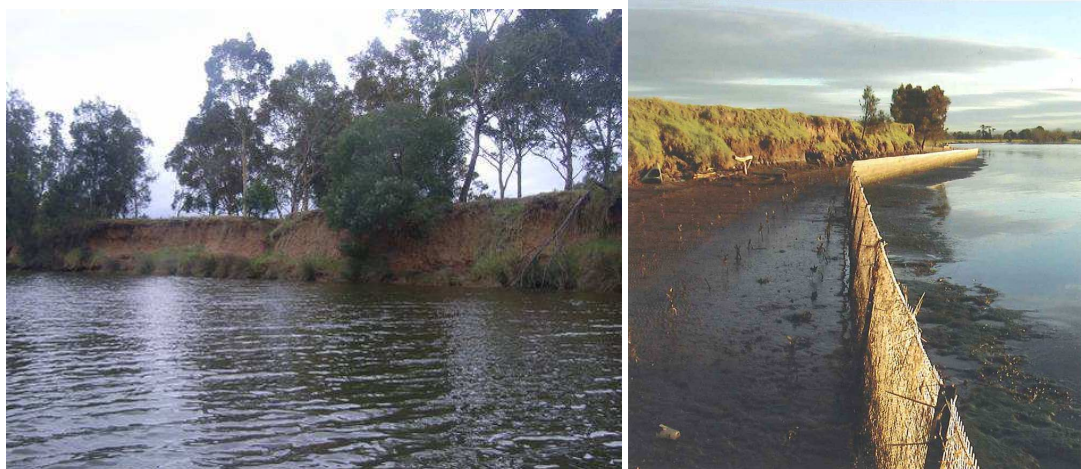
Figure 7.50 – Severe erosion on steep and height bank at South Park (left) and possible solution\* from the DECCW, 2009 (right)

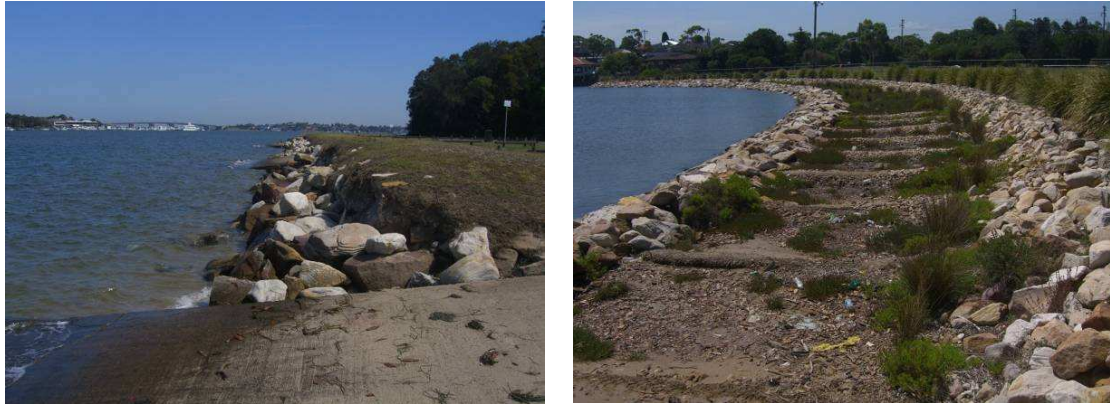
*Figure 7.54 – Moderate erosion along low bank at Dover Park (left) and possible solution\* e.g. Claydon Reserve at Kogarah bay (right)*

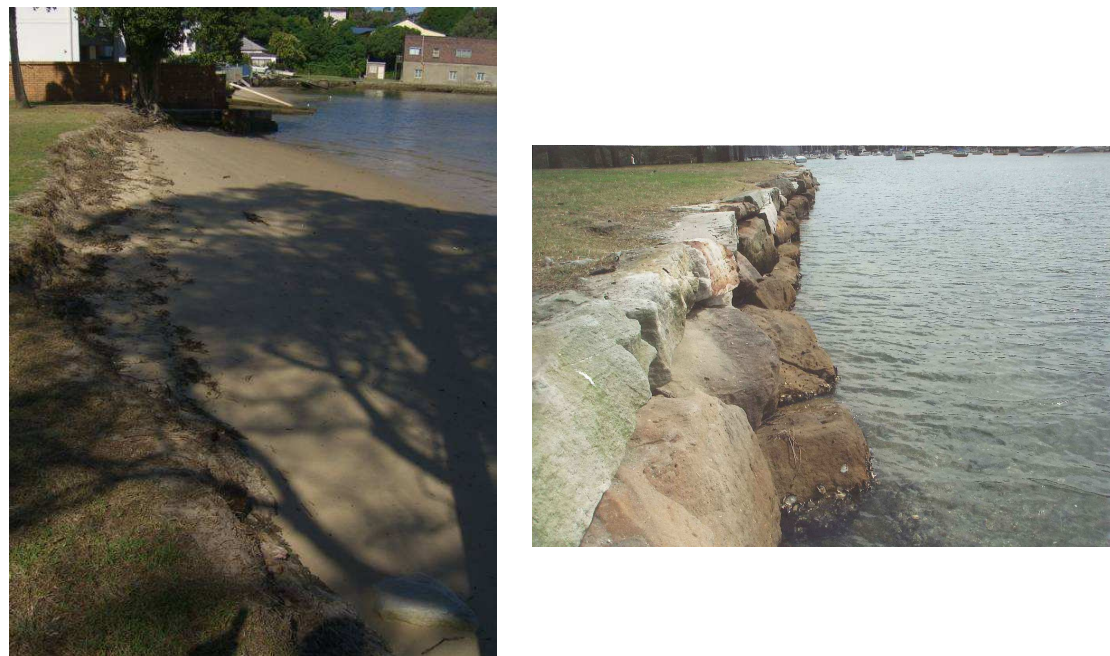
*Figure 7.55 – Moderate erosion along low bank at Connells Point Reserve (left) and possible solution\*\* from the DECCW, 2009 (right)*

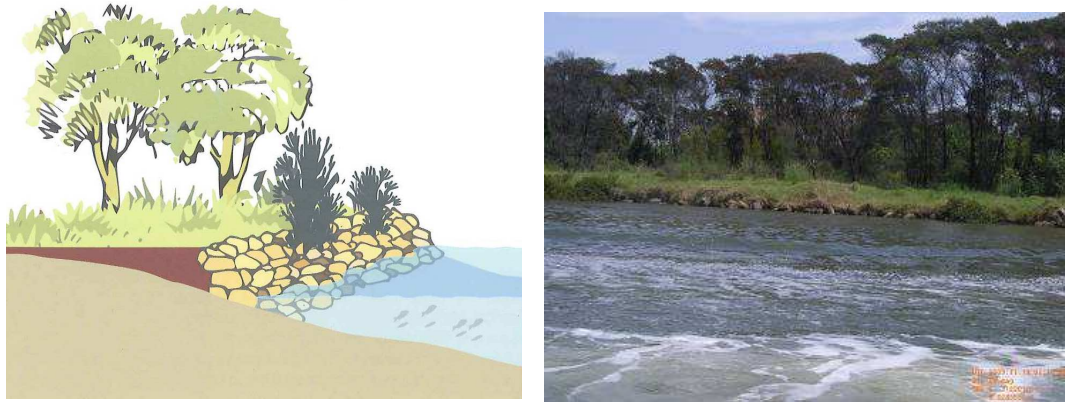
Figure 7.58 – Dumped materials along Benedict Recycling plant (right) and possible solution from DECCW, 2009 (left)

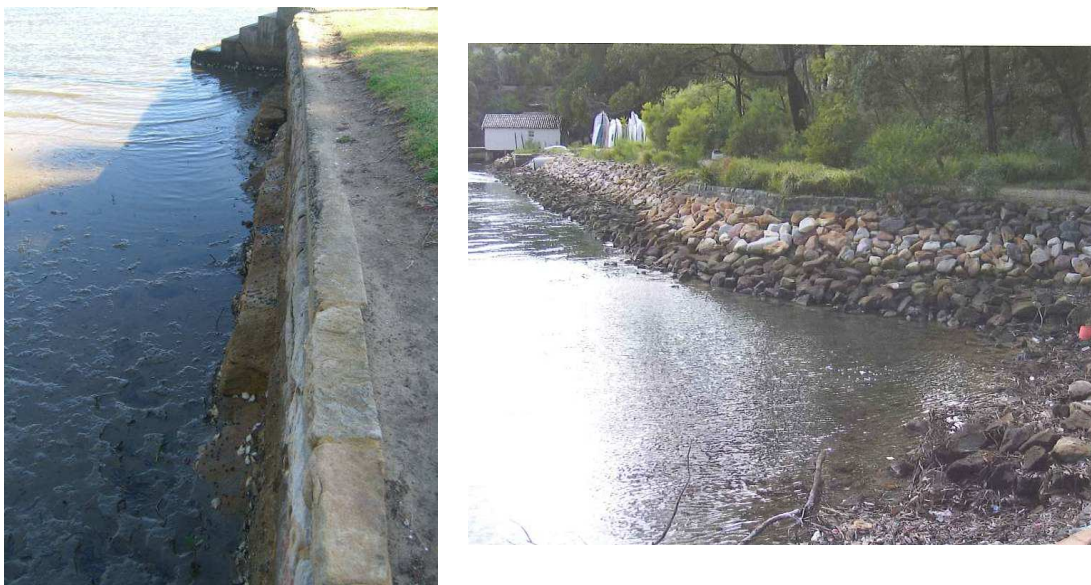
Figure 7.59 – Vertical seawall along Carss Park (left) and possible improvement from DECCW, 2009 (right)

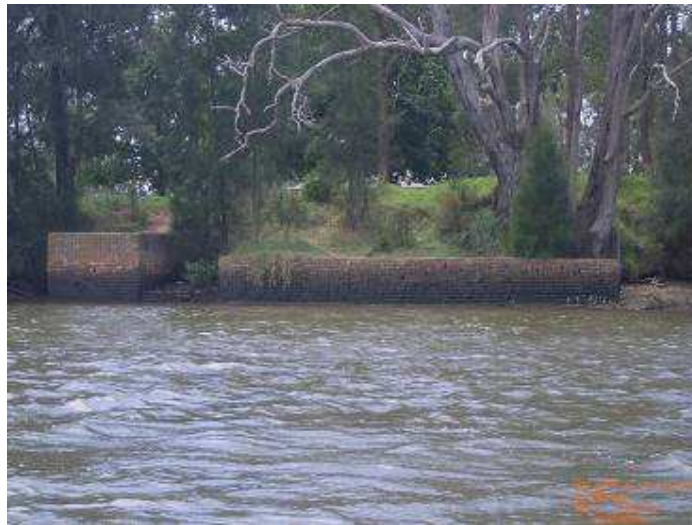
Figure 7.61 – Abandoned brick wall, east of Prospect Creek Mouth

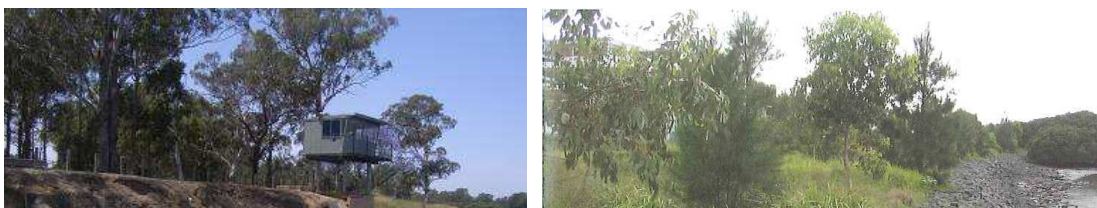
*Figure 7.62 – Remnant of seawalls opposite Williams Creek (left) and possible solution from DECCW, 2009 (right)*

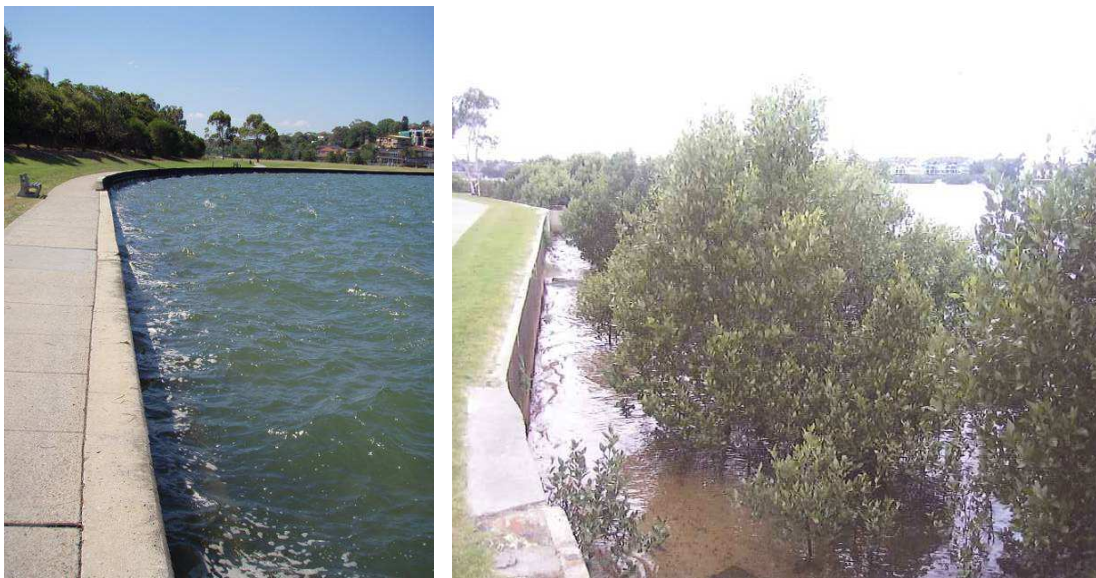
*Figure 7.63 – Vertical seawall along Carss Park (left) and possible improvement from DECCW, 2009 (right)*

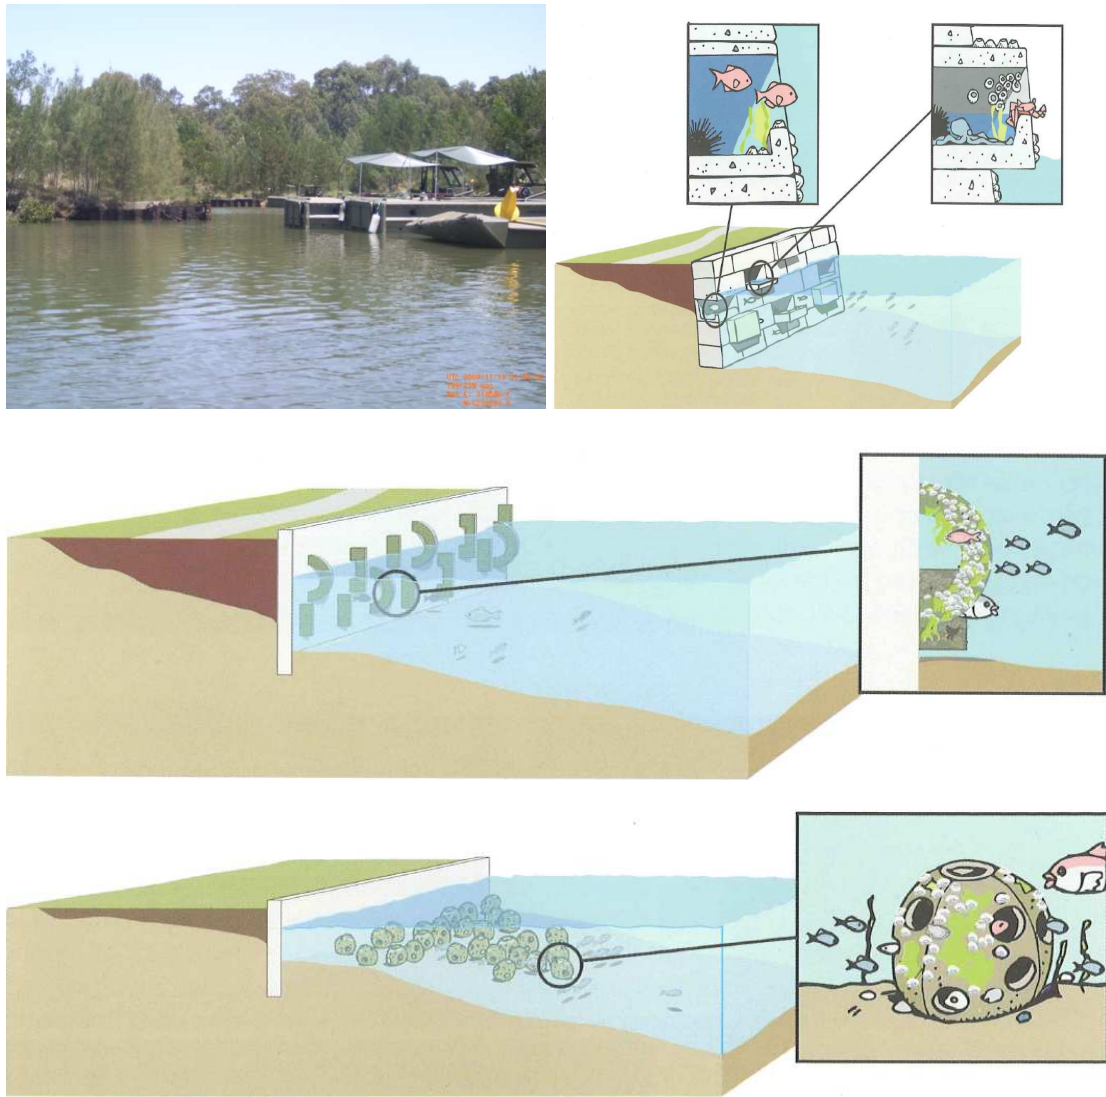
Figure 7.64 – Rusty sheet pile seawall at the military entrance upstream of Deadmans Creek mouth and possible actions to increase habitats (DECCW, 2009)

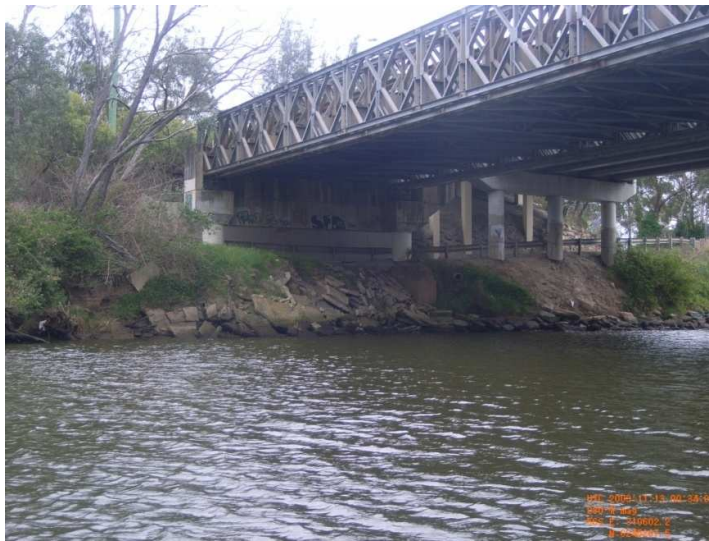
Figure 7.65 – Example of poor condition protection located under Governor Macquarie Bridge
