**Figure 8.12w:** Ecological Management Priorities  
Scarborough Park Ponds, Rockdale LGA

**Project Title:** Georges River Estuary Process Study  
DECCW Amended Figure

**Figure 8.12x:** Ecological Management Priorities Bado-Berong Creek, Rockdale LGA

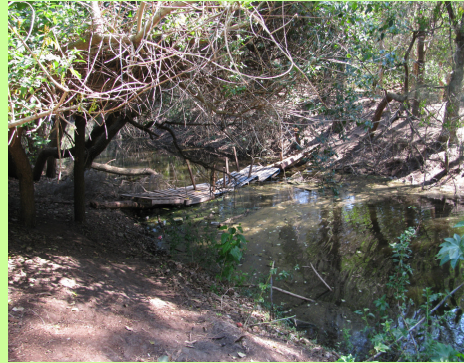
Artificial crossing to island out of wooden crates causing circulation restriction. Crossing used to gain access to island to create bike trail which is destabilising island sediments. Crossing should be removed and island stabilised with riparian species.

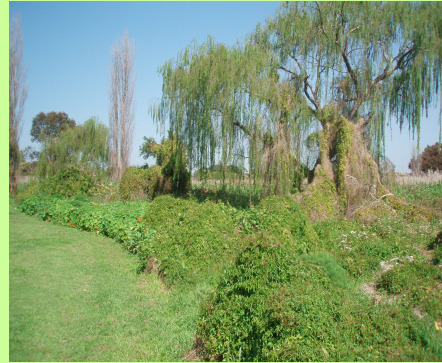
Perimeter of Sydney Freshwater Wetlands EEC dominated by exotics and weeds. Would be a good opportunity to control weeds and remove exotics and replace with native species to create a buffer around the wetlands from the urban area.

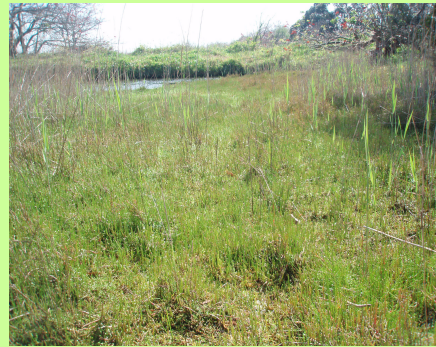
Small patch of saltmarsh amongst reeds. Monitor saltmarsh and control access.

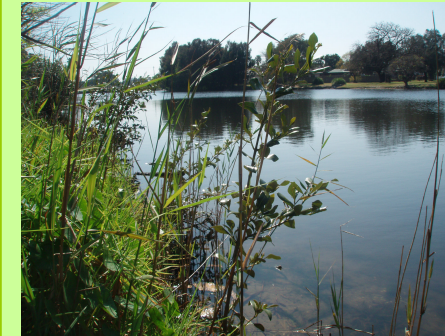
Mangrove seedlings and trees scattered along the eastern and western foreshore. Potential to expand mangroves along both the eastern and western foreshore up to the bridge via planting seedlings to increase this important habitat type.

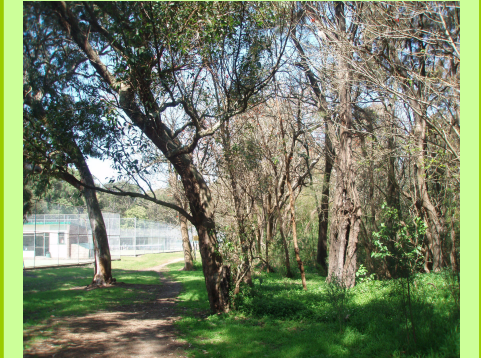
Good condition Kurnell Dune Forest EEC vegetation. Minimal impacts. Continue to protect and educate public via signage. Removal of exotics adjacent to tennis courts.

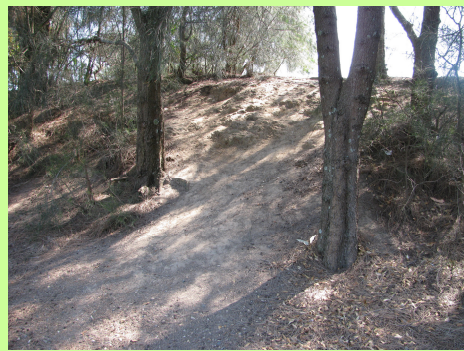
Bank erosion due to lack of groundcover and ad hoc access between access path and parklands contributing sediments to ponds. Control erosion via establishing ground cover species under Casuarina trees and limiting access.

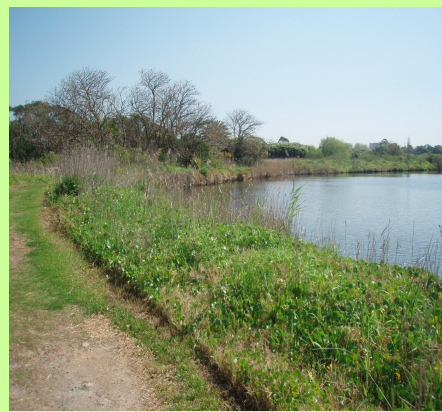
Foreshore and areas adjacent to mown trail dominated by weeds. Bush regeneration activities required to control weeds and replace with native species.

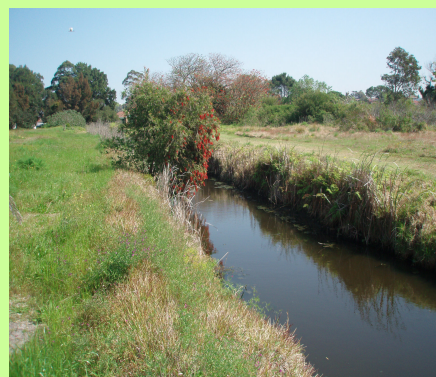
Excellent opportunity for extensive revegetation along this drainage channel. Weeds dominate and there is a lack of native riparian species while there is plenty of available land.

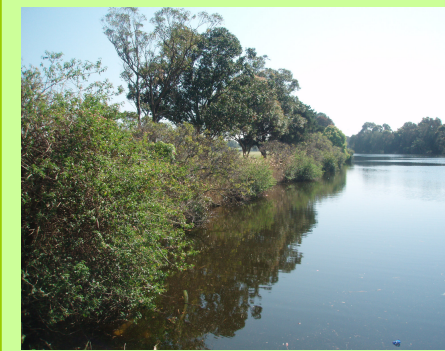
Exotic species dominating foreshore along western bank with limited native riparian vegetation. Revegetation of the riparian zone with native species required. Ample space to allow a good width riparian buffer.

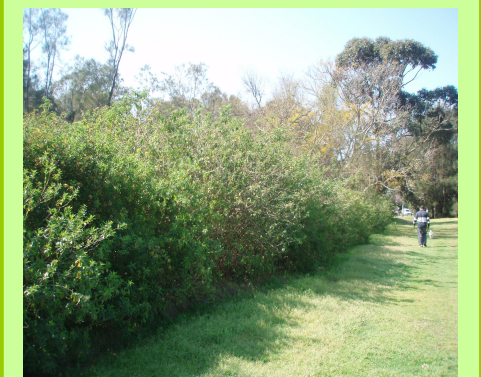
Weed infestations along western bank from pipes to 1<sup>st</sup> bridge with limited native riparian vegetation. Weed removal and revegetation with native species required to create a buffer along foreshore.

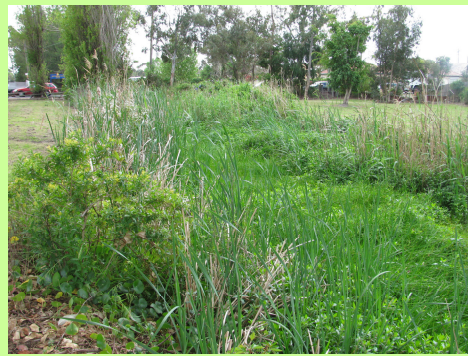
Channel choked by aquatic macrophytes upstream of this point.

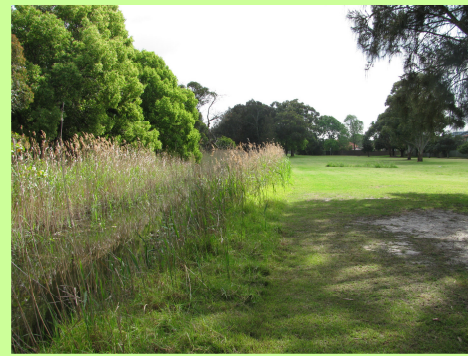
Council mows right up to phragmites on the eastern foreshore with limited native riparian vegetation. Revegetation of the riparian zone with native species required. Ample space to allow a good width riparian buffer.

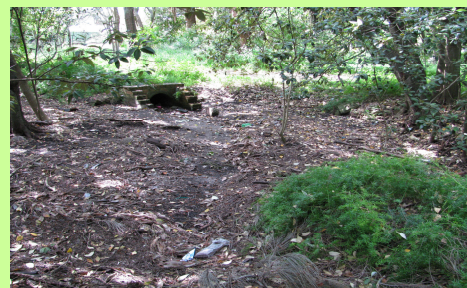
Patch of mangroves amongst Casuarina trees adjacent to creek and connected by a pipe. Mangroves heavily impacted by foot traffic and sediment / leaf litter from stormwater. Small patch of saltmarsh and extensive weeds patches throughout. Griffiths St is the mangrove limit of the creek.

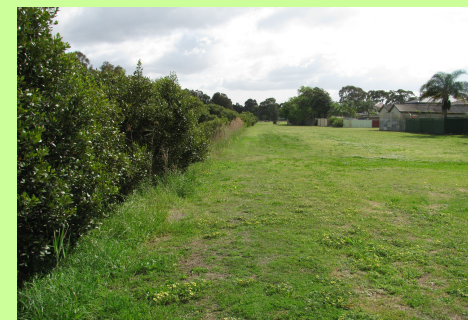
Council mows right up to phragmites on the eastern foreshore with limited native riparian vegetation. Revegetation of the riparian zone with native species required. Ample space to allow a good width riparian buffer up past Ida St. Some patches of no vegetation and stretches of bank erosion.

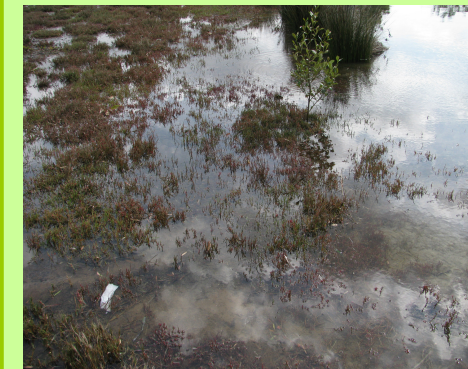
Mangrove seedlings establishing in saltmarsh closest to channel. Council to consider merits of removing mangroves into the future as will continue to be an issue.

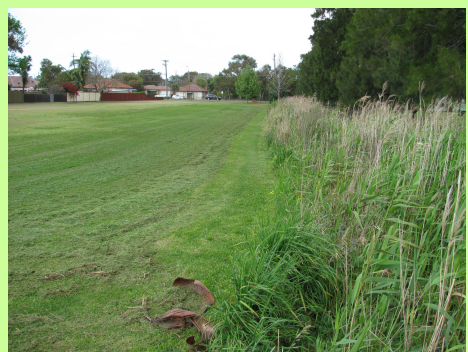
Council mows right up to phragmites on both sides of foreshore with limited native riparian vegetation. Revegetation of the riparian zone with native species required. Ample space to allow a good width riparian buffer.

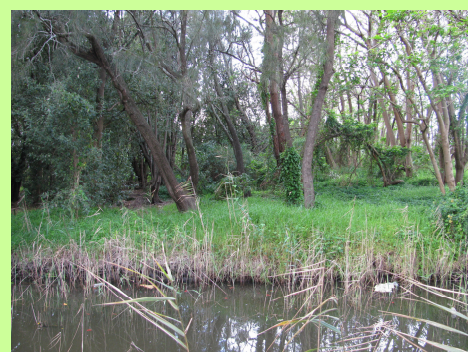
Extensive weeds in this patch of vegetation. Bush regeneration required.

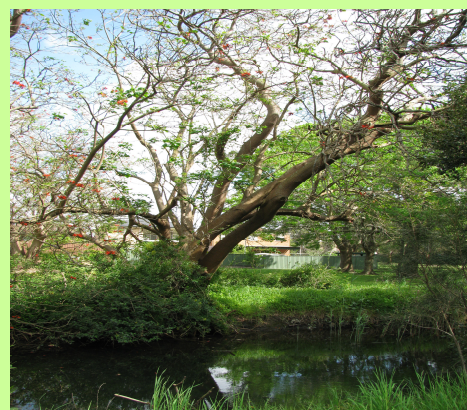
Exotic coral trees dominate western bank which would drop large quantity of leaf matter into creek. Council to explore removing and replace with native trees.

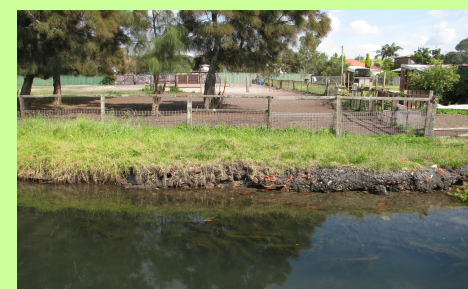
Bare earth in horse enclosures on top of bank, with bank erosion also evident along western foreshore. Possible opportunity to revegetate bank on creek side of landowners fence to control any sediment washing into creek. Section of bank has also been used to dump fill which is slumping into creek.

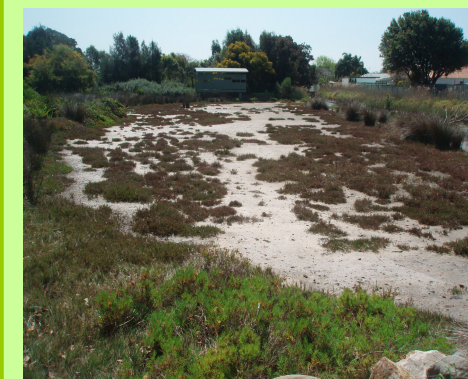
Trial incorporation of mulch to topsoil to increase cover of saltmarsh vegetation in bare areas. Minor replanting of riparian species bordering saltmarsh to maintain buffer in certain small patches.
