Project Name:	Georges River Data Compilation and Estuary Processes Study
Project Number:	3001765
Report for:	Georges River Combined Councils Committee

Georges River Data Compilation and Estuary Processes Study

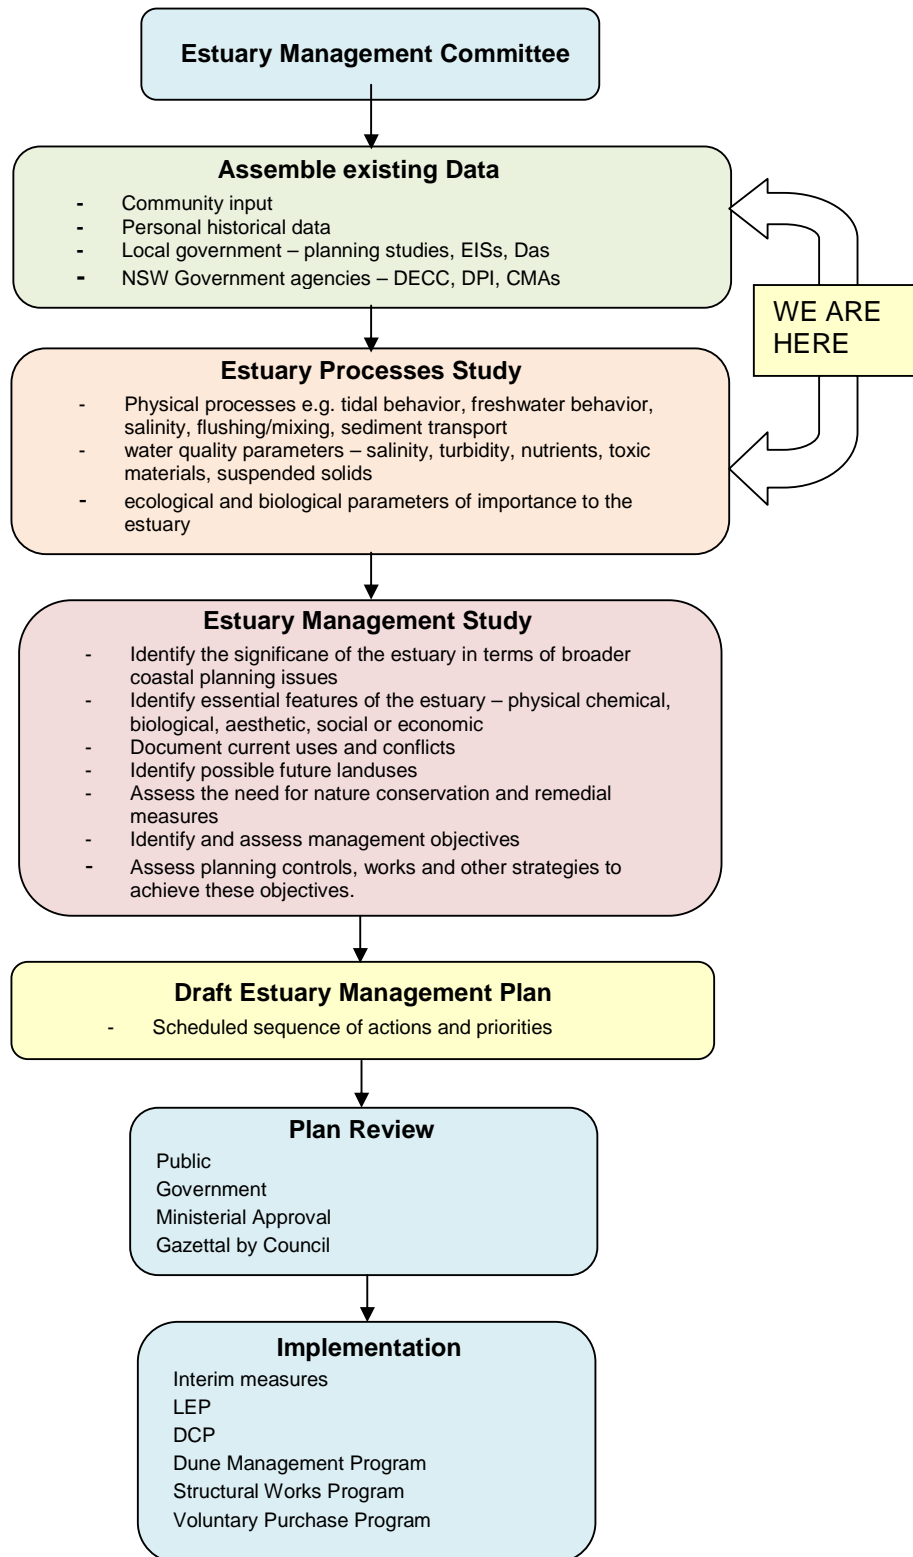
Figure 1.1 – The NSW Estuary Management Process (NSW Government, 1992)

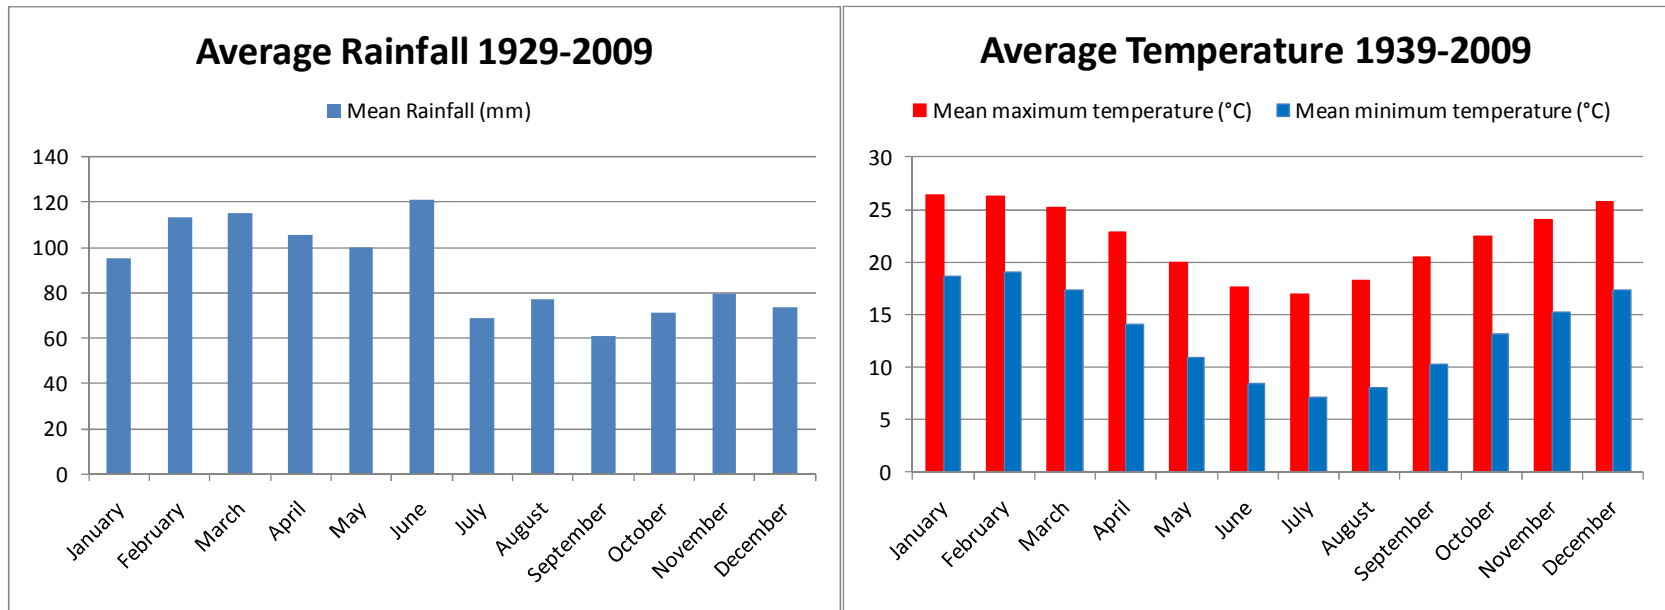
Figure 2.3 – Monthly rainfall and monthly temperature at Sydney Airport

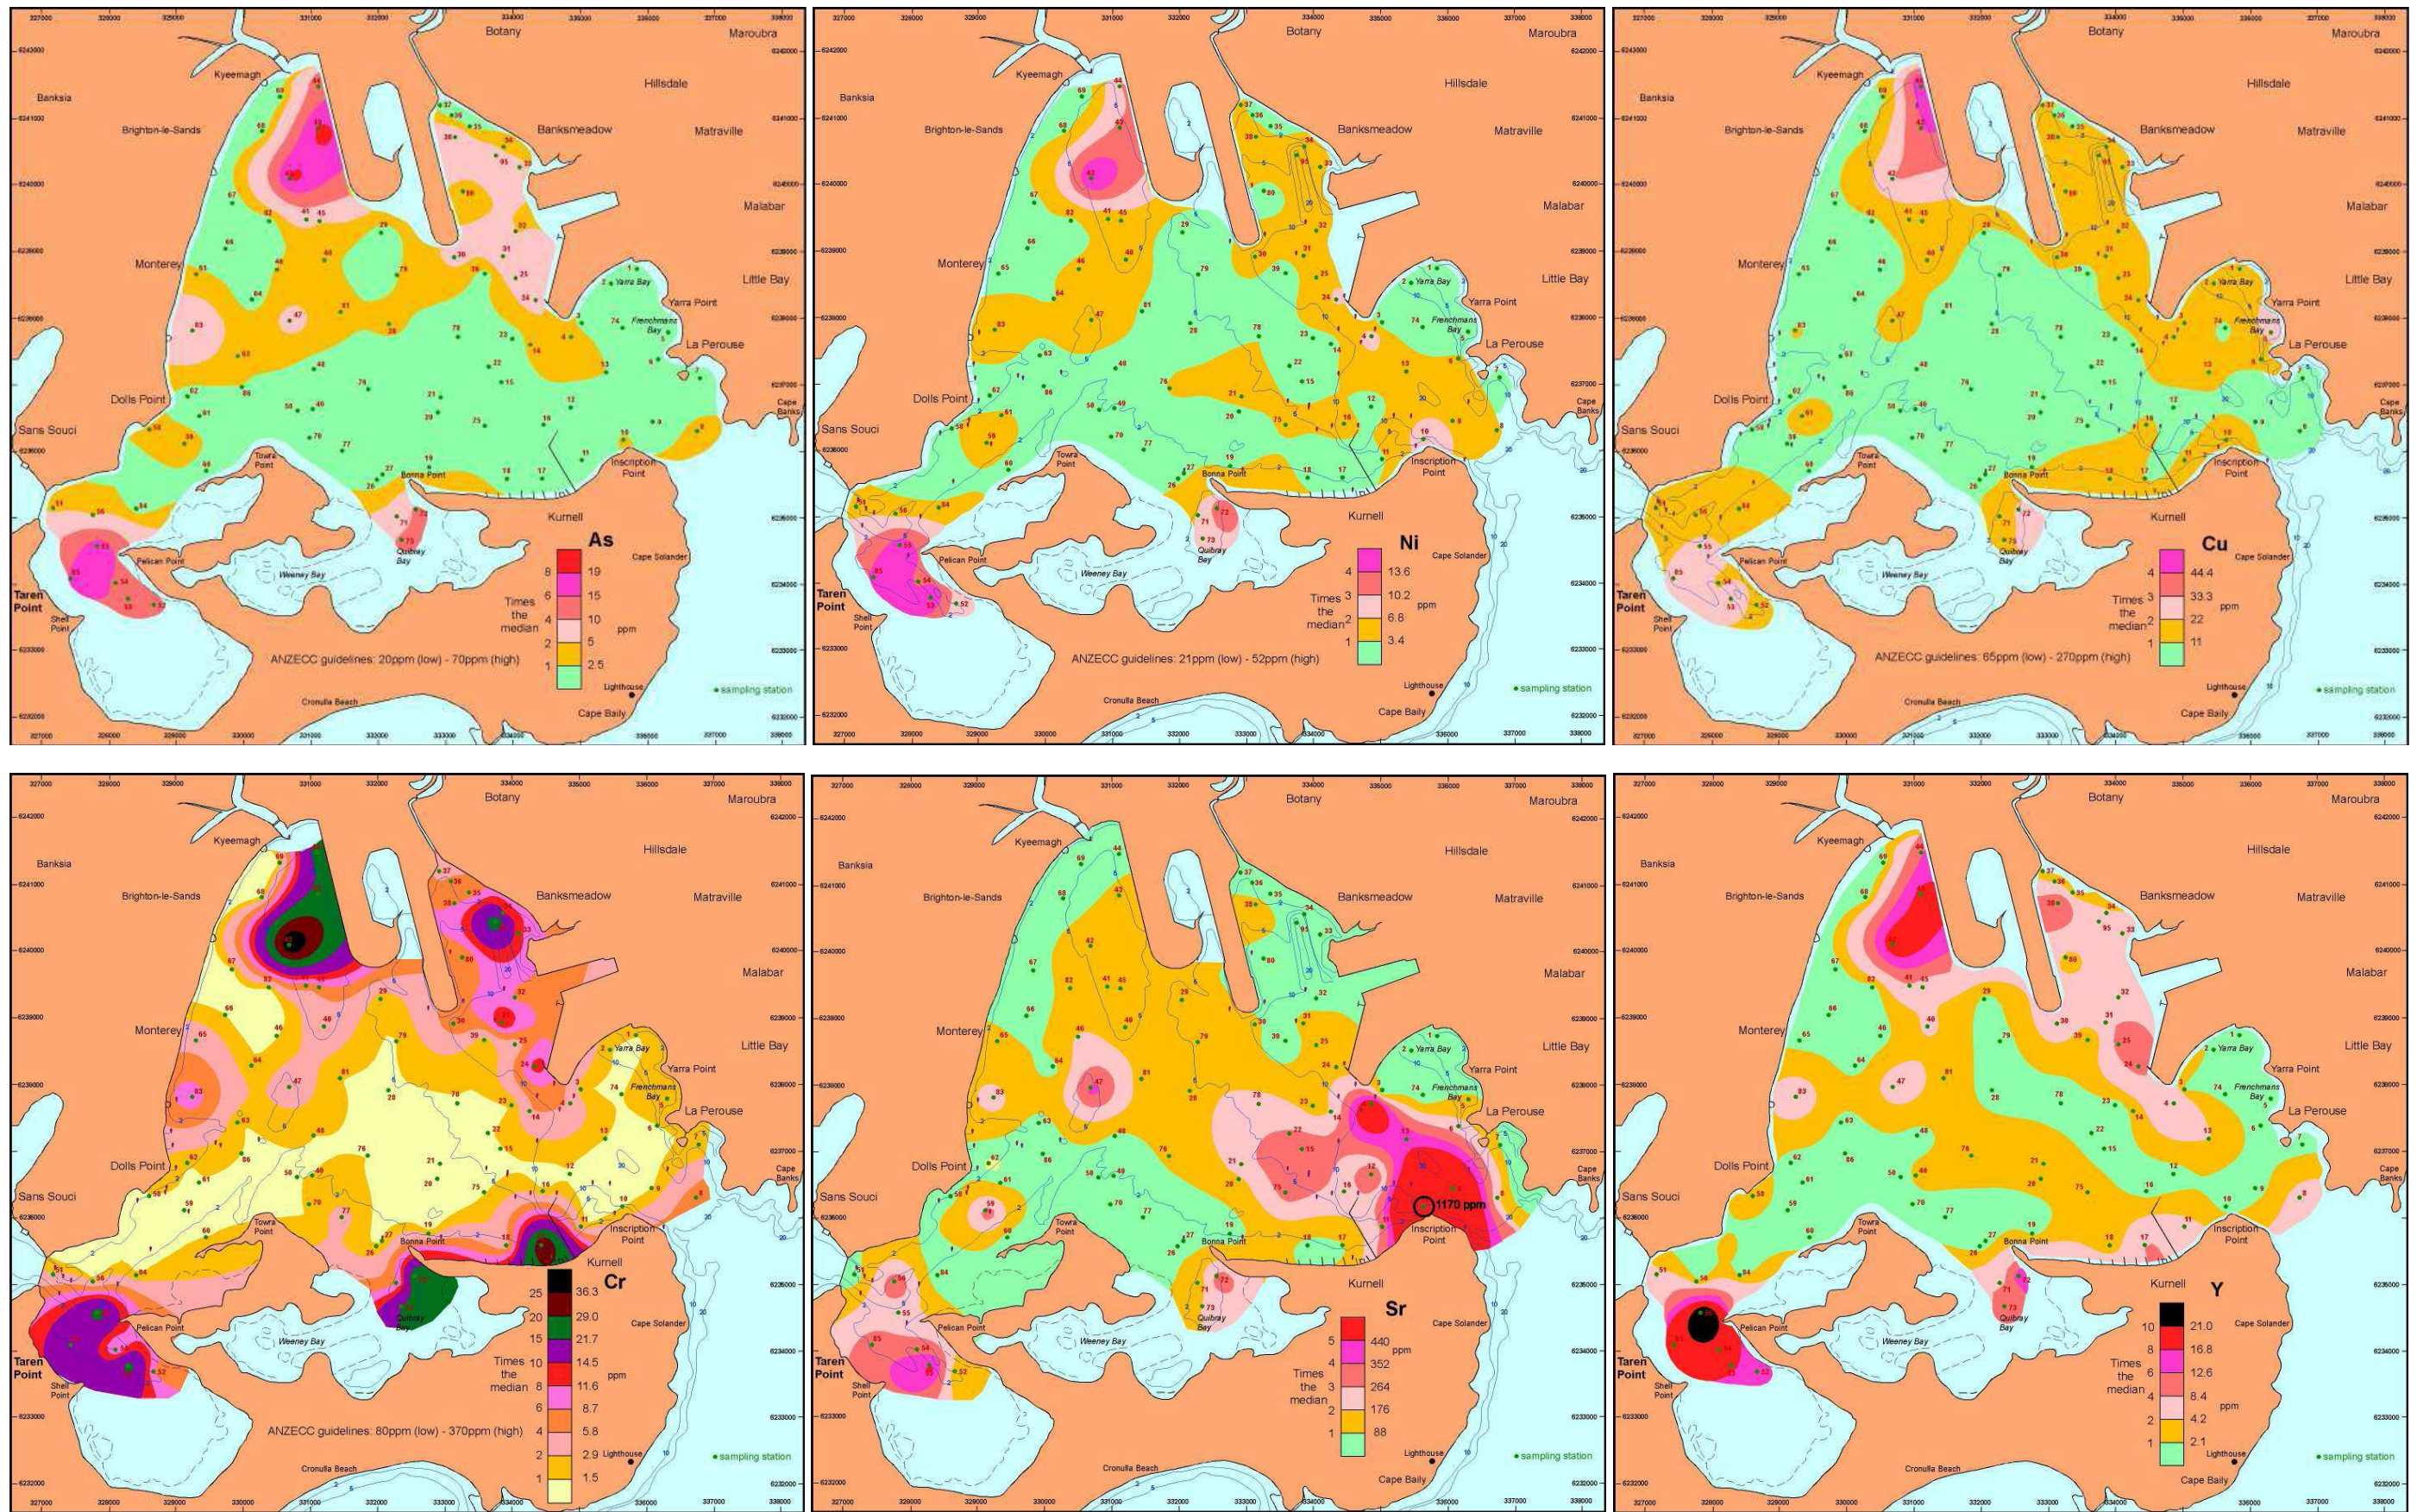
Figure 3.2 – Elevated heavy metal concentrations in Botany Bay (BCCCI, 2008)

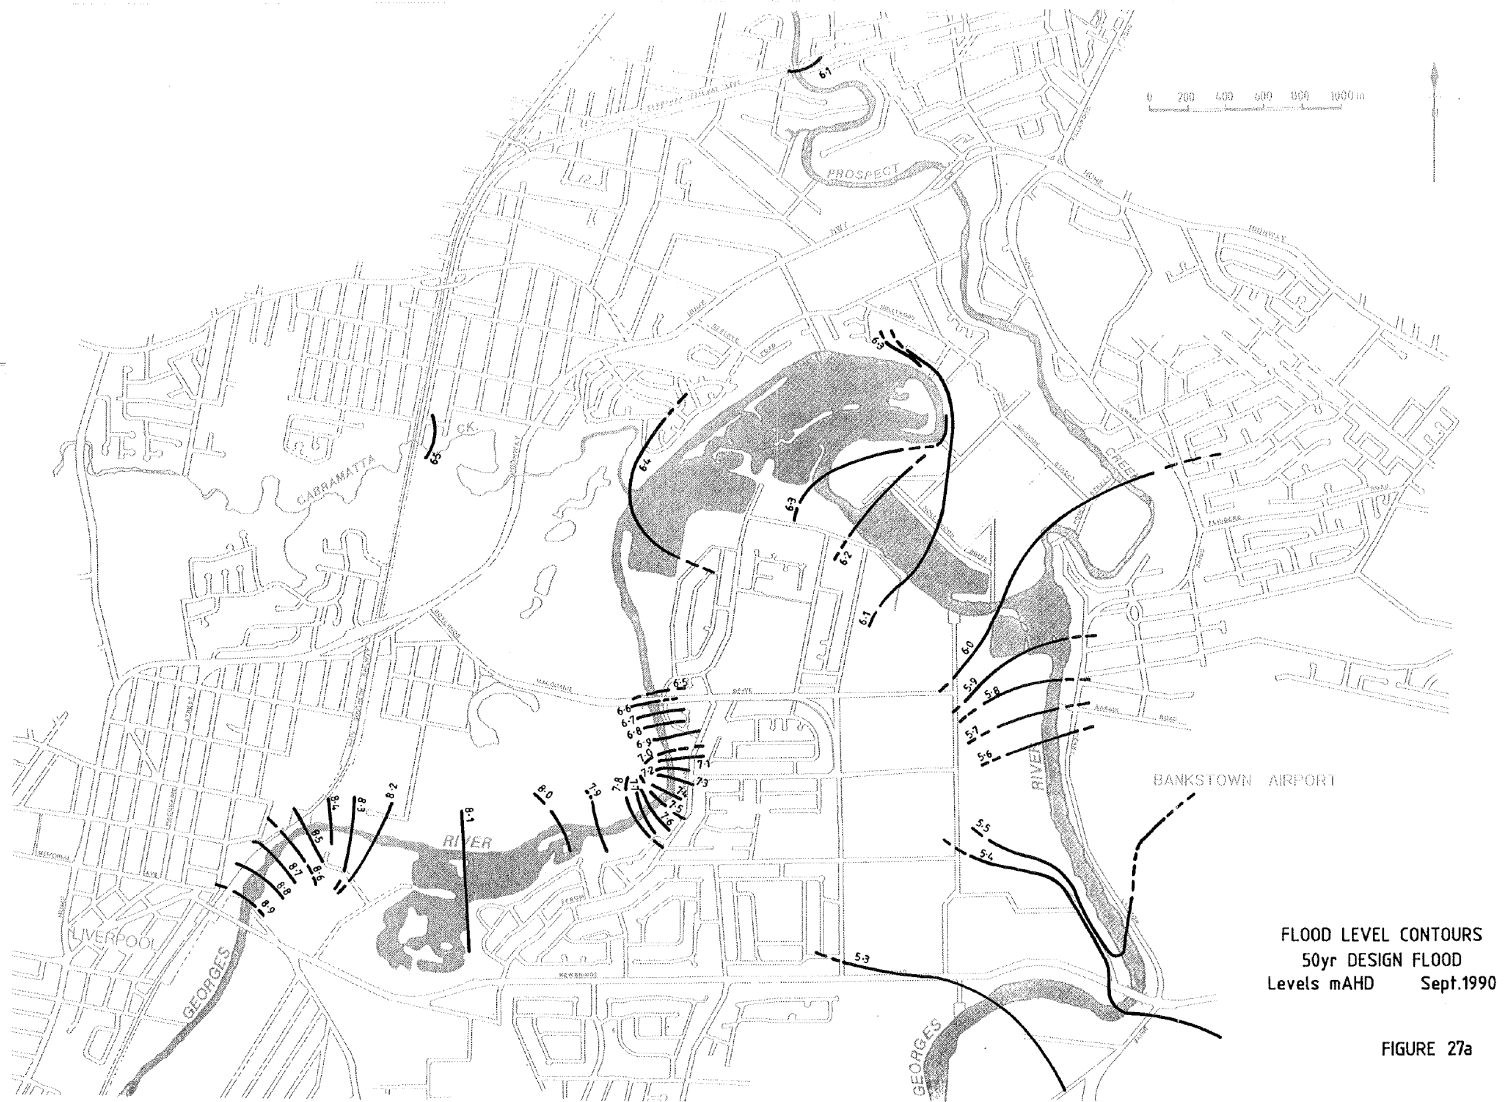
Figure 5.7 – Flood Level Contours between Liverpool Weir and Newbridge Road Bridge for a 50 year ARI event (PWD/WRL, 1991)

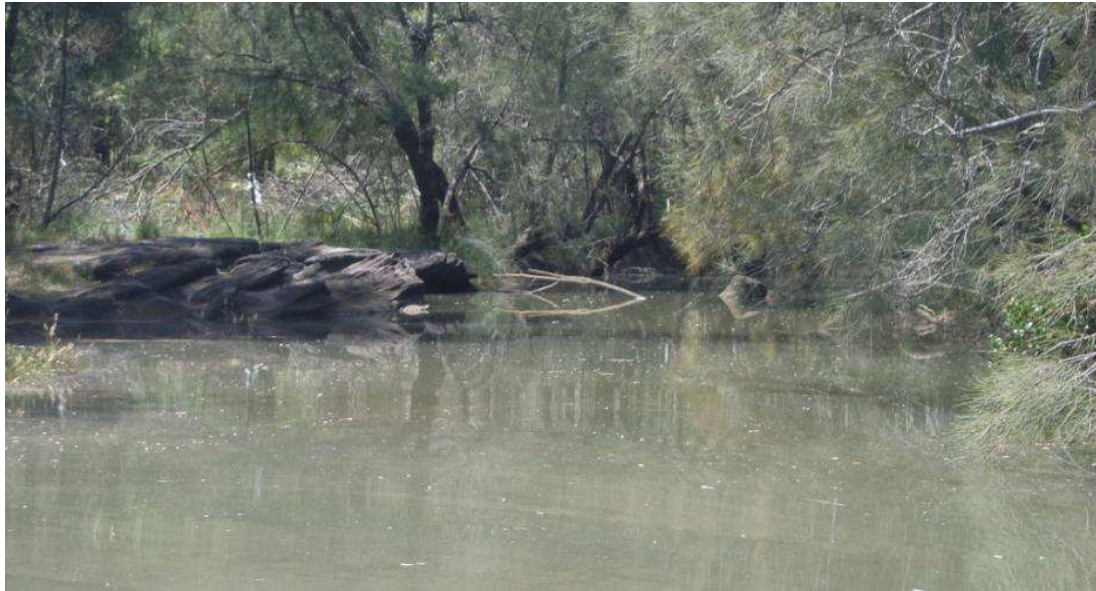
Figure 6.7 – Turbidity in Harris Creek

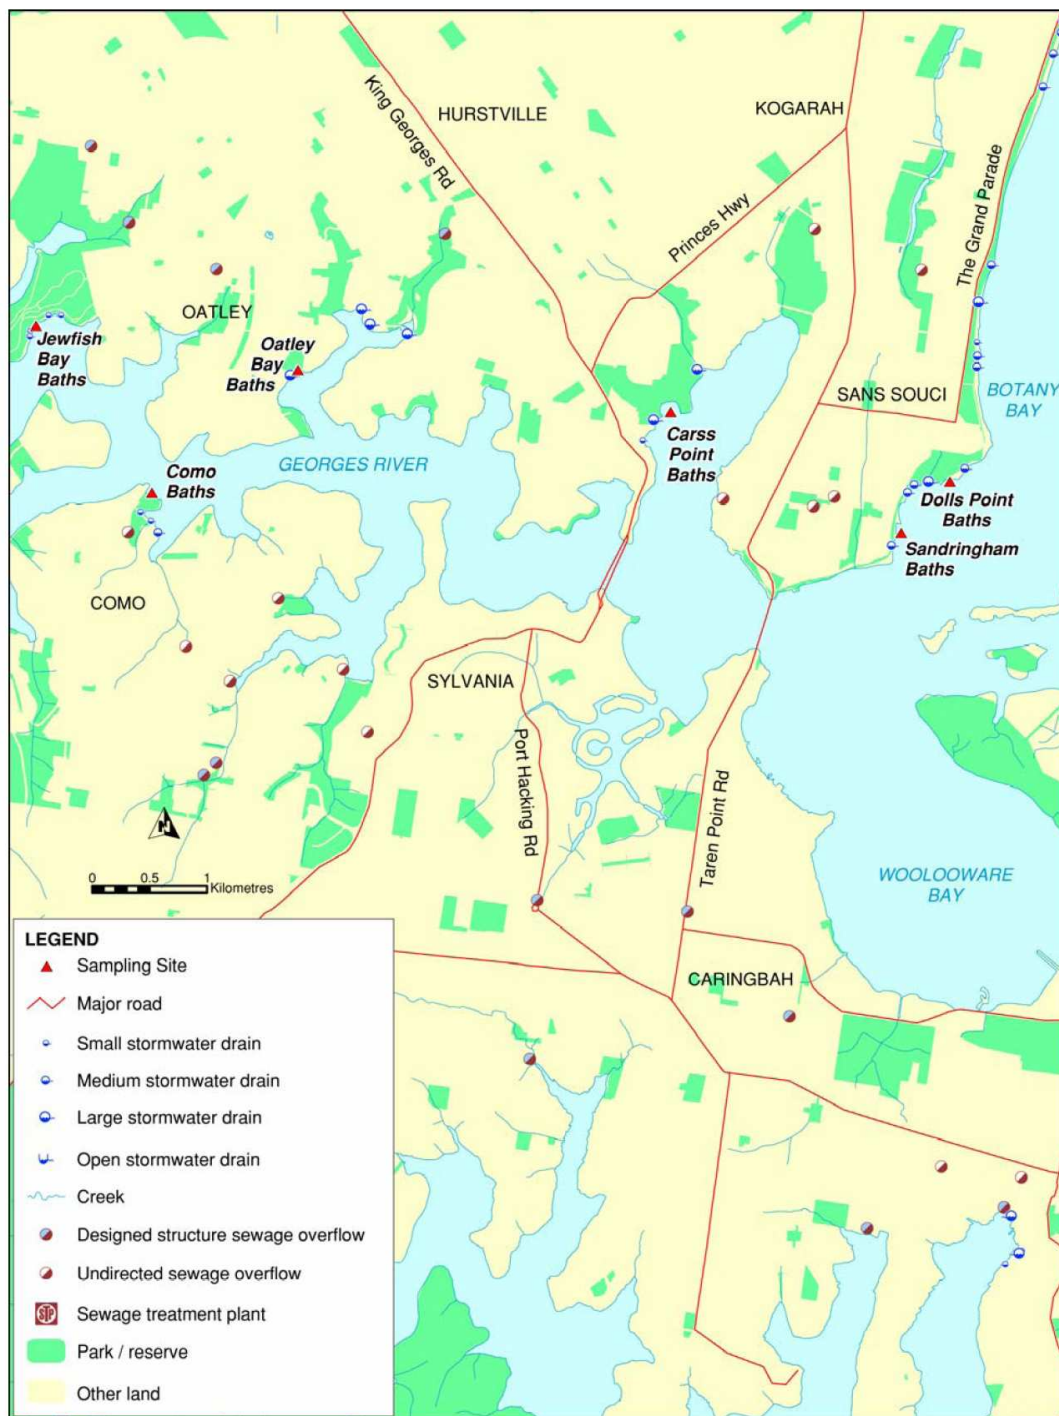
Figure 6.18 – Water quality sampling sites, sewer overflows and stormwater drains in the lower Georges River catchment (Harbourwatch, 2008).

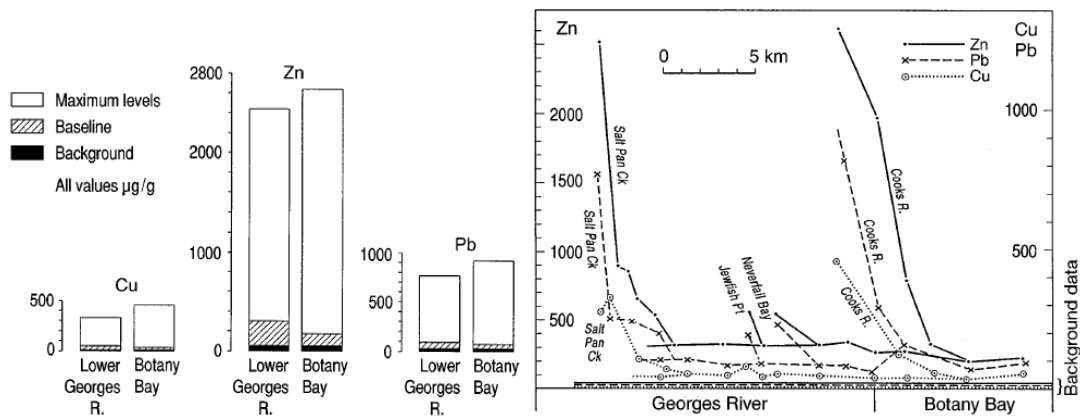
Figure 6.24 – Copper, Zinc and Lead concentration along the Georges River (Birch et.al, 1996)

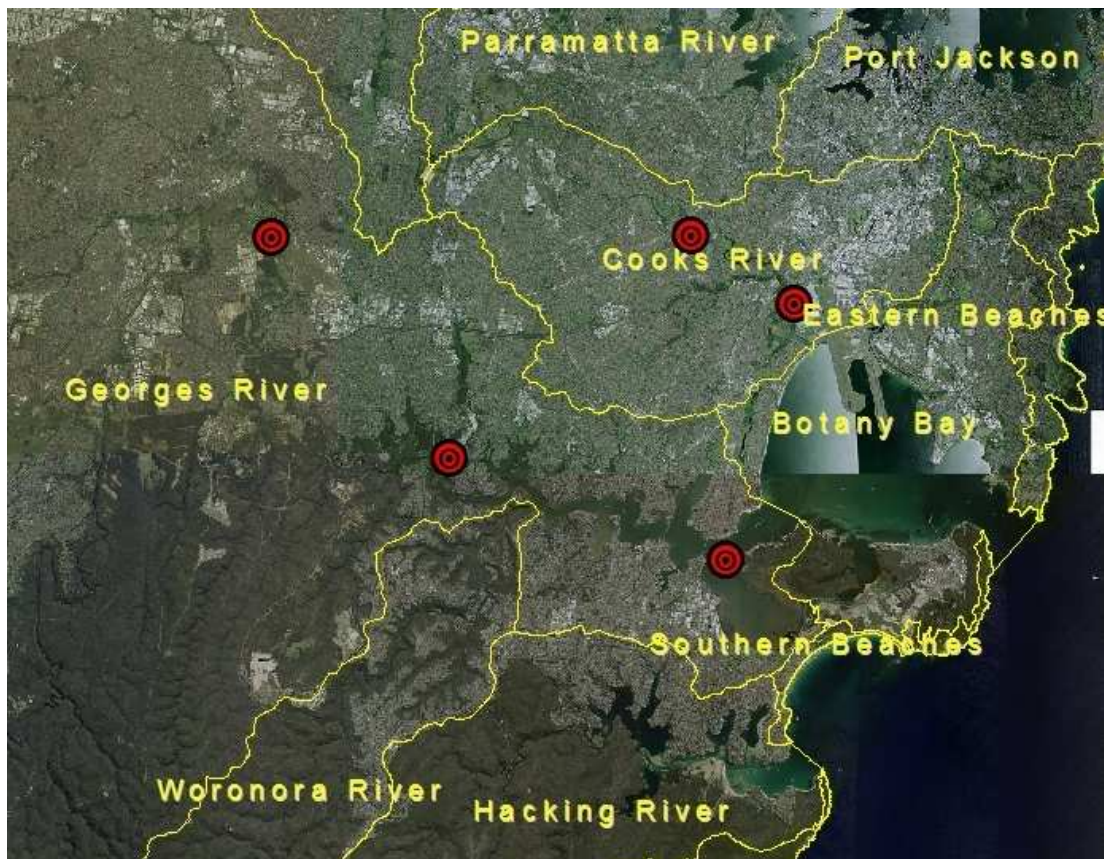
Figure 6.27 – Location of the monitoring stations within the Botany Bay catchment (<http://www.sydney.cma.nsw.gov.au/bbcc/monitoring-network.html>)
