Horning Street Saltmarsh Revegetation Project 2013/14 Annual Report

Local Land Services Greater Sydney Prepared for Sutherland Shire Council August 2014

Item	Detail
Project Name	Horning Street Saltmarsh Revegetation Project – 2013/14 Annual Report
Prepared by	Carl Tippler (CTENVIRONMENTAL)
Reviewed by	Brendon Graham (SSC) and Nerida Gill (GSLLS)
Approved by	Brendon Graham (SSC)
Status	Final
Cover photo	Nerida Gill

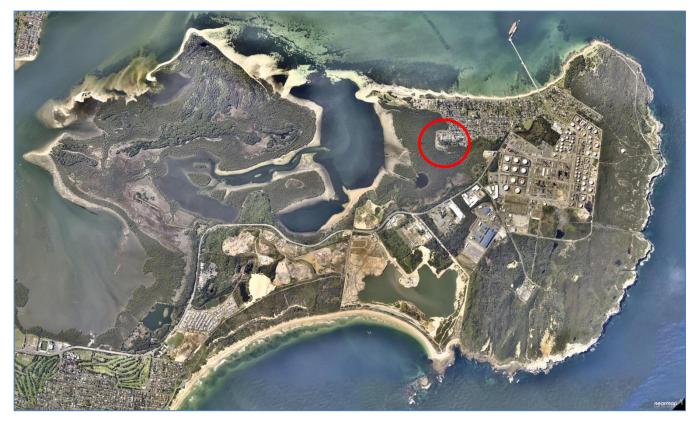
Figure 1. Aerial photo of Kurnell Peninsular taken September 11, 2014. Location of Horning St. Saltmarsh circled in red. Source: Near Map 2014.

Horning Street Saltmarsh is located within the north western tip of the Kurnell Peninsular, NSW, and covers an area of 2.9 hectares (Figures 1 and 2). Surrounding landuse includes light industrial and residential and a large expanse of mangroves connects the Site to the 600 hectare RAMSAR listed Towra Point Nature Reserve (DSEWPC, 2012).

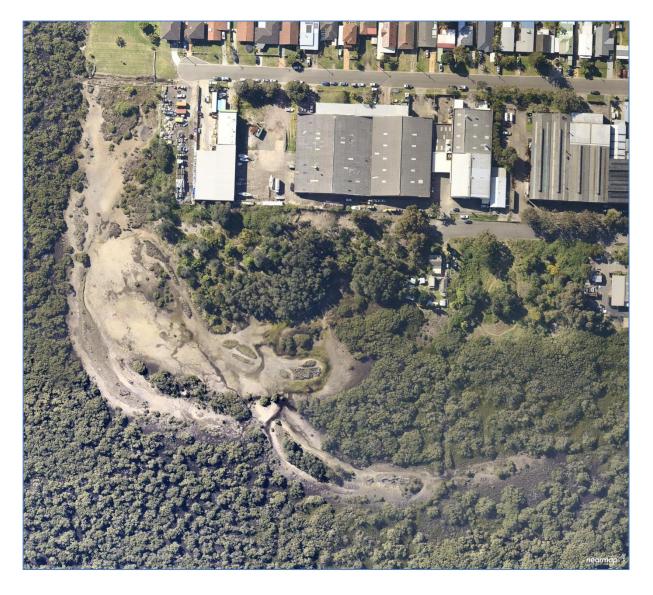
Figure 2. Aerial photo of Horning St. Saltmarsh taken June 30, 2014. Source: Nearmap 2014.

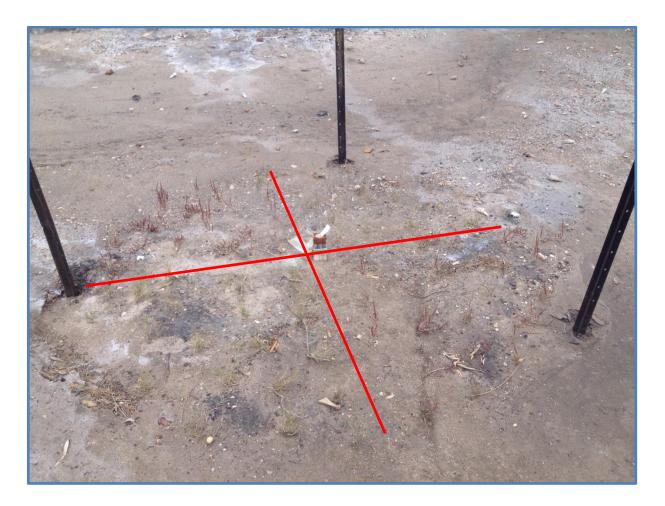
Figure 3. Revegetation plot with alternate planting pattern and protective steel posts. Red line delineates planting quadrants.

alternate quadrants in a pattern of 22 *Sarcocornia quinqueflora*, 22 *Sporobolus virginicus*, 22 *Sarcocornia quinqueflora* and 22 *Sporobolus virginicus* (Figure 3). Seedlings were planted at a density of 28 plants/m². A number of plots were surrounded by three steel fence posts to provide protection from illegal car or motorbike activity.

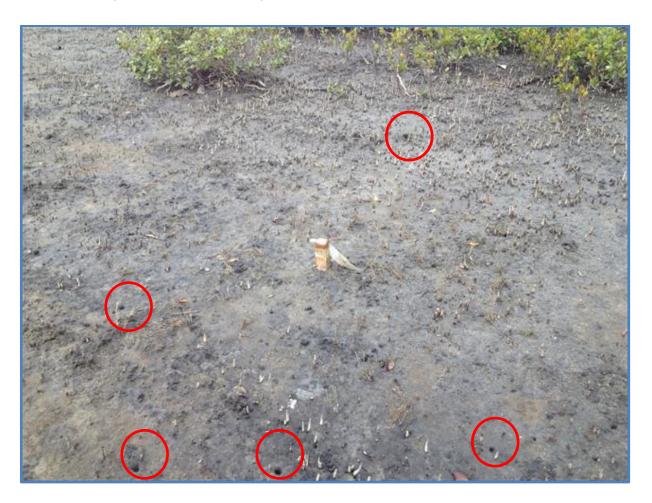
Figure 4 Low control category survey plot with active crab holes circled in red

Crab burrow abundance is a reliable surrogate of crab numbers and is commonly used in studies of saltmarsh crab populations. Survey of crab burrow abundance offers a non-destructive sampling technique which minimises site disturbance during sampling (Kelleway, 2006, Mazumder *et al* 2006, McFarlane 2010 and Warren 1990). The link between crab abundance and the function of the saltmarsh ecosystem is important as there is a direct trophic link between crab zoeae and itinerant fish species that feed in saltmarsh in periods of inundation (Mazumder *et al*, 2006).

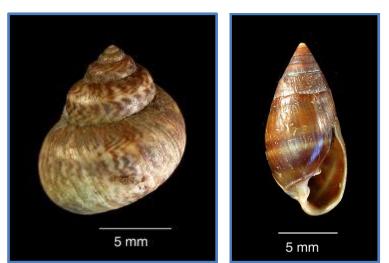
Figure 5 . Gastropods (snails) *Phallomedusa solida* (formerly *Salinator solida*) (left) and *Ophicardelus spp.* (right).

Gastropods (snails) *Phallomedusa solida* (formerly *Salinator solida*) and *Ophicardelus spp.* are common taxa which have been previously studied in saltmarsh communities of the Georges River and Towra Point (Green *et al* 2009, Kelleway 2006). Gastropods have also been shown to be an important food source for fish and wading birds (Freewater *et al* 2007) and sampling of gastropods in saltmarsh communities is commonly used to understand trophic relationships and habitat associations (Kaly 1988, Buck *et al* 2003, Green, J *et al* 2009).

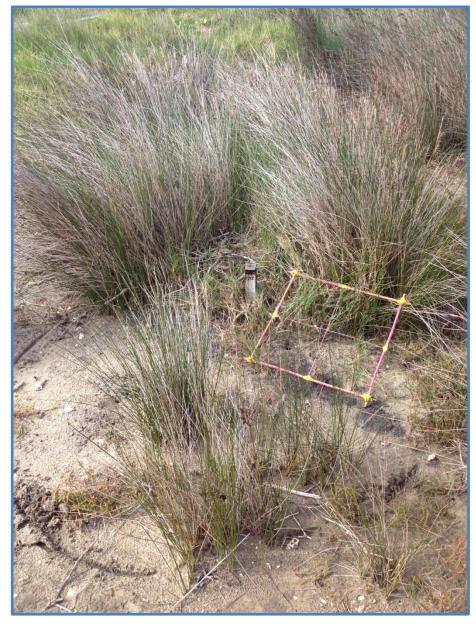
Figure 7 High reference category survey plot with 600 mm survey stake as centre point and 50 cm x 50 cm invertebrate survey quadrant.

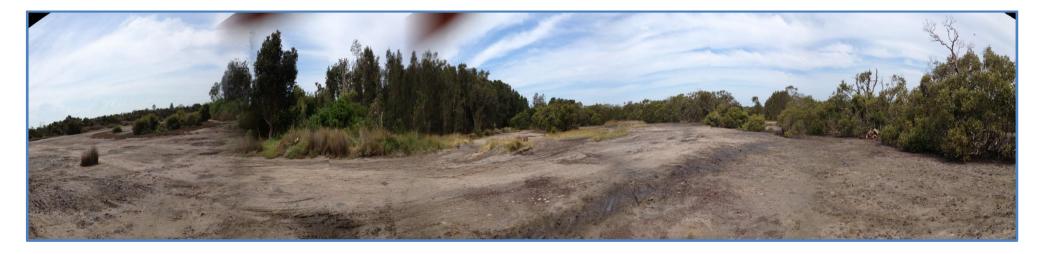
In November 2012 (Figure 8) conditions typical of the Site prior to rehabilitation and revegetation can be seen with deep vehicle wheel ruts and scarce vegetation visible. Incremental change can be seen throughout the photograph series with reductions in vehicle wheel ruts evident in April and June 2013 (Figure 9 and 10), the establishment of an algae mat in July 2013 (Figure 11) and re-establishment of saltmarsh vegetation in June 2014 (Figure 12).

Figure 8 . Panoramic photograph of Site. Taken November 2012 prior to the commencement of site rehabilitation works.

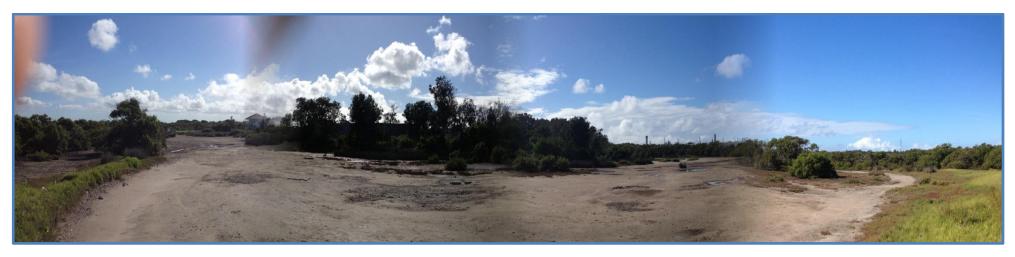
Figure 9. Panoramic photograph of Site. Taken April 2013 shortly after the Site was fenced to prohibit illegal vehicle access.

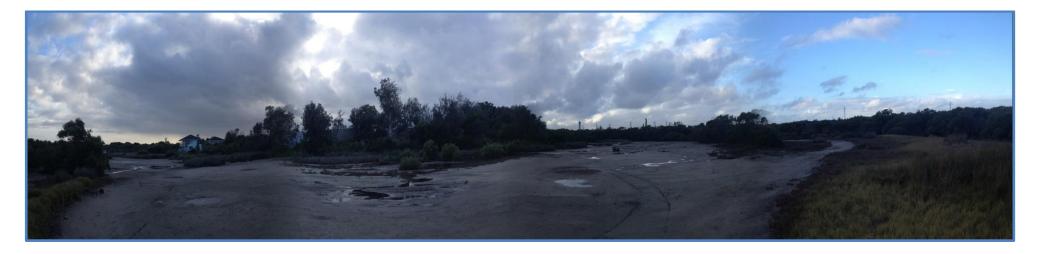
Figure 10. Panoramic photograph of Site. Taken June 2013 during revegetation works.

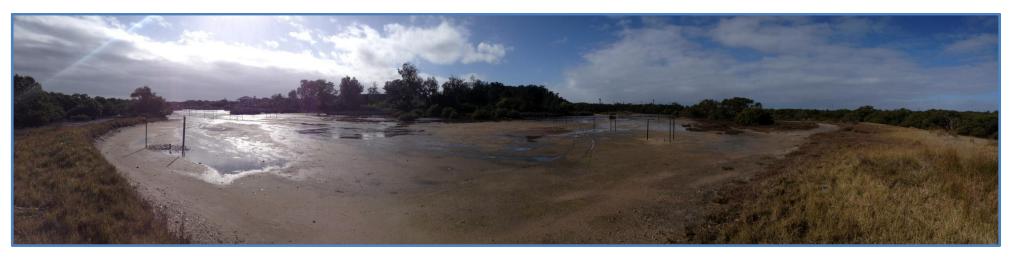
Figure 11. Panoramic photograph of Site. Taken July 2013 after the completion of revegetation works.

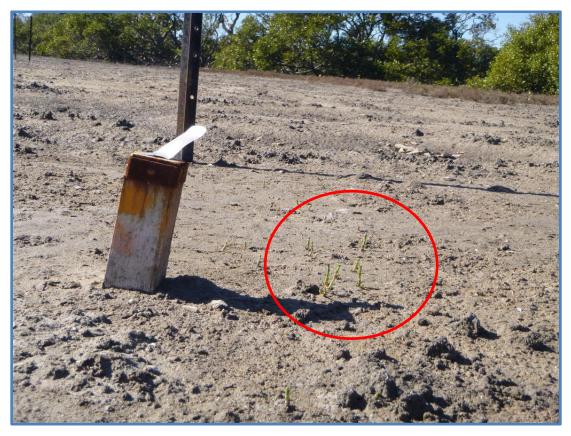
Throughout the monitoring period natural regeneration of *Sarcocornia quinqueflora* was observed across the site (Figure 13). Although not accounting for significant vegetation change, plots with natural regeneration were recorded. 17 high plots were found to have regenerating *Sarcocornia quinqueflora*, with the highest rate of regeneration recorded in winter 2014 (7 plots). In addition 16 low plots were found to have natural regeneration with the highest rate (5 plots) recorded in spring 2013 and autumn 2013 (Figure 14)

Figure 13. Natural regeneration of *Sarcocornia quinqueflora* in a low control plot 2013/14 monitoring period. (Photo: Nerida Gill).
