COMMUNITY RIVER HEALTH MONITORING PROGRAM

REPORT CARD - SPRING 2010

RIVER HEALTH REPORT CARD SPRING 2010

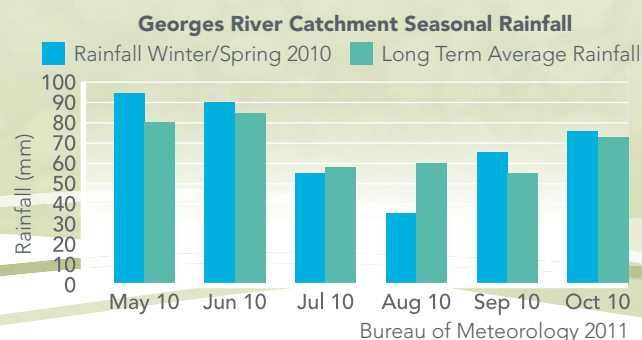
CATCHMENT AVERAGE RAINFALL

Since Autumn 2010, monthly rainfall totals across the Georges River catchment were mostly average to above average. Despite the impacts of stormwater and urban run-off, regular rainfall events throughout spring have provided continual flows, refreshing and revitalising many of the waterways throughout the catchment.
