RIVER HEALTH REPORT CARD AUTUMN 2011

A SNAP-SHOT OF RIVER HEALTH

COMMUNITY RIVER HEALTH MONITORING PROGRAM REPORT CARD - AUTUMN 2011

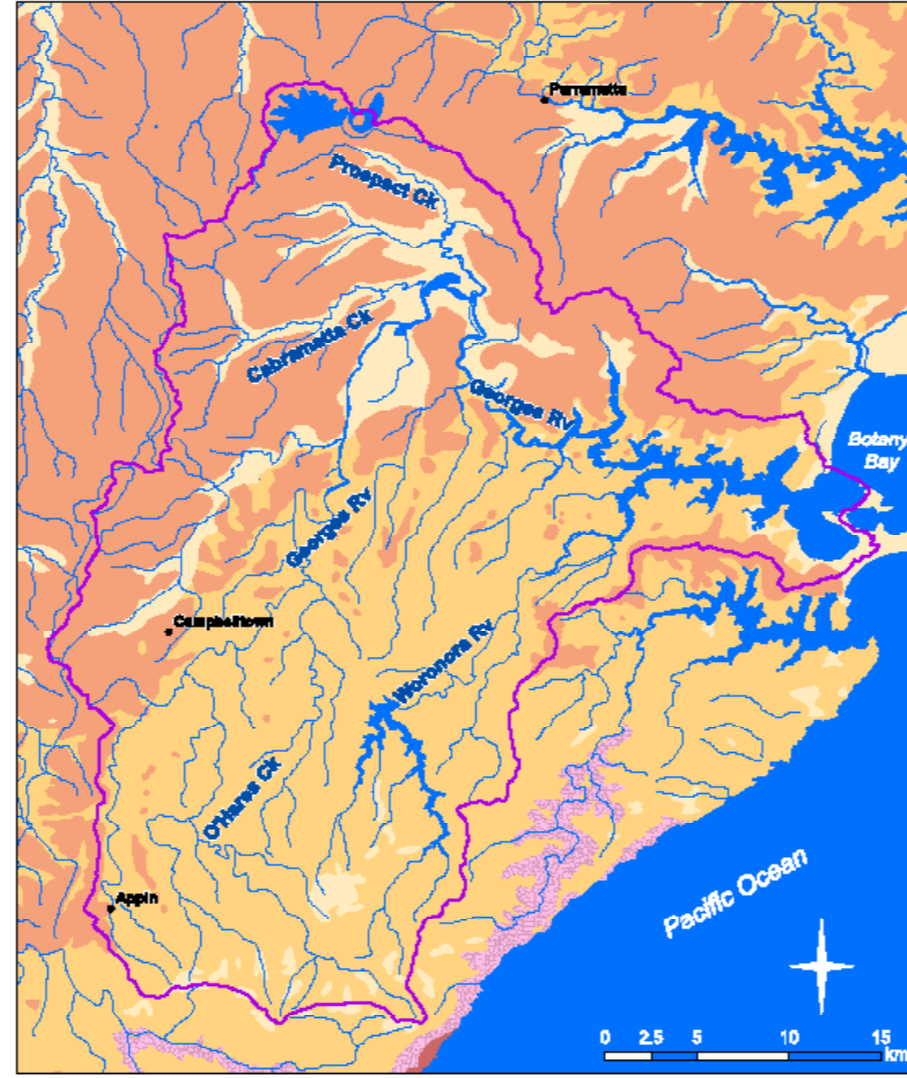
GEORGES RIVER CATCHMENT GEOLOGY

The catchment is divided into two broad soil groups. The western area of the catchment has predominantly fertile soil derived from Wianamatta Shale while deeply incised Hawkesbury Sandstone valleys dominate the northern, southern and eastern catchment areas. Land use within the catchment is mixed. Usage includes industrial, agricultural, mining, a large area of defence force land and protected areas such as drinking water catchments and conservation areas. The catchment area supports nearly 1.2 million people while approximately 45% of the catchment remains in natural or near natural condition.

- Georges River Catchment
- Drainage
- Wianamatta Shale
- Hawkesbury Sandstone
- Narrabeen Sandstone
- Blayney Coal Measures

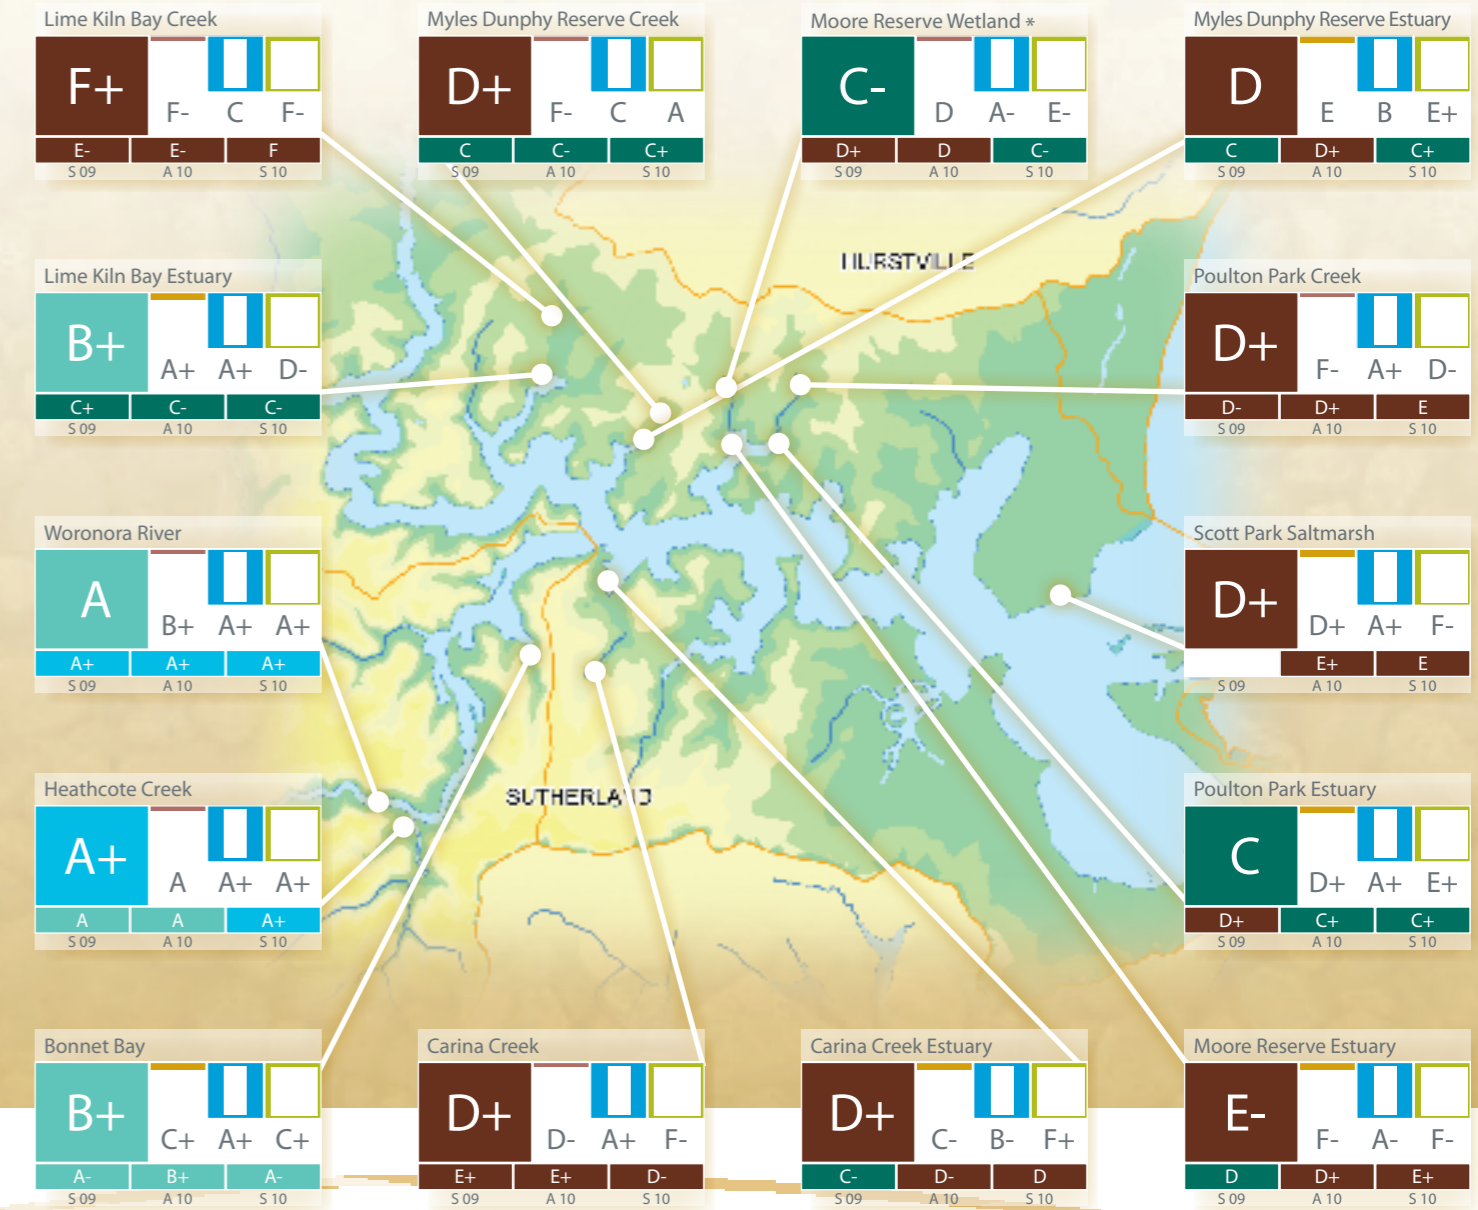
LOWER GEORGES RIVER REPORT CARD AUTUMN 2011

The overall grade for the lower sub catchment was C which indicates that the condition of freshwater ecosystems in this subcatchment is fair. Waterways within the highly urbanised parts of the lower catchment displayed elevated nutrient levels, altered chemical properties and severely degraded riparian vegetation. These factors in combination with altered stream flows and habitat modification, due to urbanisation, were reflected in the sampling results which found macroinvertebrate communities low in diversity and lacking in sensitive species. In contrast, Heathcote Creek and Woronora River remain in good ecological condition; similar to sites found in the clean upper areas of the catchment due to minimal urbanisation within each of these sub catchments.

No change to the overall grade of estuarine areas in the lower catchment was observed during autumn 2011 monitoring with the ecological condition remaining fair. Slight fluctuations in macroinvertebrate communities were observed across monitoring sites, and constant tidal flushing is likely to have maintained reasonable water quality in the lower end of the catchment despite an increase in the volume of stormwater entering the lower estuary due to the wet conditions experienced during autumn 2011.

* This site has been specifically designed to capture and treat stormwater
