2016 - 2017

# RIVER HEALTH

## GEORGES RIVER REPORT CARD

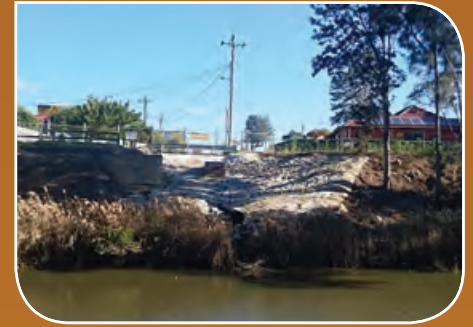
## FAIRFIELD CITY COUNCIL BROMLEY STREET REHABILITATION PROJECT

The bank at Bromley Street, Canley Vale was eroding into Prospect Creek. Without remediation, the erosion posed a threat to the sewerage and road infrastructure, plus the local environment. Rehabilitation included replacing and realigning the stormwater pipe, removal of some concrete and road pavement, stabilizing the bank with rip rap and replanting the regraded bank with native vegetation to hold soils together.
