## 2 Features

Existing Features Yeramba Lagoon Masterplan

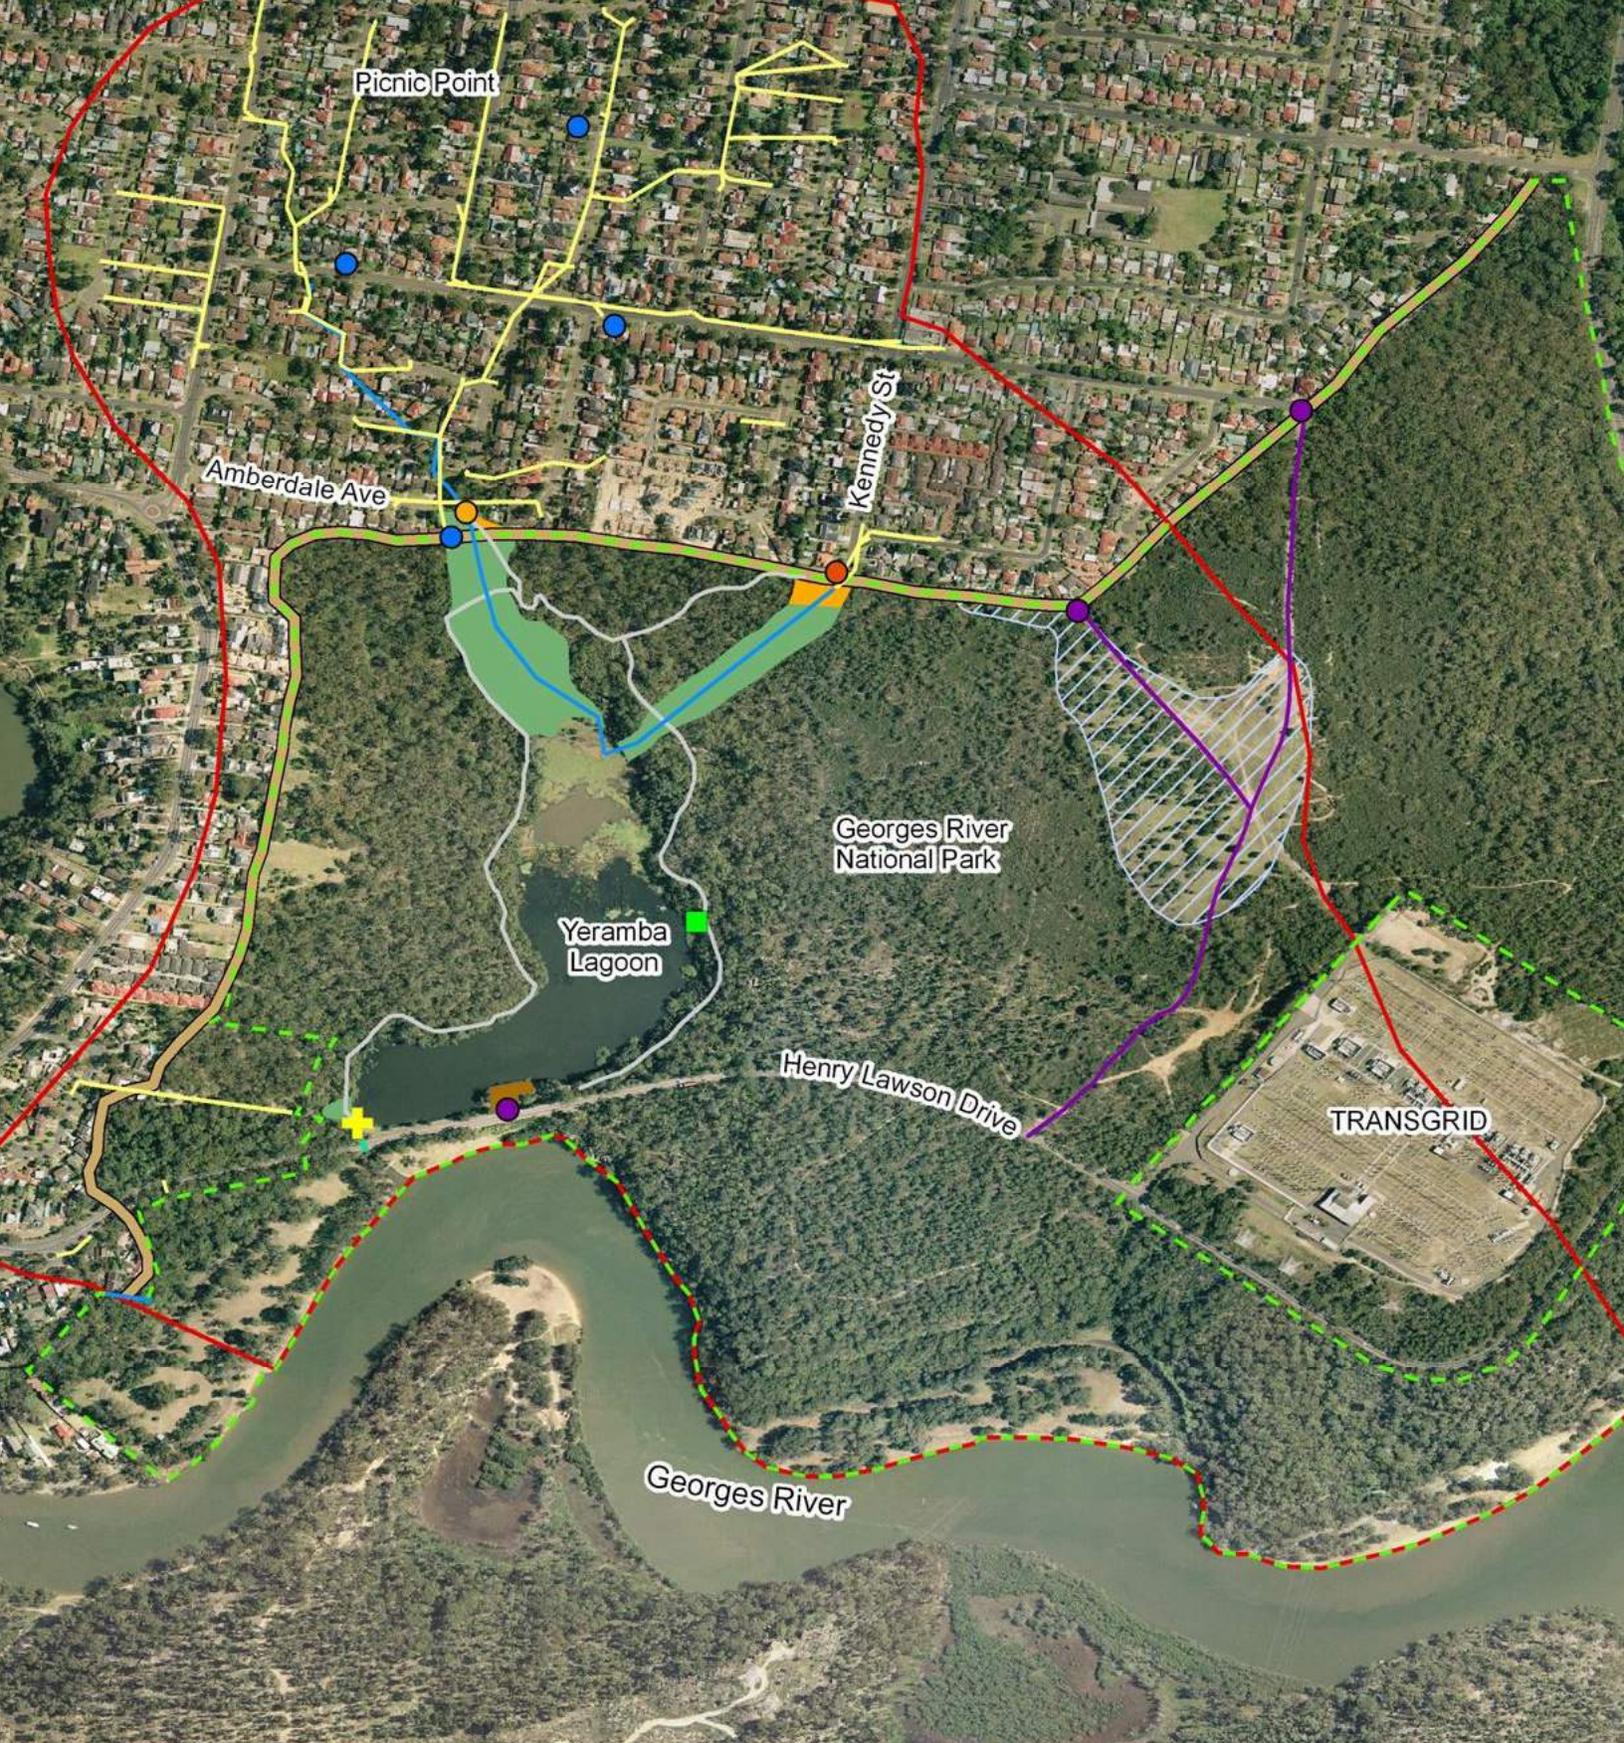
The stormwater network is illustrated in **Figure 4**. It includes infrastructure such as pipes, water pollution control devices and culverts. Unconstructed drainage lines and the lagoon are also shown.

Sewer overflows contribute to the poor health of the lagoon and bushland in drainage lines. They are also undesirable for health and aesthetic reasons. Four sewer overflows have been identified in the catchment (**Figure 4**): downstream of Amberdale Avenue, at the western end of Burns Road, at the northern end of Drysdale Avenue, and in Austin Street.

Pedestrian access is available to the national park at several locations from surrounding areas, the main ones of which are shown in **Figure 4**. There is a need for improved signage at access points and along the main track network.

Members of the community highly value the ability to access the park from their local streets. This Masterplan does not promote tracks that are not part of the main track network identified in **Figure 4** by identifying them or recommending signage. However, it recognises that many of these walking tracks have minimal impact whilst allowing people to connect to and value the natural environment.

An electricity sub-station to the east of the lagoon is the largest utility feature in the catchment (**Figure 4**). Management of the sub-station property, however does not appear to affect conditions in the national park or lagoon.

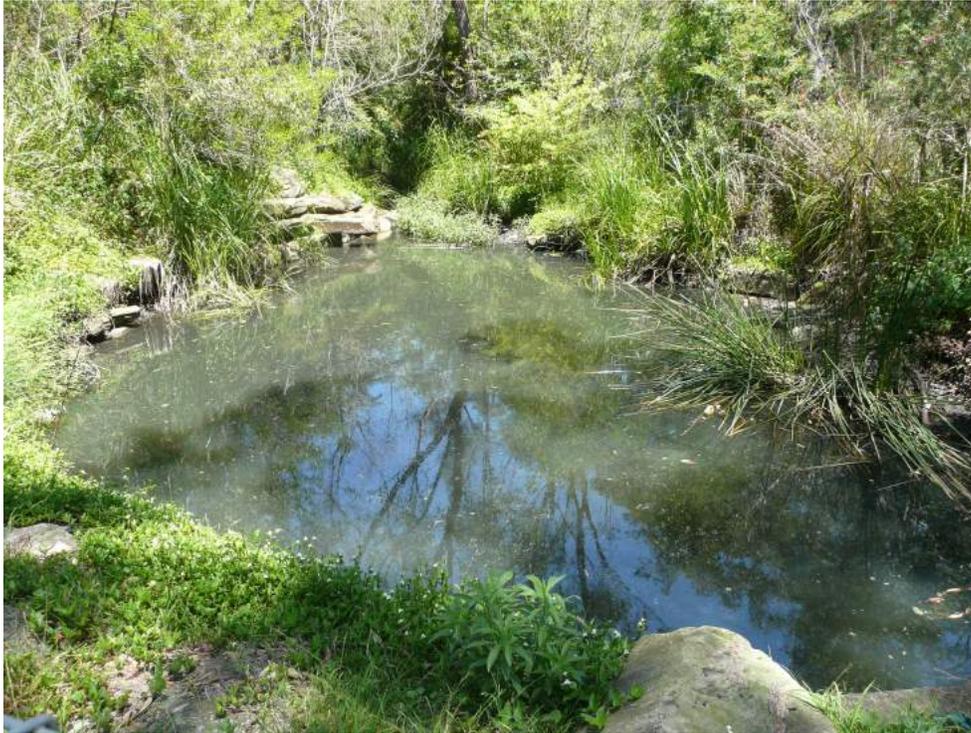
Constructed stormwater detention pond at Amberdale Ave

There are two main inflows to the lagoon. The first is the main gully system below Amberdale Avenue that picks up the urban drainage from Amberdale, Samoa, Joyce, Karen and Drysdale Avenues. Stormwater passes through a gross pollutant trap (GPT) and into a detention pond/constructed wetland located behind a residence at the bottom of Amberdale Avenue.

Stormwater pollution control devices have been installed at outlets from Amberdale Avenue (GPT and detention pond) and Kennedy Street (trash rack). The GPTs at Amberdale Avenue are maintained by Council. However, the pond and trash rack have received minimal maintenance. Accumulated sediment and pollutants at these locations is undesirable for environmental and aesthetic reasons. Appropriate maintenance of the stormwater pollution control devices at these locations will lead to improved performance.

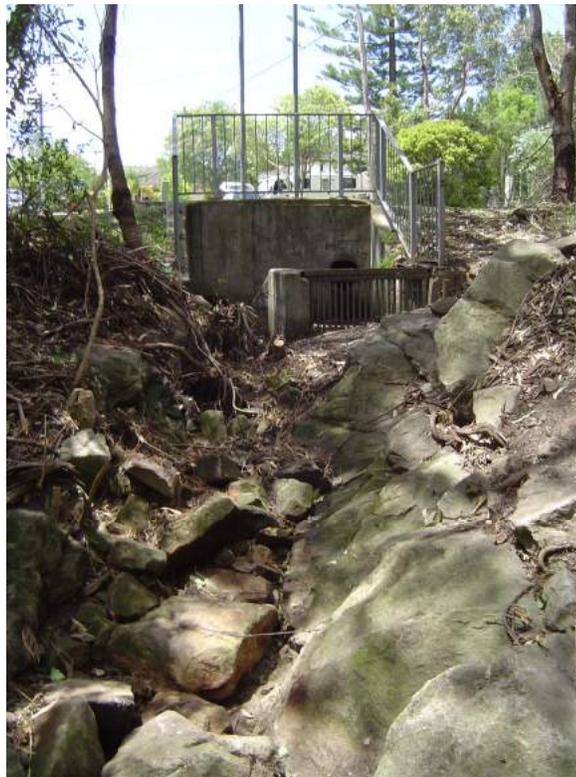
Trash rack at Kennedy St

The second is the outlet below Kennedy Street, which also picks up urban drainage and flows into the lagoon after passing through a trash rack. A number of smaller creek systems flow into the lagoon, including two from the east that flow out of the ridgetop heathland.

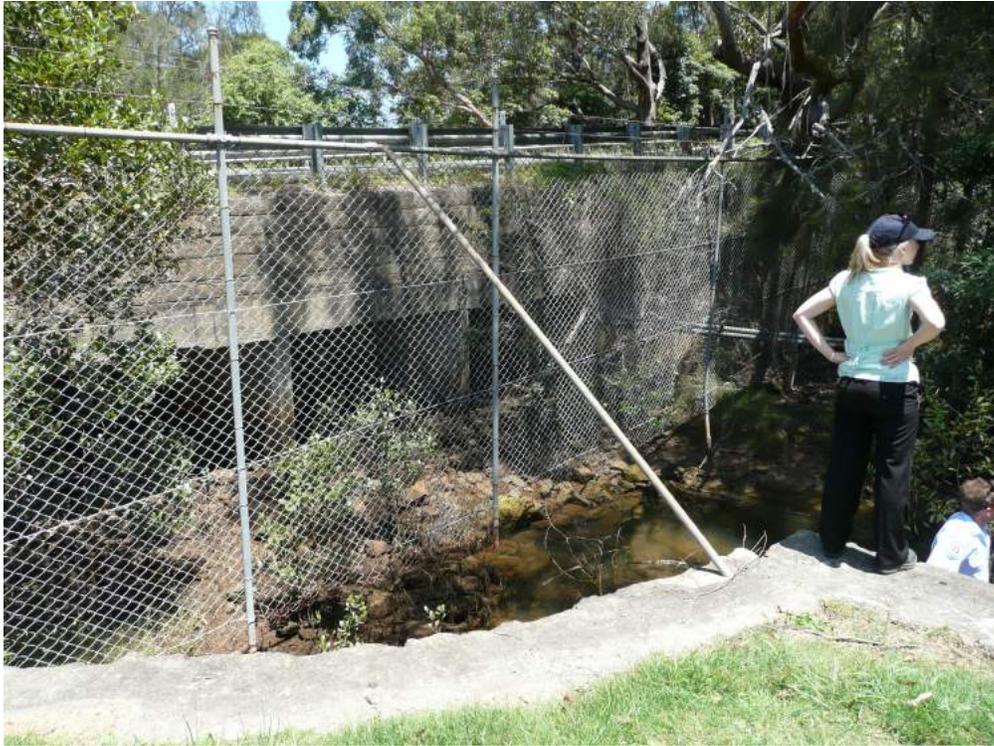
Culverts under Henry Lawson Drive

Freshwater discharge from the lagoon flows over a concrete weir, through box culverts under Henry Lawson Drive, then along a concrete channel to the Georges River. Their location is indicated in **Figure 4**. Photos of the culvert and weir are given on the following pages.

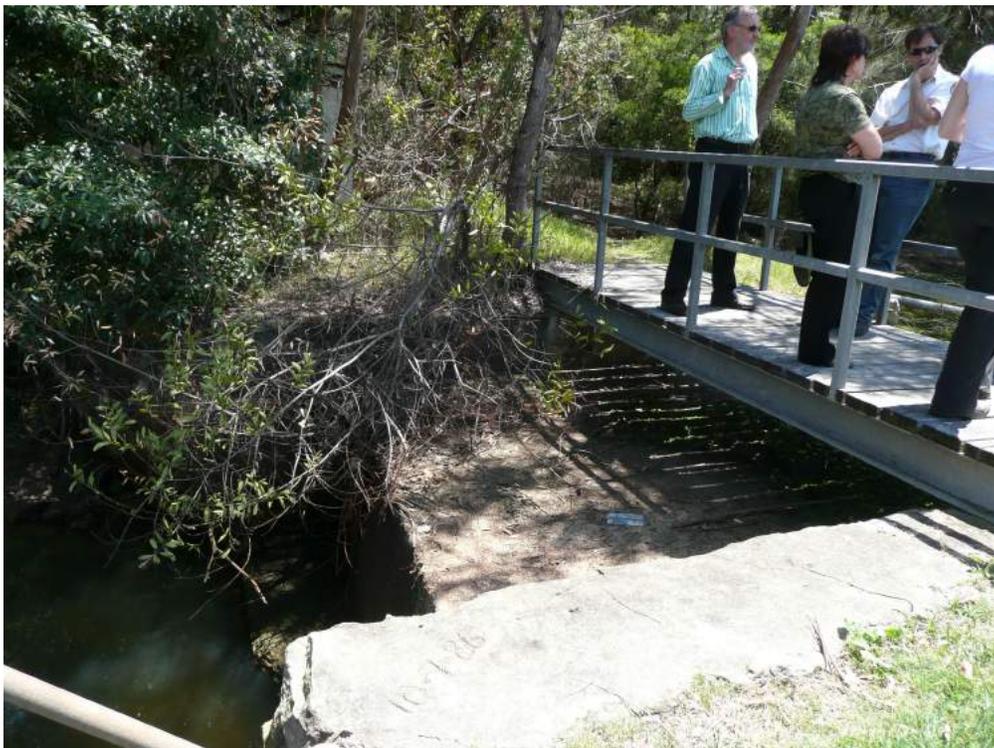
Weir and footbridge
