## 7 FORESHORE EROSION AND STRUCTURES ASSESSMENT

### 7.1 Introduction

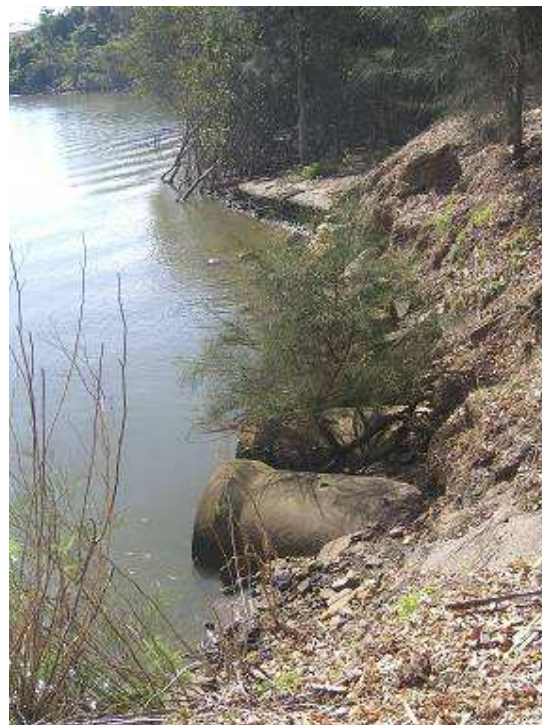
At Moore Reserve Boat Ramp, some erosion is visible on the foreshore between the boat ramp and a big stormwater overflow west of the ramp. Along Poulton Park (Figure 7.35), some severe erosion is noticeable, certainly due to two overflow pipe or the runoff water from the road (location reference E89-90).

Figure 7.35 – Erosion at the southern end of Poulton Park

Location	LGA	Priority Rating	Possible Management Response (Options provided refer to Erosion Options of Section 7.3.1 of the report)
E89.Moore Reserve Boat Ramp	Kogarah	Medium	Levelling of the bank to reach a stable slope and vegetation planting (Option E1) Stabilisation of seawall toe with small seawall (Option E2)
E90.Southern end of Poulton Park	Kogarah	High	Levelling of the bank to reach a stable slope and vegetation planting (Option E1)

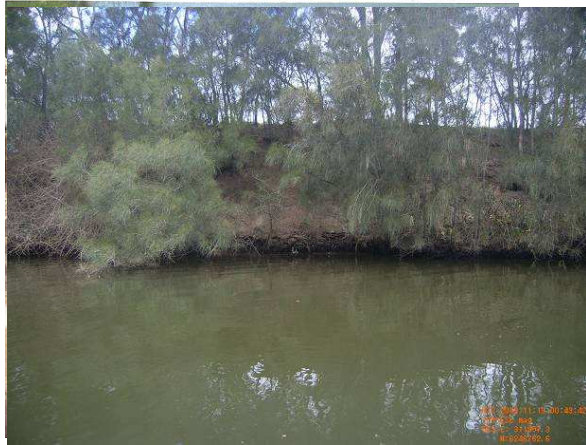
7.51 – Undercutting at Strong Park (left) and possible solution\*\* from the DECCW, 2009 (right)

In areas of light erosion at the toe of a steep slope, the erosion can be stopped by setting some rock seawall at the bottom of the bank where mangrove seedlings can grow amongst the gaps between the rocks (Figure 7.51).

\*\*Once again, this solution would be possible where the water is not too deep. In this case, a replenishment of the toe of the bank would be a better solution.

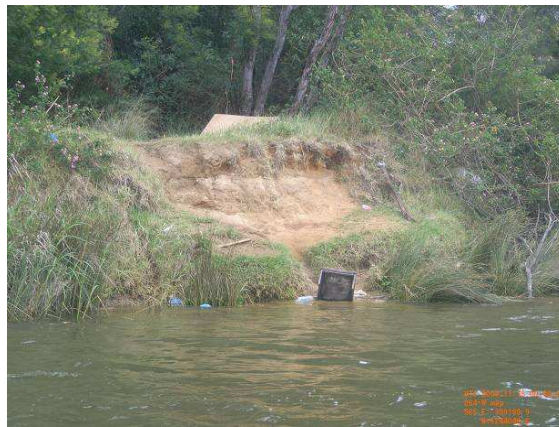
Figure 7.52 – Erosion between gap of vegetation at Moore Lake

In areas where erosion occurs in gaps of vegetation, some native vegetation can be planted to close the gaps and avoid further erosion (Figure 7.52).

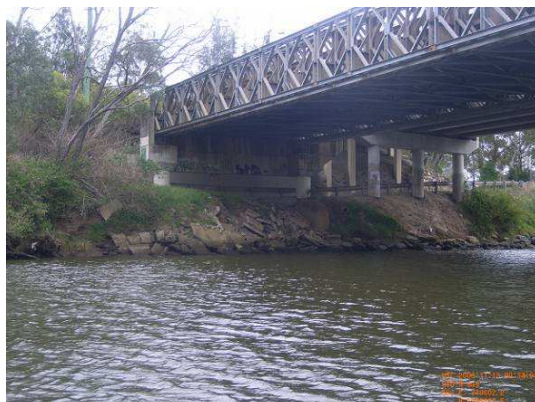
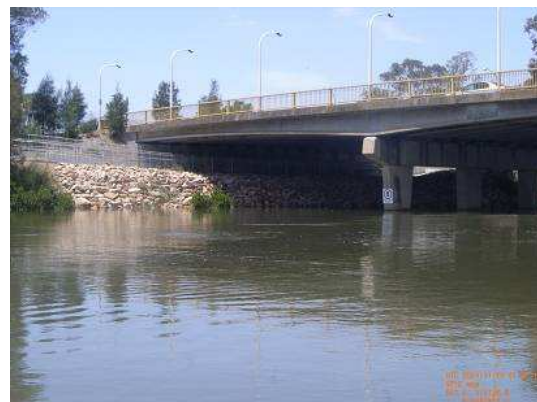
*Figure 7.53 – Erosion under seawall at Governor Macquarie Bridge (left) and possible bridge abutment scour protection e.g. Newbridge Road Bridge (right)*

In areas located under bridges or along concrete structures in the river, some seawalls should be built to prevent the bank from eroding due to the turbulences generated by the obstacle structure (Figure 7.53).

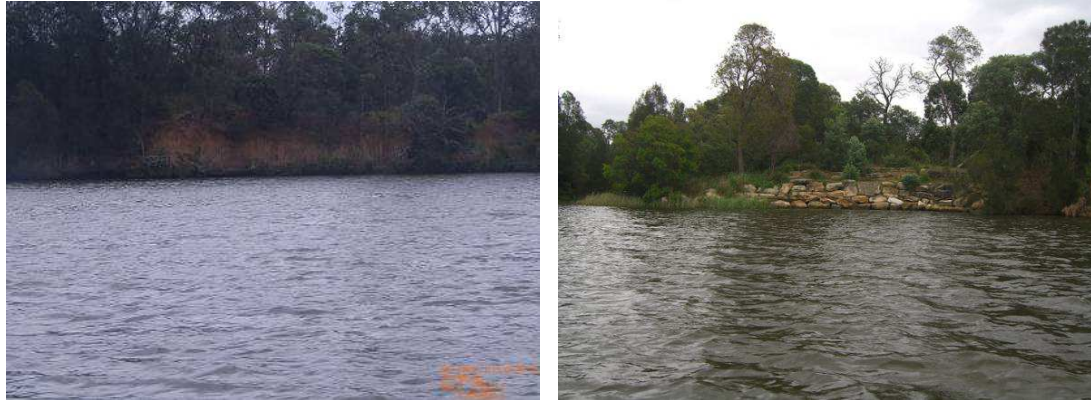
*Figure 7.56 – Comparison between western side (left) and eastern side (right) of Cabramatta Creek entrance*

The entrance of a creek where one side has been stabilised by rocks, like at Cabramatta Creek entrance, should be stabilised on the second side to avoid further erosion. This stabilisation could be undertaken by constructing step seawalls or seawalls made of various sizes and boulders without cement between the rocks to provide some habitat in the crevices (Figure 7.56).

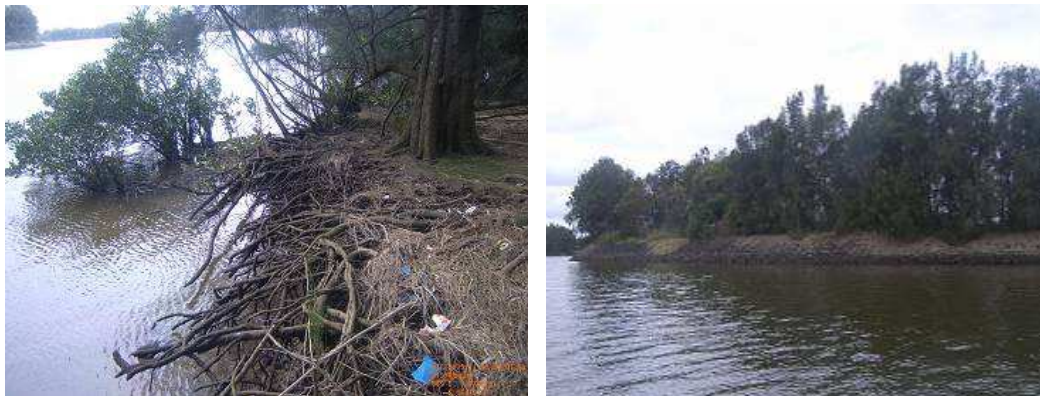
*Figure 7.57 – Erosion along Wildlife Island (left) and possible solution e.g. along Daruk Island (right)*

The different islands located within Chipping Norton Lake could be protected using the same method as on Daruk Island, i.e. a layer of small rocks of around 20-30 cm of diameter all along the island (Figure 7.57).

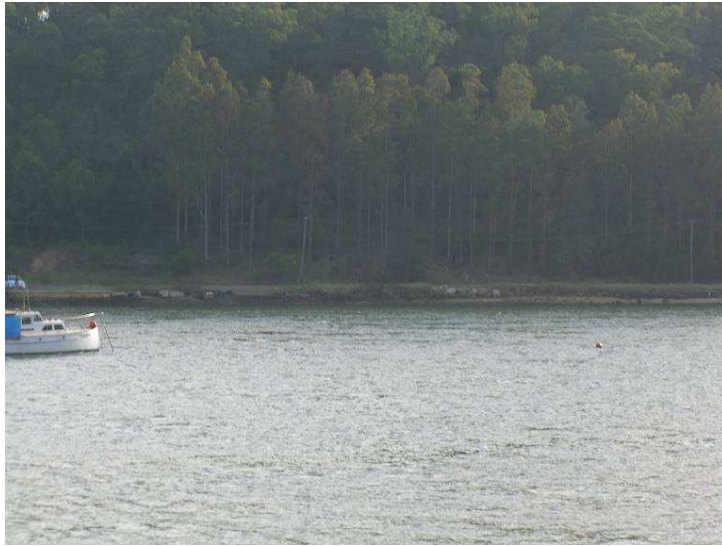
Figure 7.60 – Old seawall provoking edge effect at Illawong opposite Lugarno

Seawalls surrounded by erosion (such as at Illawong, Figure 7.60) should either be extended or dismantled to stop edge effects.

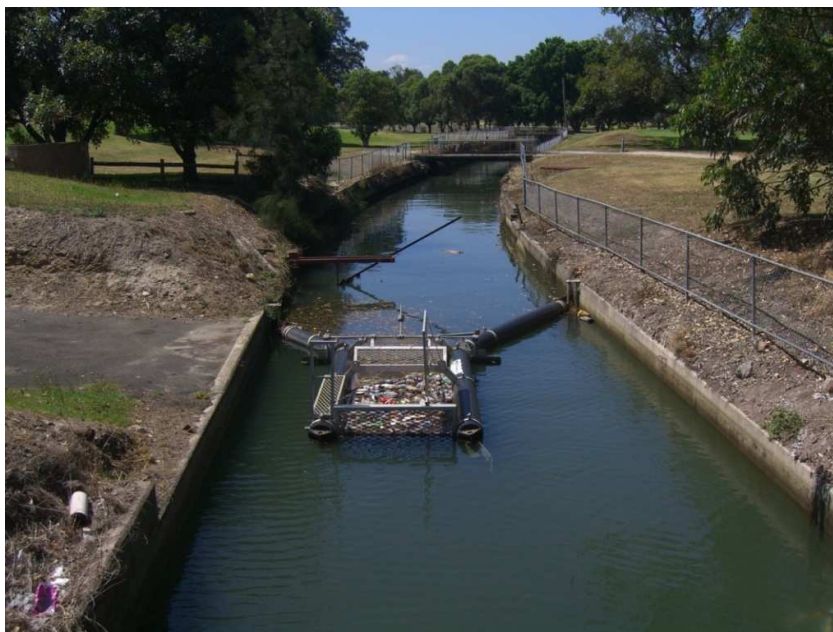
- A common GPT within Kogarah Council is made of floating plastic tubes across channels or creeks, forming a constriction generating a funnel effect where a metal grid stops the gross pollutants (Figure 7.66). The Kogarah Council's GPTs that have been observed were in good condition and working efficiently.

*Figure 7.66 – Kogarah Council GPT at Kogarah Bay*

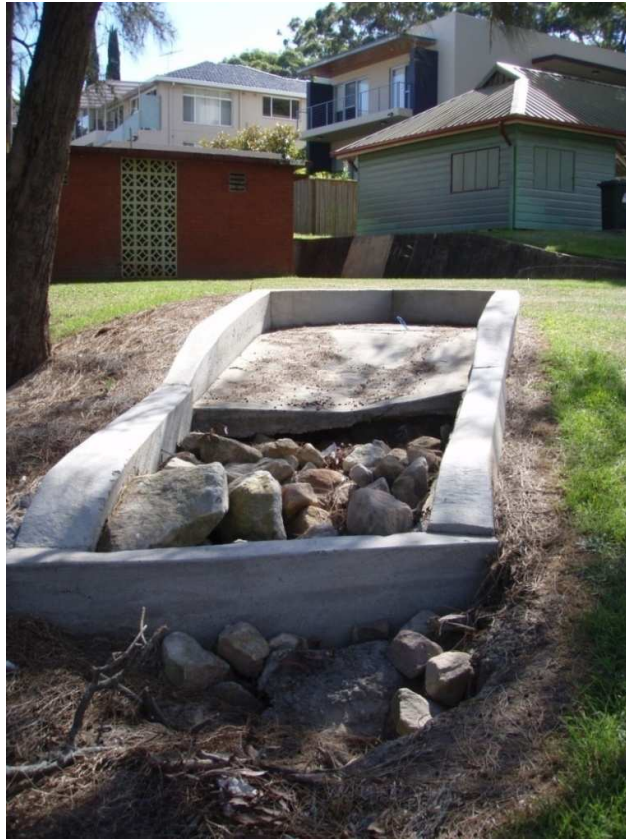
- Another GPT/stormwater overflow outlet was observed at Connells Point Reserve, Kogarah (Figure 7.67). This infrastructure appears to be under-capacity and overflow from the structure appears to have created a gully along the reserve.

*Figure 7.67 – GPT/Stormwater overflow outlet at Connells Point Reserve*

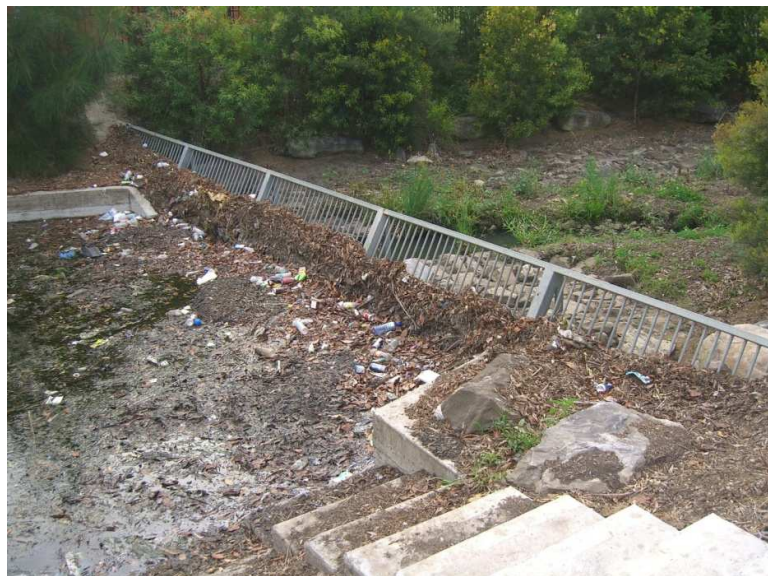
- A GPT was observed near the northern end of Salt Pan Creek (Figure 7.68). This GPT comprises of a trash rack crossing the whole channel trapping the gross pollutants. The GPT was full of gross pollutants during the site visit whereas the channel was almost dry.
- A last type of GPT was observed along Woollooware Bay (Figure 7.69). This GPTs is also comprised of a trash rack crossing the channel in front of a stormwater outlet.

*Figure 7.68 – GPT located at the north-eastern end of Salt Pan Creek*
