FIGURE TITLE Stormwater Outlet Assessment
Liverpool Weir to Vale Of Ah

PROJECT TITLE Georges River Data Compilation
and Estuary Processes Study

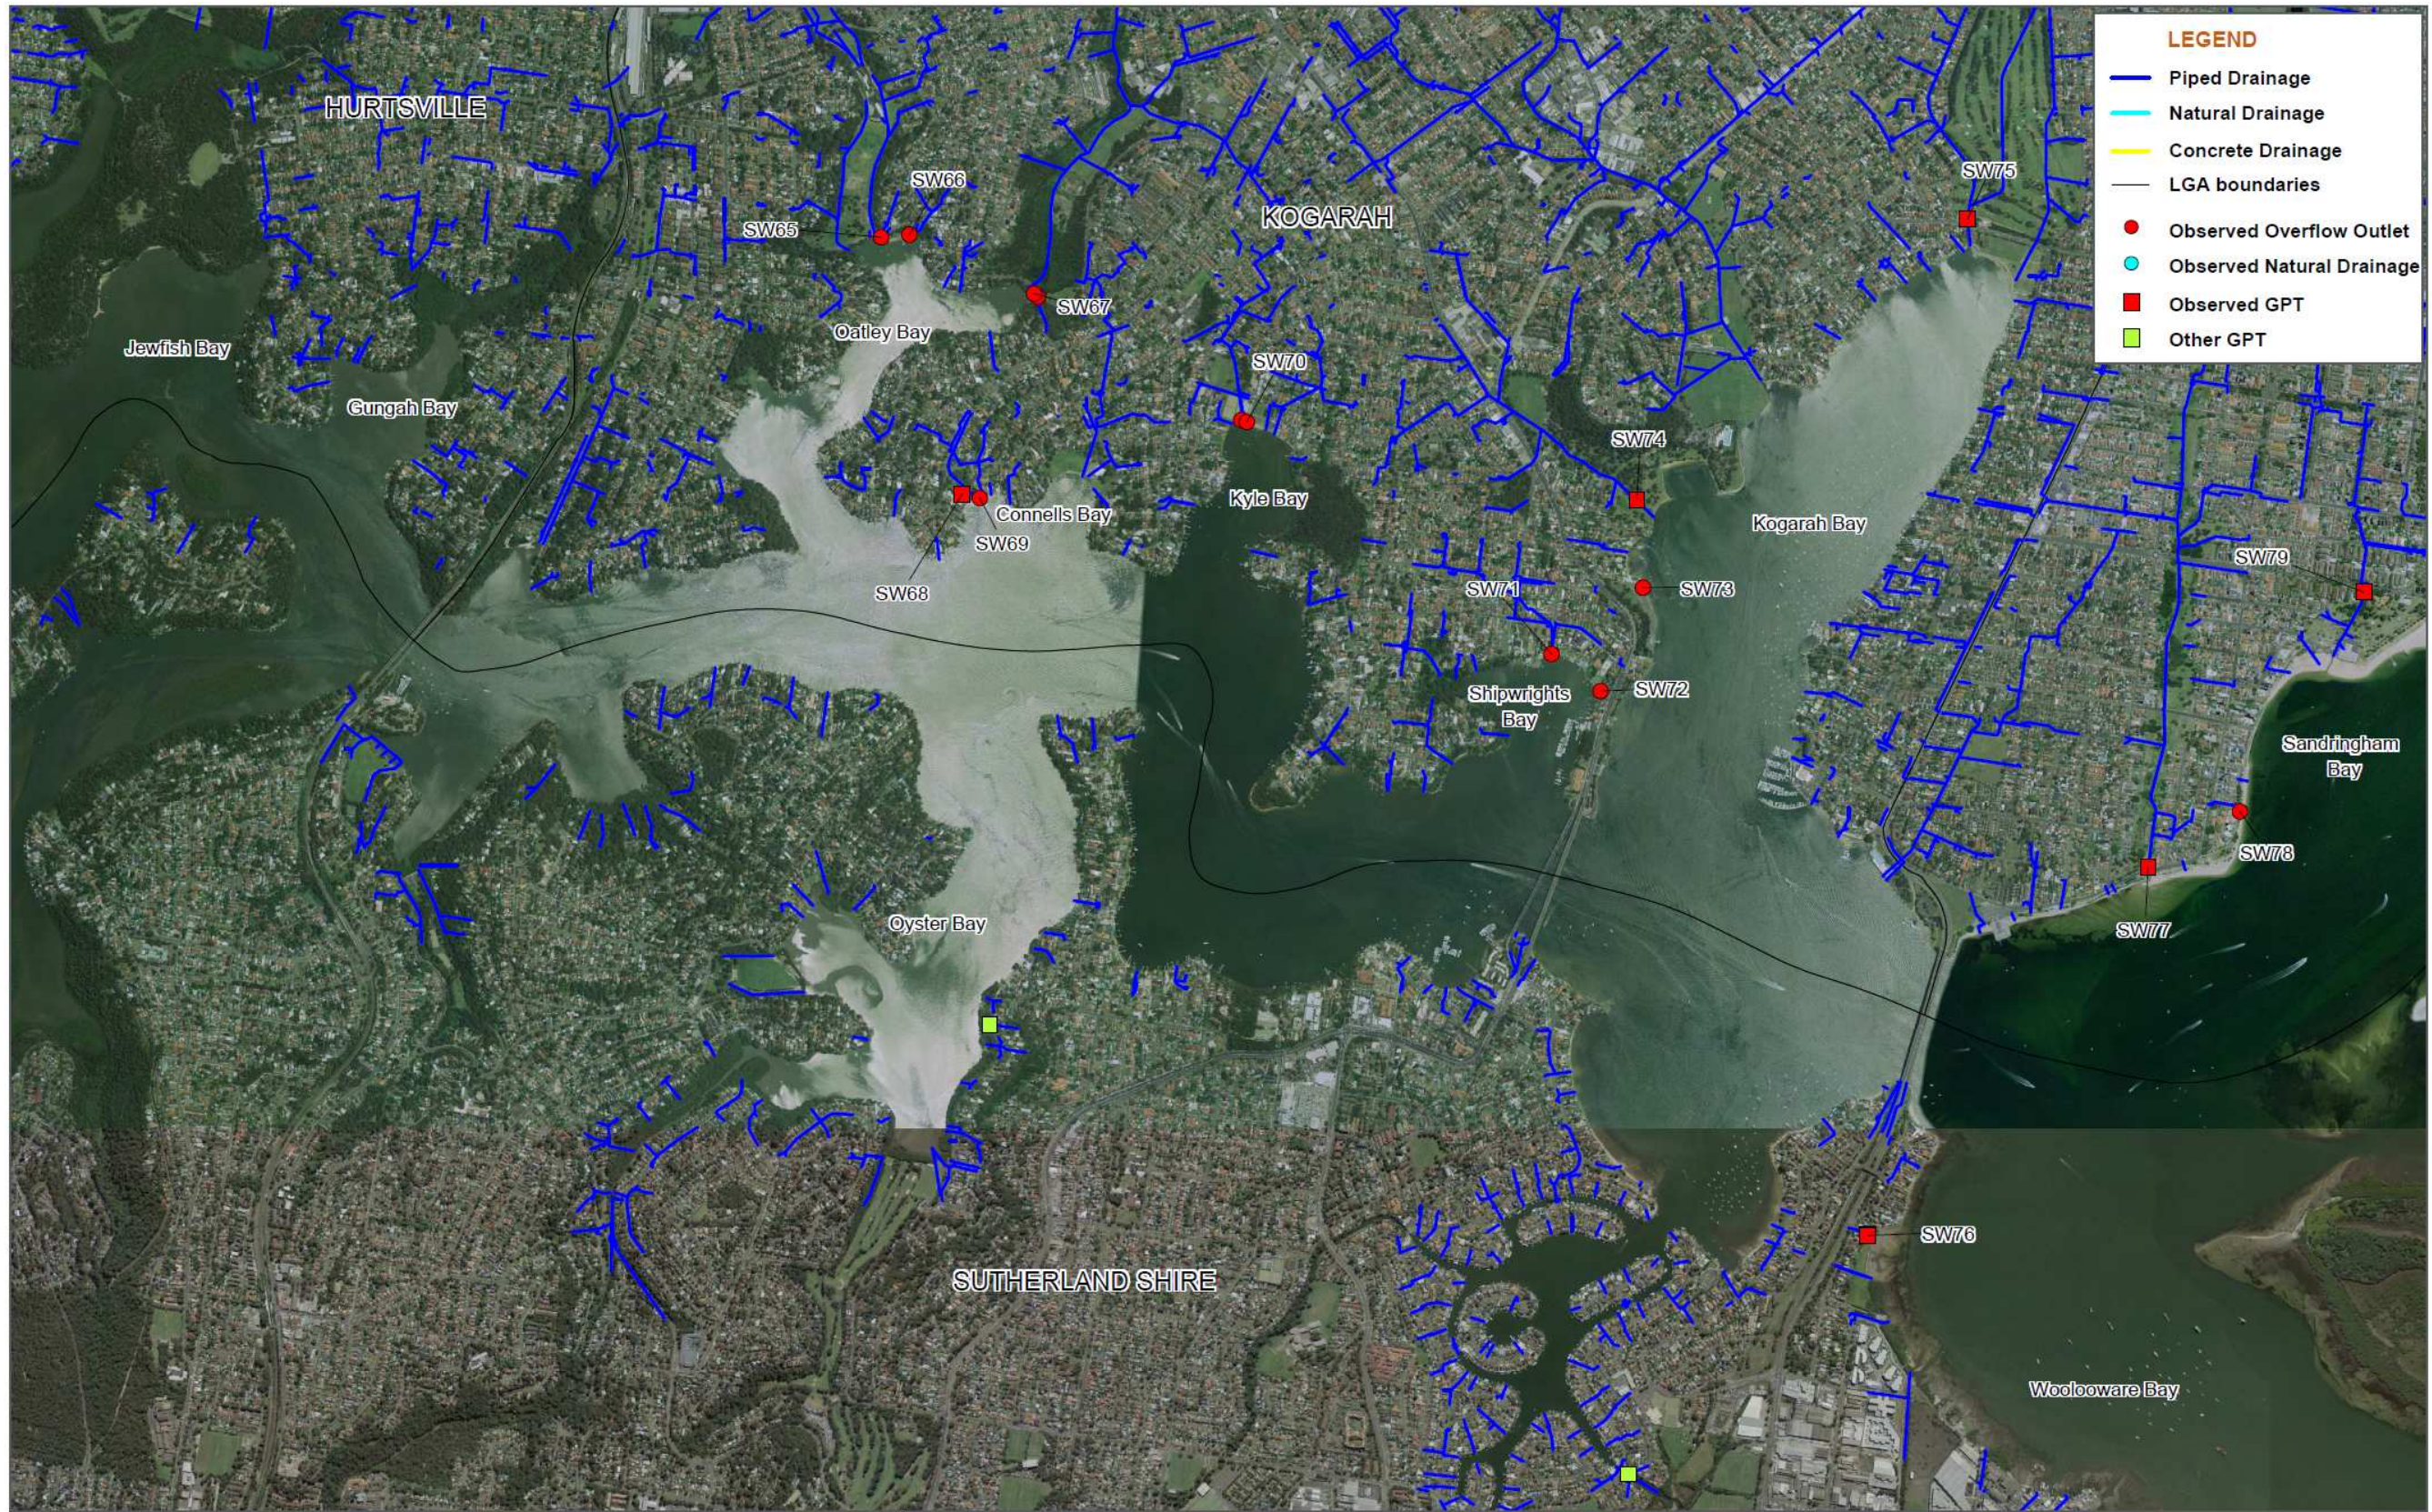
<p>DATE 11/05/2010</p> <p>0 400 800 metres</p> <p>COORDINATE SYSTEM GDA 94 Zone 56</p>	<p>FIG NO. 49</p> <p>FIGURE TITLE Stormwater Outlet Assessment Jewfish Bay to Sandringham Bay</p>	
<p>PROJECT NO. 3001765</p> <p>PROJECT TITLE Georges River Data Compilation and Estuary Processes Study</p>	<p>CREATED BY M. GLATZ</p> <p>LOCATION I:\projects\3001765 - Georges River Estuary Process Study\009DATA\GIS\MapInfo Workspaces</p>
